FIELD OBSERVATION REPORT

West Hardin Middle School, 202280 -CA8

Date: 4/29/2026 Time: 11:30 AM

Report No: 36

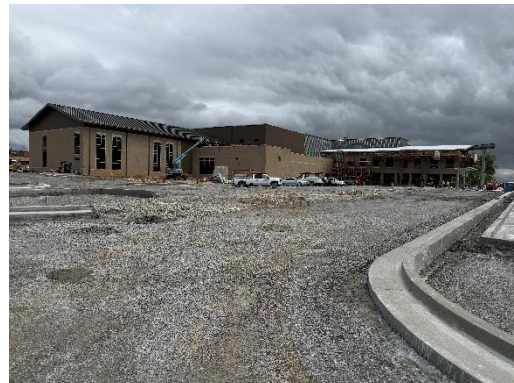
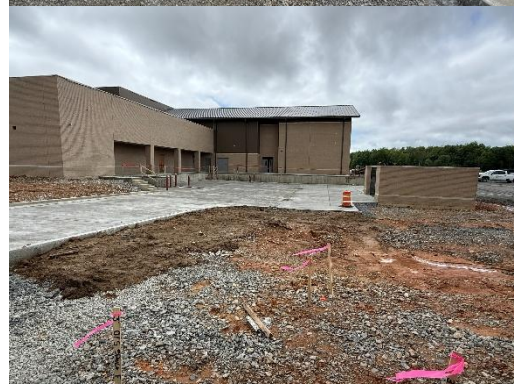
- a) Extruded concrete curbs were being installed site wide. This will allow the base course of the asphalt paving to be laid, making the site easier to navigate and help keep the interior of the building cleaner.
- b) The paved concrete aprons were poured at the loading dock area.

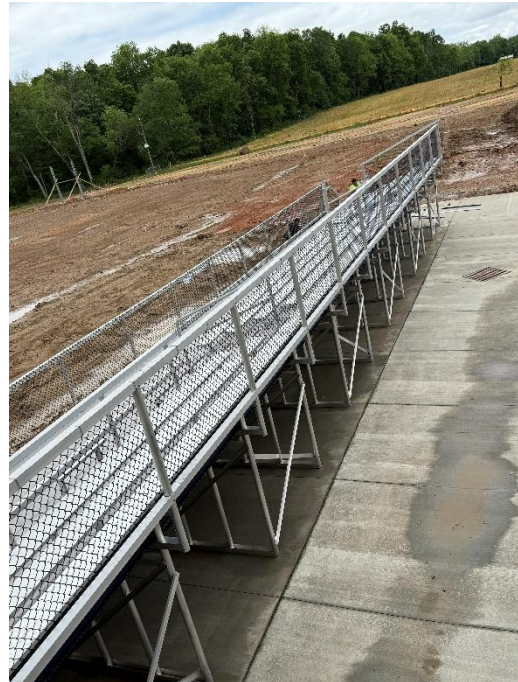
- c) It appeared that the bleachers at the playing field were nearing completion. A punch list inspection of the bleachers is scheduled for Wednesday, May 6, 2026. The bleachers were set on a concrete pad which was poured a few weeks before.

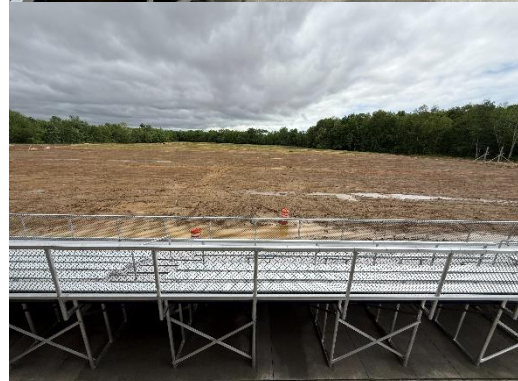
The view from the pressbox and concession stand of the field is excellent.

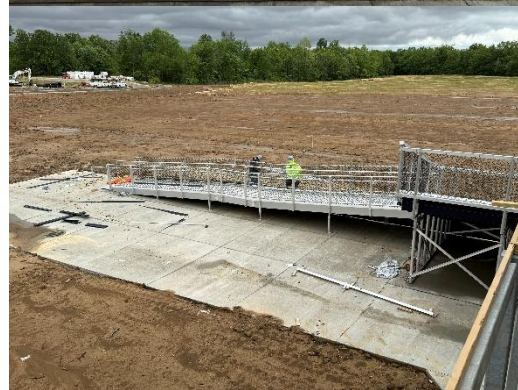
The east end of the bleacher platform is accessible via ramp for accessible viewing positions.

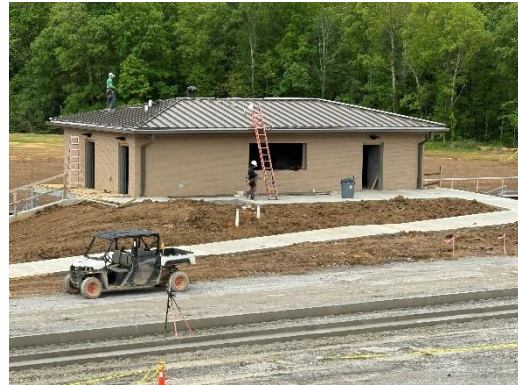
d) The concession building is nearing completion. Electrical and mechanical work was underway.

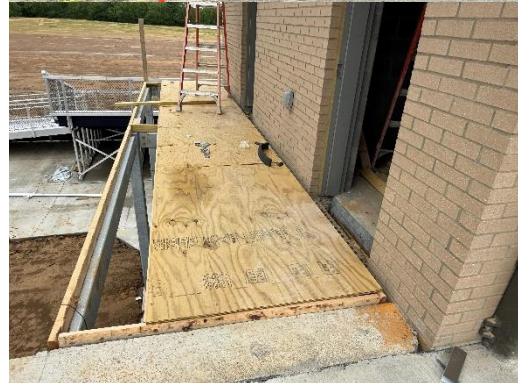
e) Plywood had been installed to gain access to the toilets off the elevated platform to the east of the concessions building.

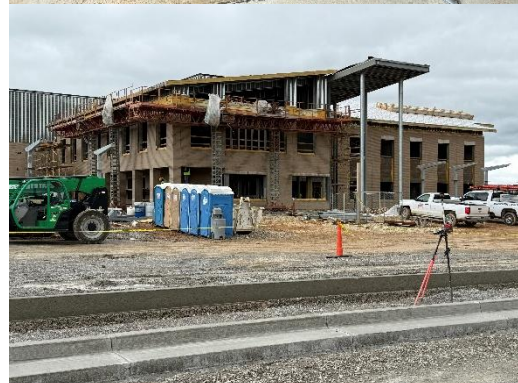
f) Bricks have been laid on the first and second floor of Area A and appeared to be almost complete. This includes the administrative area on the first floor and the library on the second floor.

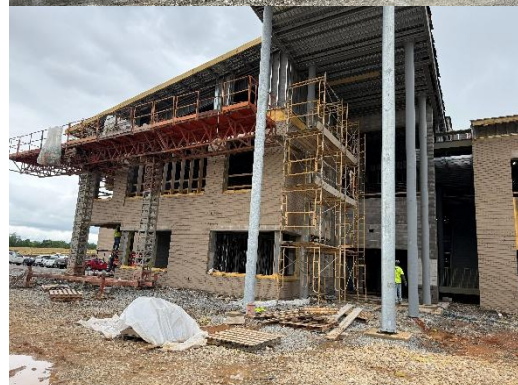
g) It appeared that masonry work was almost complete in the south entry and the library above.

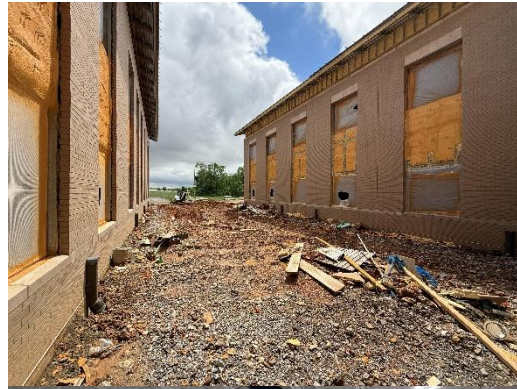
- h) Temporary window closures were in place so that the first coat of paint could be applied in the classroom wings.

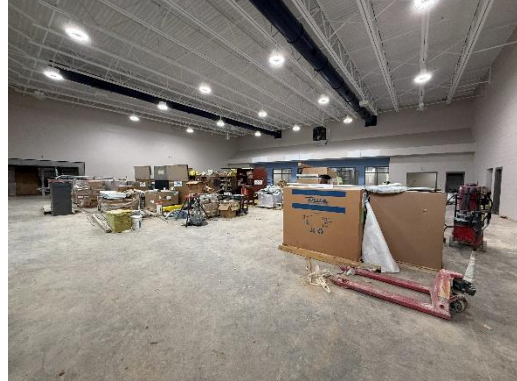
- i) The cafeteria was still being used for equipment and tool storage.

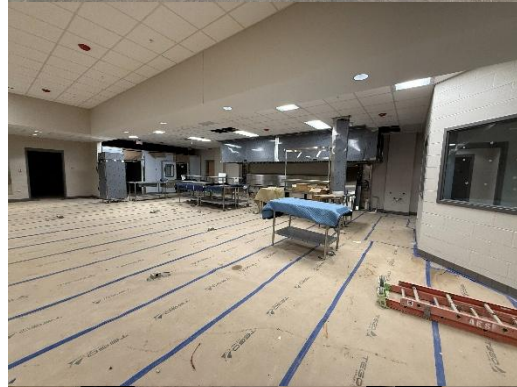
- j) More equipment was installed in the kitchen.

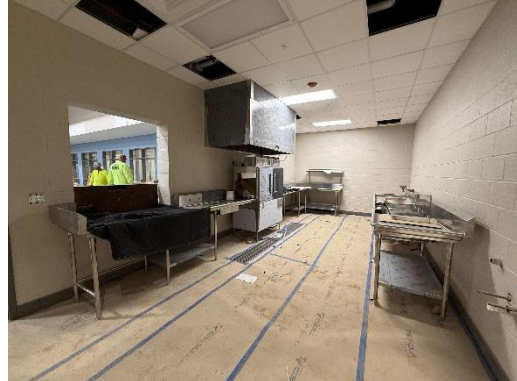
- k) The dish machine was installed along with dish tables.

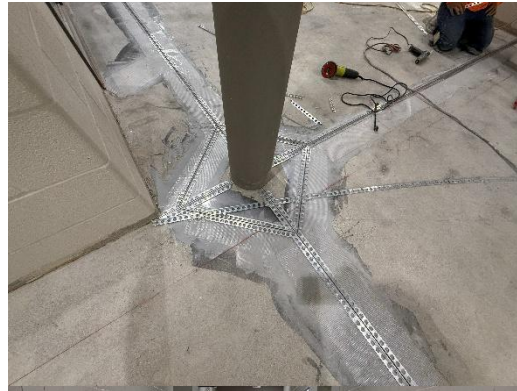
- l) Metal dividers strips for the thin-set terrazzo flooring were put into place in the cafeteria corridor.

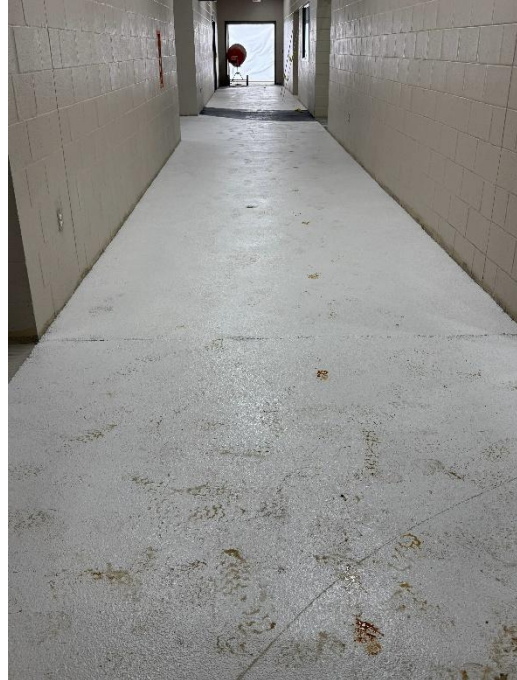
- m) Terrazzo was poured over most of the cafeteria corridor. This area had not been ground.

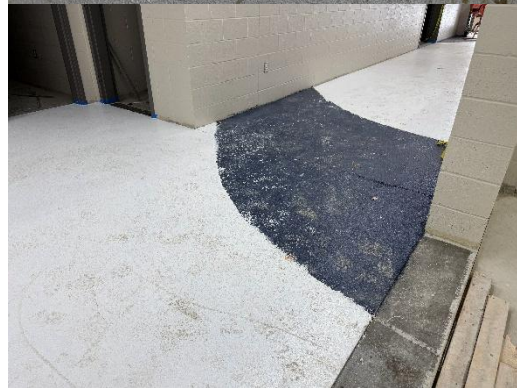
Blue arcs were poured in a similar manner to the stained concrete arcs at East Middle School.

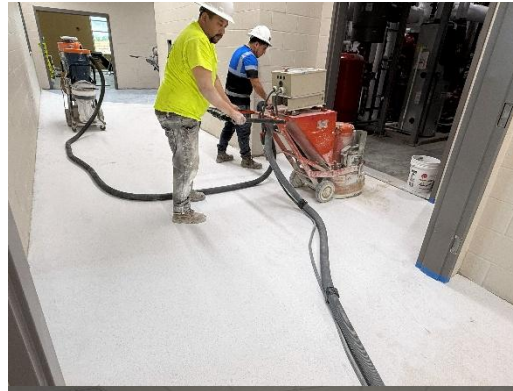
- n) The terrazzo corridor in the music suite was being ground. Workers were trying to keep dust levels down as the grinding generated it.

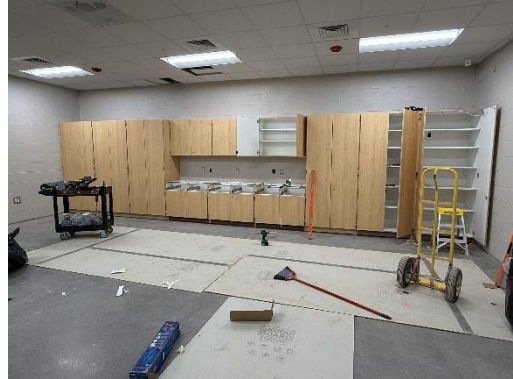
- o) Concrete slabs were being ground in Area D. The slab was polished in the Computer Room allowing the casework to be installed.

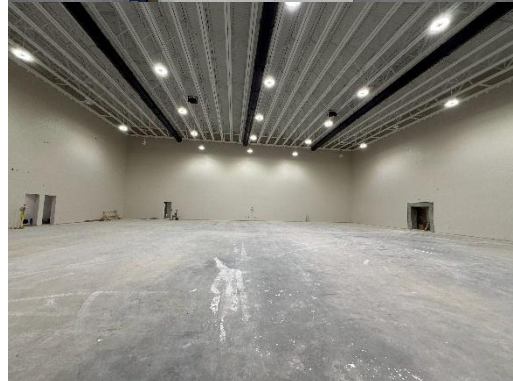
- p) The gym was cleaned and appeared ready to receive the wood strip flooring system. Jeremy continues to monitor moisture levels for the required humidity which must be confirmed before installation can begin.

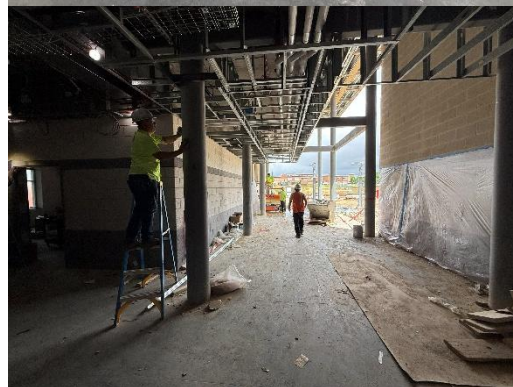
- q) The main corridor will continue to be open until the glass curtainwall system can be installed.

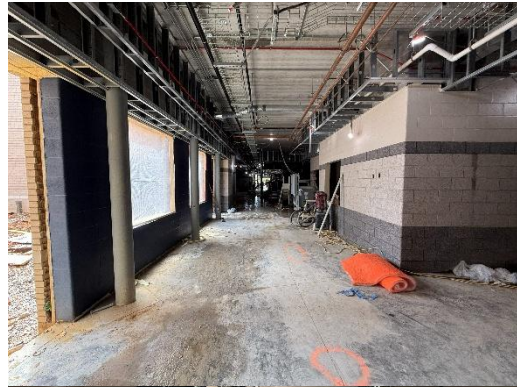
- r) It appeared that a good job is being done to keep the main corridor clean, but until the windows are installed rain will enter the area.

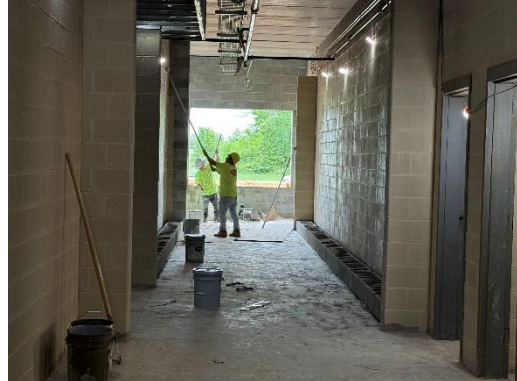
- s) Prime coats of wall paint were being applied in the classroom wings.

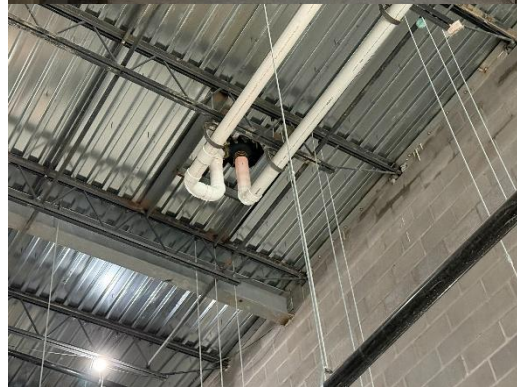
- t) The roof drainage system was installed over the main corridor. Once the base course of roofing is in place, the corridor will be dried in from above.

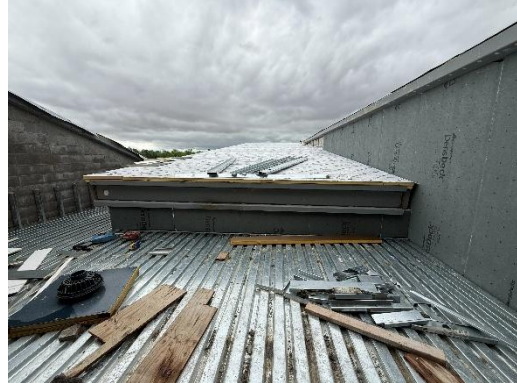
- u) The roof installation over the south entrance was ongoing. The vapor barrier for the sloped metal roof was in place.

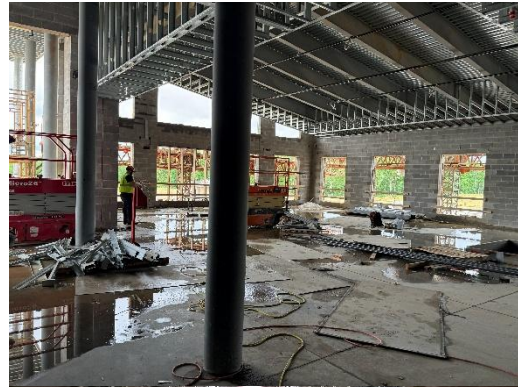
- v) Light gauge metal framing for soffits such as these in the library were being installed.

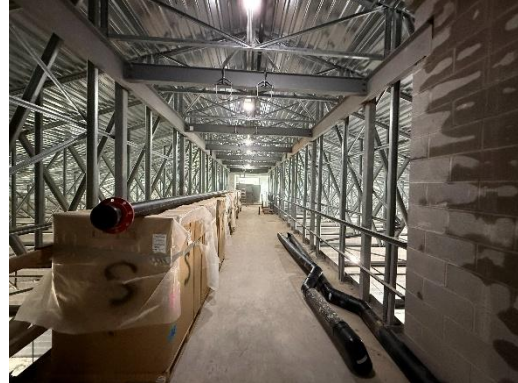
- w) The mechanical platforms over the classroom wings provide an easily accessible area to install HVAC equipment.

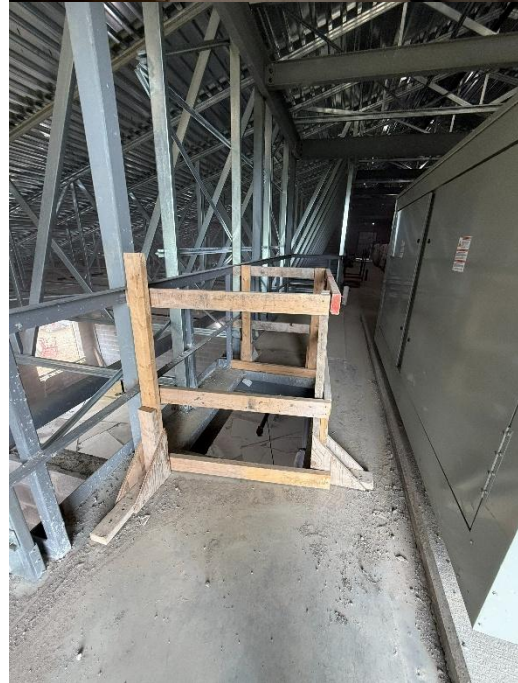
- x) Fall protection was in place at the opening for the vertical ladders at the end of the mechanical platforms over the classroom wings.

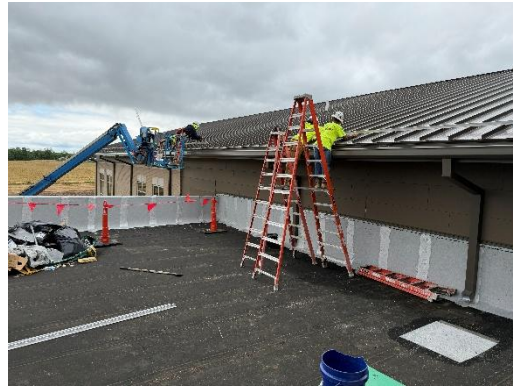
- y) Ice and snow guards were being installed on the sloped metal roofing over Area D.
