## FIELD OBSERVATION REPORT

West Hardin Middle School, 202280 -CA8

Date: 6/9/2026 Time: 1:30 PM

Report No: 38

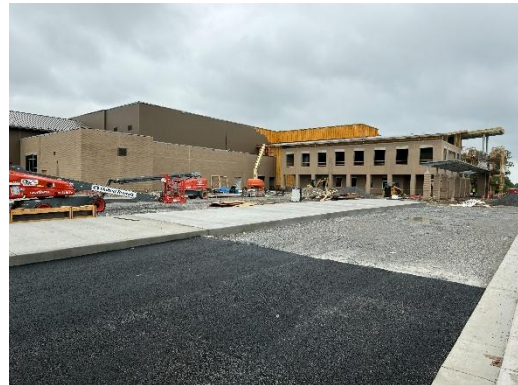
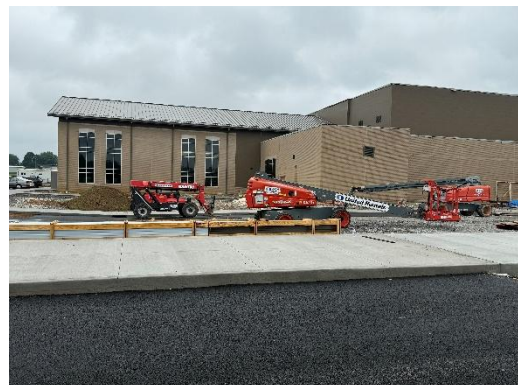
- a) Jeremy has been focusing on getting the entire building enclosed as soon as possible. He noted that Area A is requiring a great deal of work because of the differing roof configurations, the number of windows and doors and exterior finishes. Once this area is enclosed, the entire building can be under environmental control, and finishes can be installed in all areas. Cement panels are not installed on the platform enclosure, and windows are not yet in place.

Area D was the first area to be enclosed. Roofing, windows, doors and exterior finishes are mostly in place.

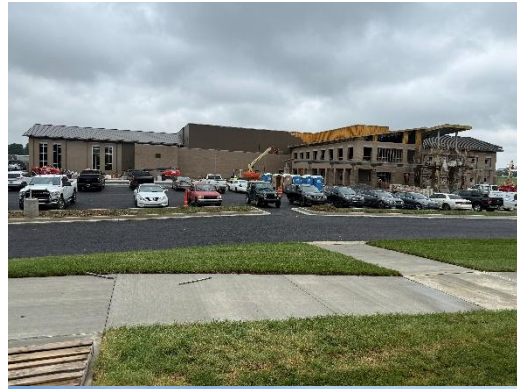
- b) Overall, the building appears capable of being fully enclosed within the next few weeks. After the enclosure is complete, the focus will shift to interior finishes and to mechanical and electrical trim and controls.

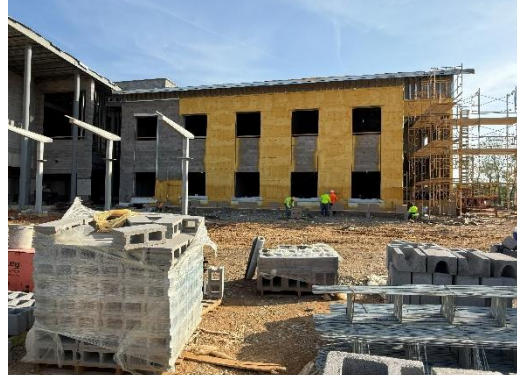
- c) The Area A classroom wing still requires brick and windows to be installed. Some of the spray insulation is not yet in place.

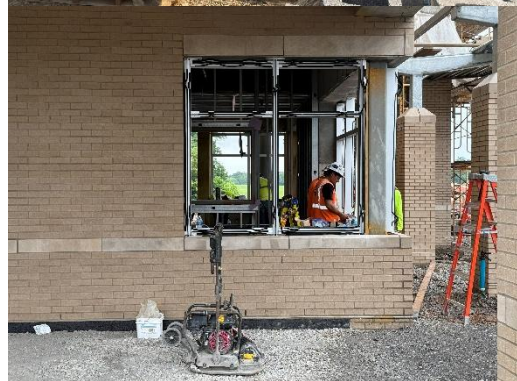
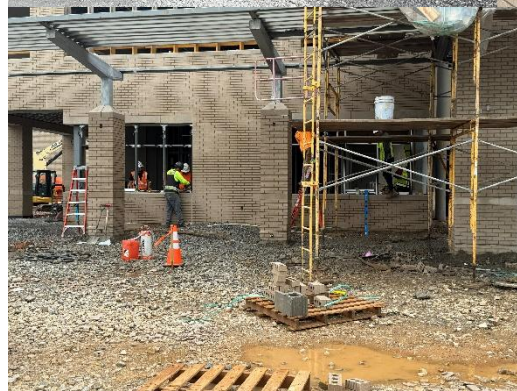
- d) Window framing was being installed in the administrative area at the south entrance to Area A.

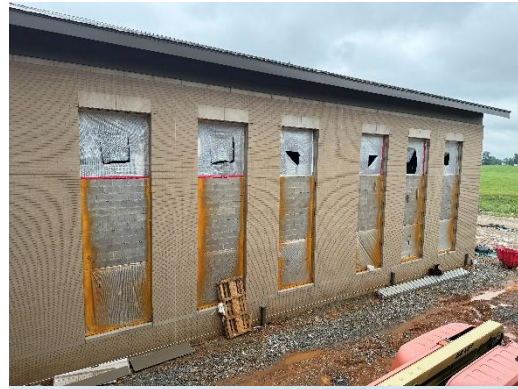
- e) Windows were not yet installed in the exterior walls in the courtyard between the Area A classroom wings.

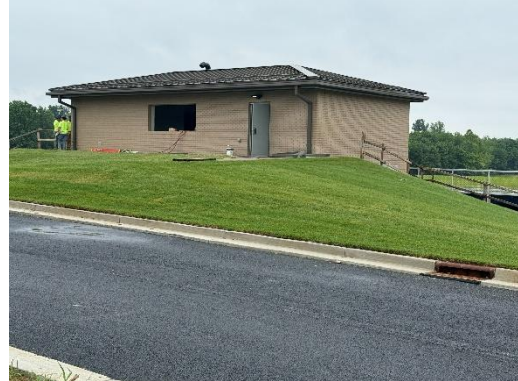
- f) Most of the enclosure for the concession building is in place. Windows and doors were in place. The coiling door at the concessions window was not yet installed.

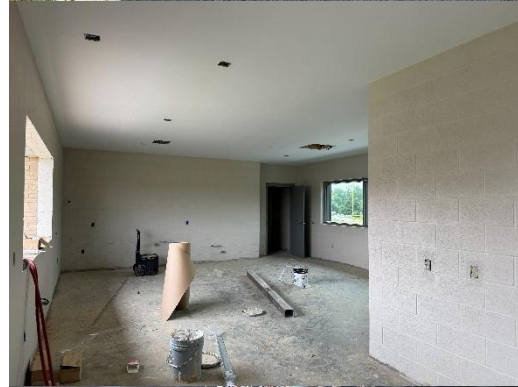
The interior of the concessions building was started and the wallboard ceiling was installed. Block-fill had been applied and the first coat of paint applied to the ceiling.

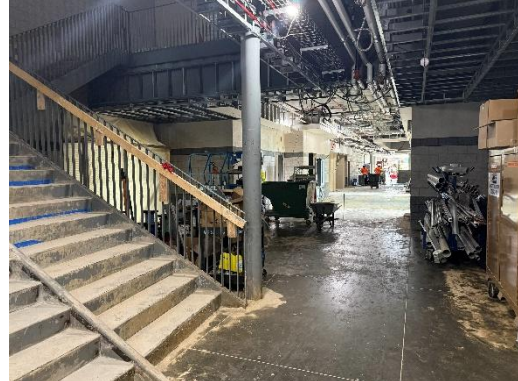
- g) The focus along the main corridor is to install wallboard over the soffit framing, complete the field areas and then hang ceiling tiles.

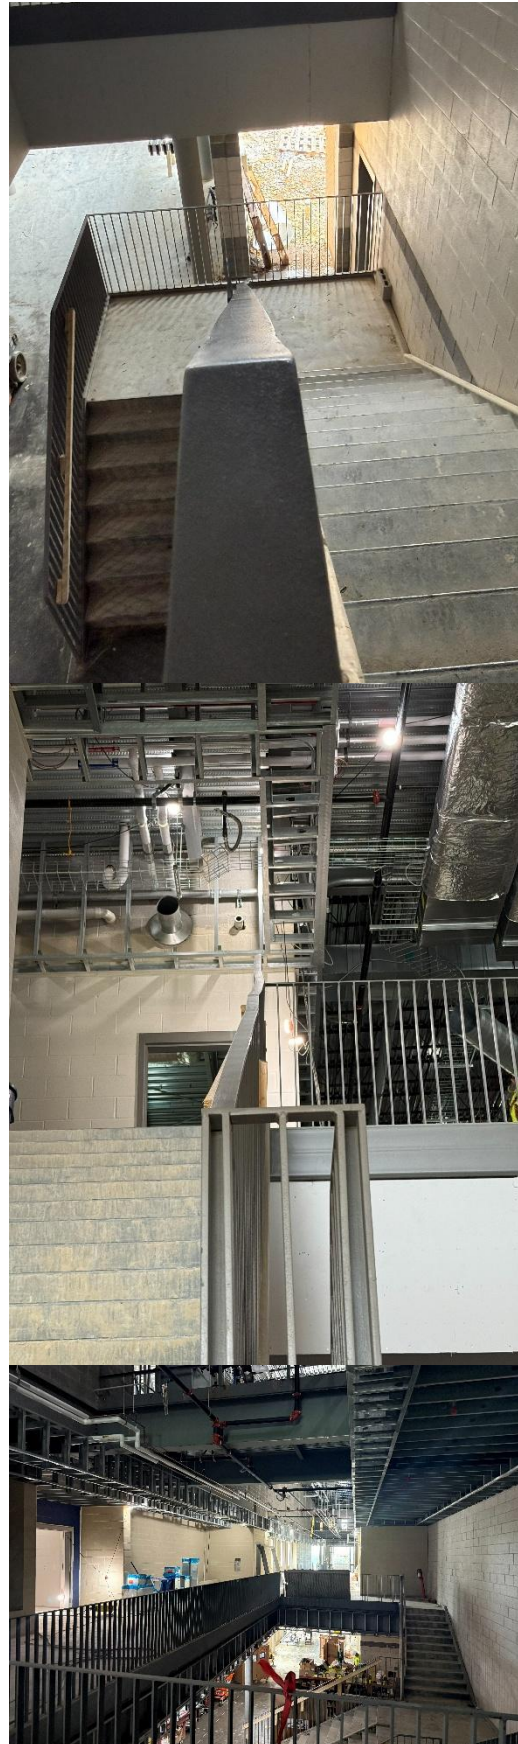
- h) During a recent walkthrough we noted that several of the top rails at the stairs were not straight from end to end.

All the top rails that are out of alignment must be straightened.

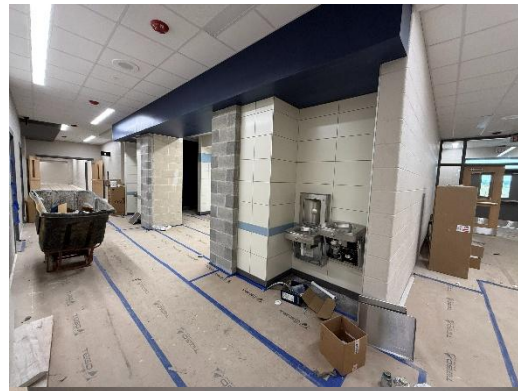
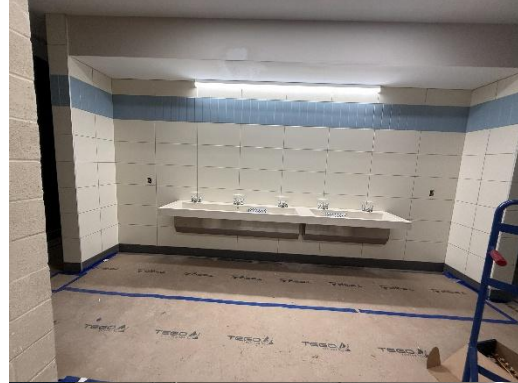
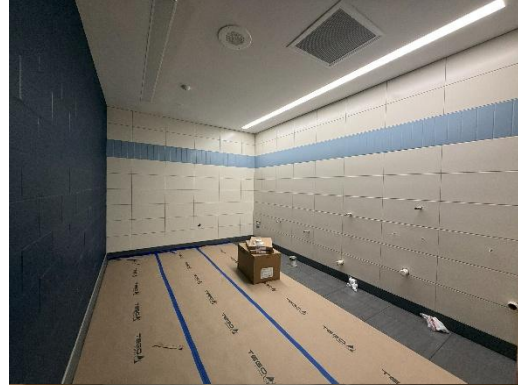
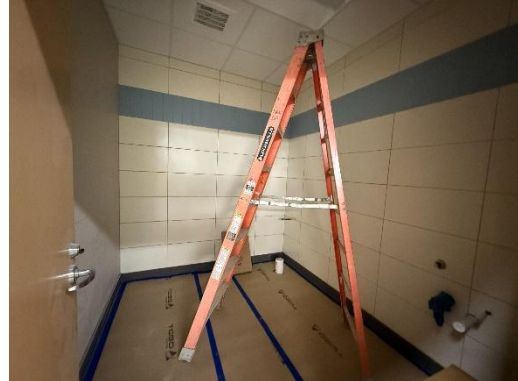
- j) Plumbing fixtures were being installed in Area D. Electric water coolers were being installed in the alcoves near the student toilets.

The handwash sink was installed at the entrance to the student toilets. Horizontal surfaces tend to be used as work benches. The sink material is durable but can still be damaged through improper use. The sink needs to be protected.

- k) With the wall and floor tile in place the toilet room is ready for the plumbing fixtures and toilet partitions.

- l) Wall and floor tiles were installed in the staff toilet in Area D.

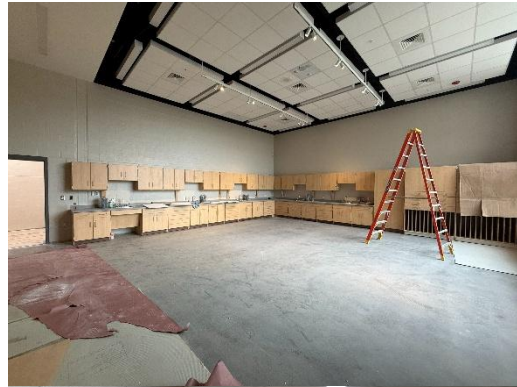
- m) Most of the finishes and cabinets were installed in the art room. The student tables still need to be installed the room.

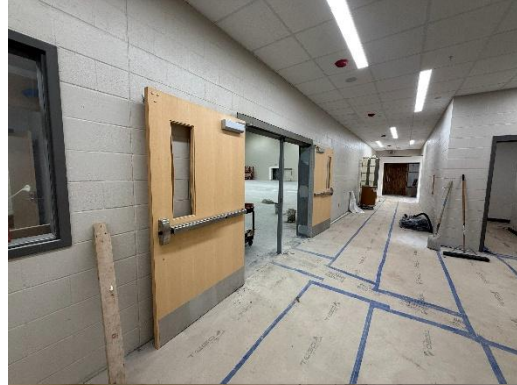
- n) Wood and hollow metal doors were being hunk throughout Area C and D.

These must be protected.

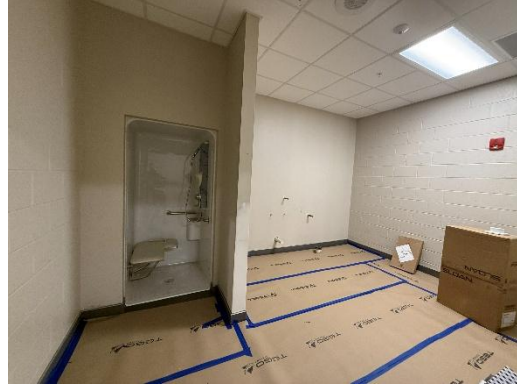
- o) The locker rooms in Area D appeared to be ready to receive the metal lockers.

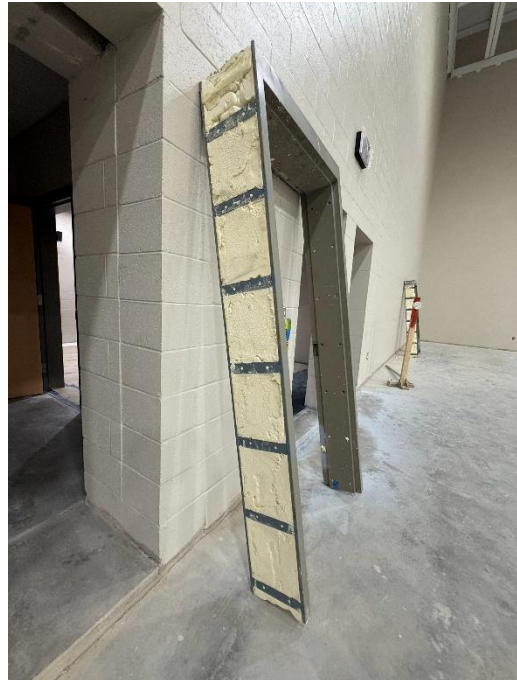
- p) The hollow metal storm shelter door frames were approved by the Kentucky Department of Housing for installation. The system used to install the frames was tested to meet the building code requirements for storm and fire protection of the storm shelter.

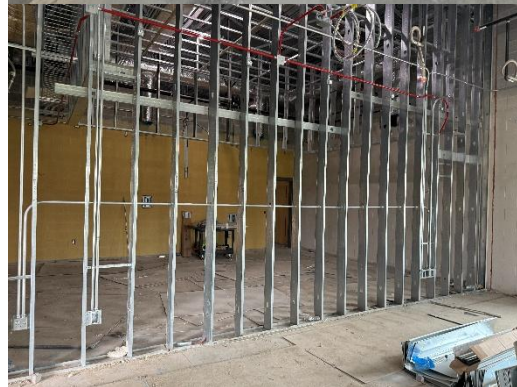
- q) Metal wall and soffit framing appeared to be mostly installed throughout the building. After electrical and plumbing work is complete in the framing, metal bridging is required to be installed.

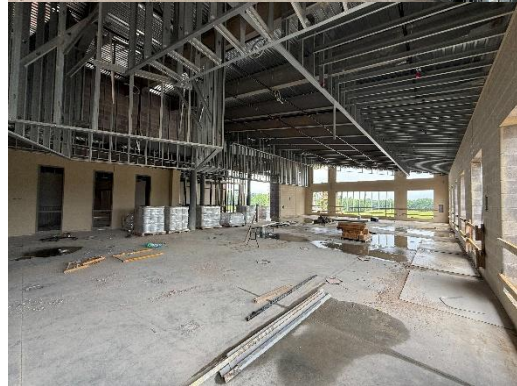
- r) The library will have wallboard soffits and a sloped acoustical ceiling.

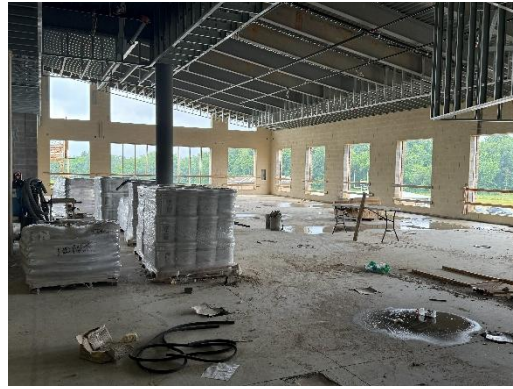
- s) The stacks and reading area for the library is surrounded with windows for natural light.
