FIELD OBSERVATION REPORT #01

2026-06 - Kenton Elementary

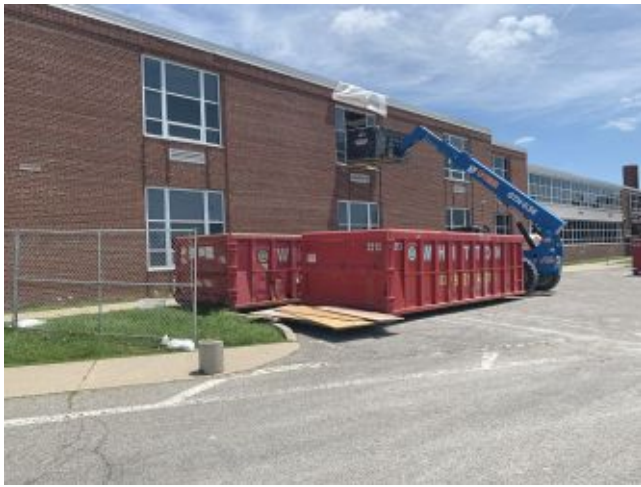
2026.06.04 – Debris removal from 2nd floor

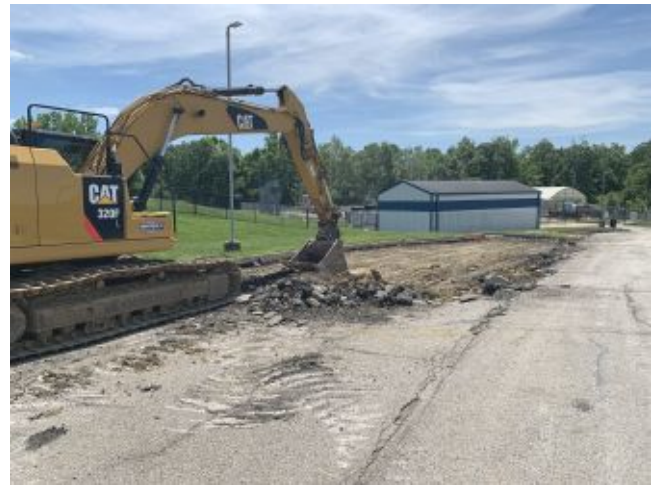
2026.06.04 – Asphalt removal

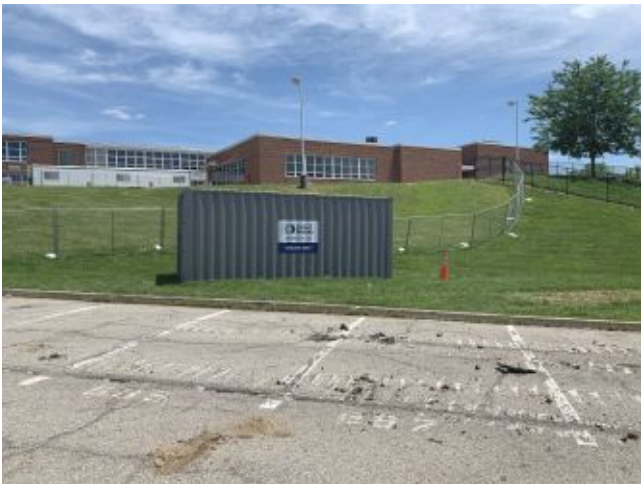
2026.06.04 – Material storage

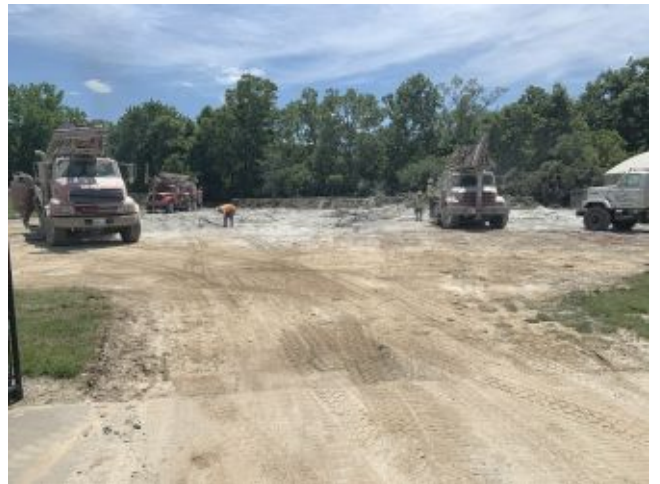
20-28.01: 2026.06.04 – It was reported the first geothermal well was drilled 5/28 and they were drilling #24 or #25 as of this meeting.

2026.06.04 – Geothermal well field installation

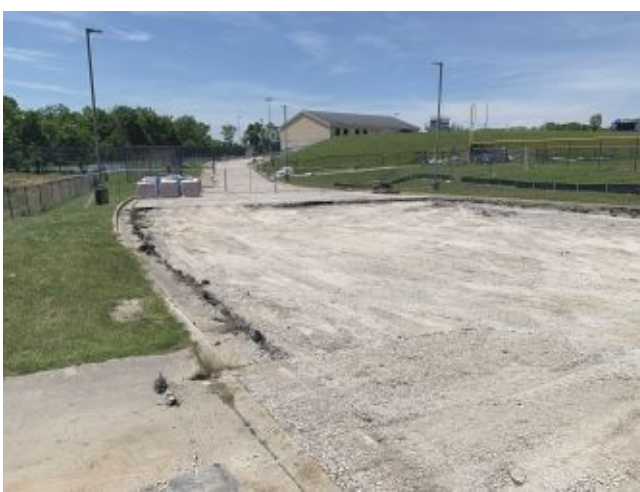
2026.06.04 – Removed asphalt parking

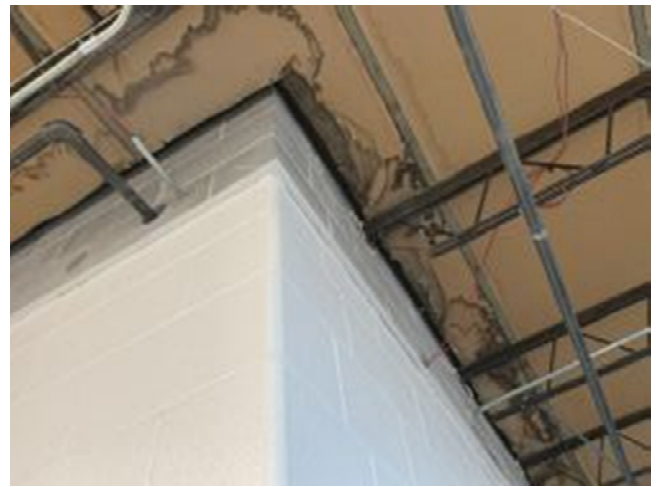
2026.06.04 – Water damage in Classroom #202

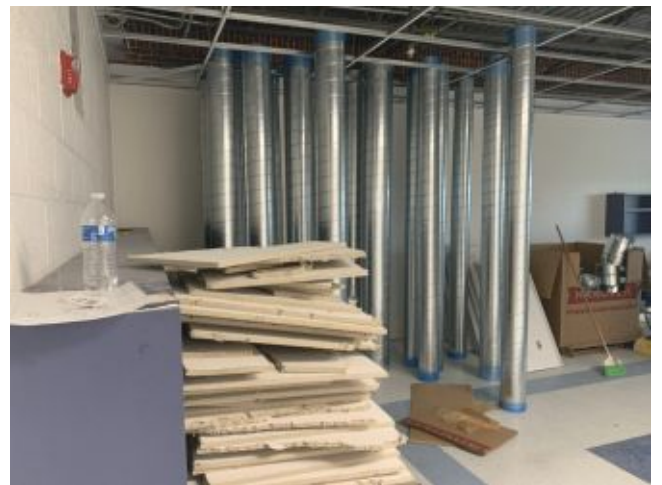
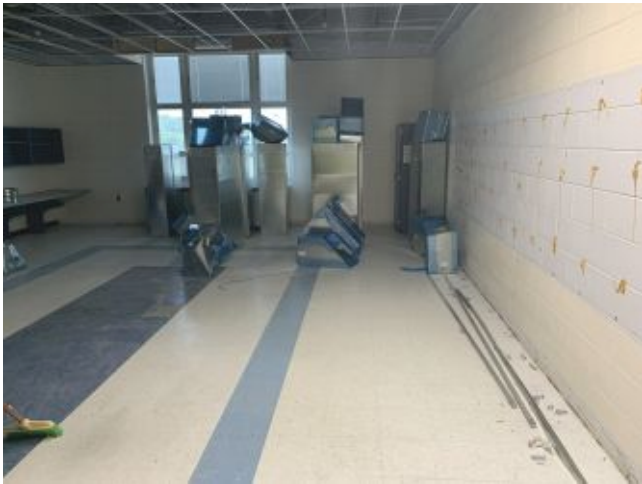
20-28.02: 2026.06.04 – Round ductwork had been staged in Area C of the second floor.

2026.06.04 – Ductwork staged in Classroom #212

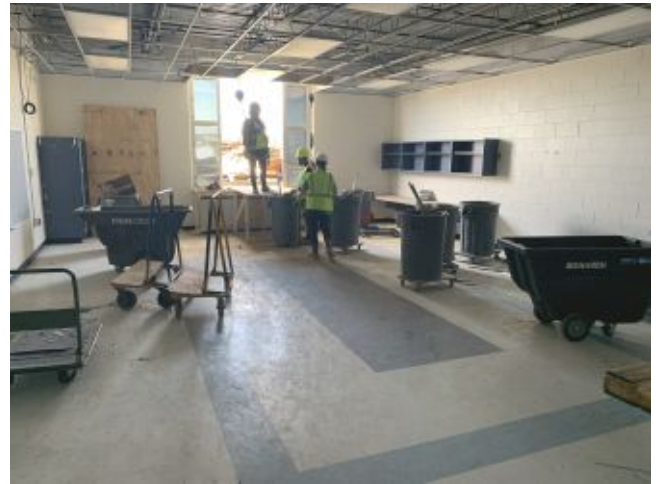
2026.06.04 – Debris removal Classroom #214

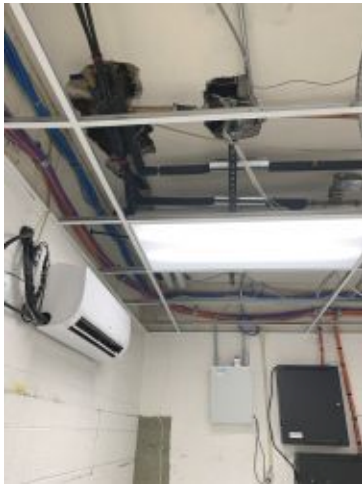
2026.06.16 – Ceiling demo in MDF #100

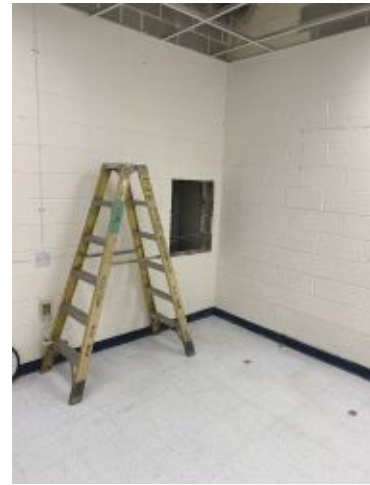
2026.06.16 – Shaft opening in MDF #100

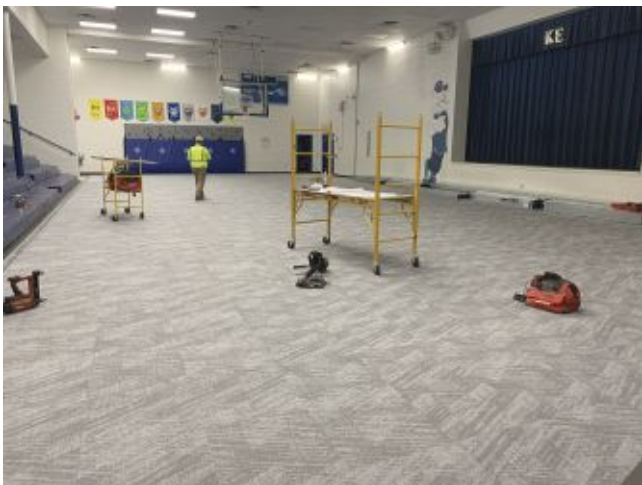
- 09.01: 2026.06.16 – Temporary carpeting had been installed in the gymnasium. Strips of temporary carpeting had been installed where temporary partitions will be installed in the Media Center.
- 09.02: 2026.06.16 – Cold-form-metal-framed partitions had been constructed in Area B of the second floor except in Classroom #202.

2026.06.16 – Gymnasium temporary carpet

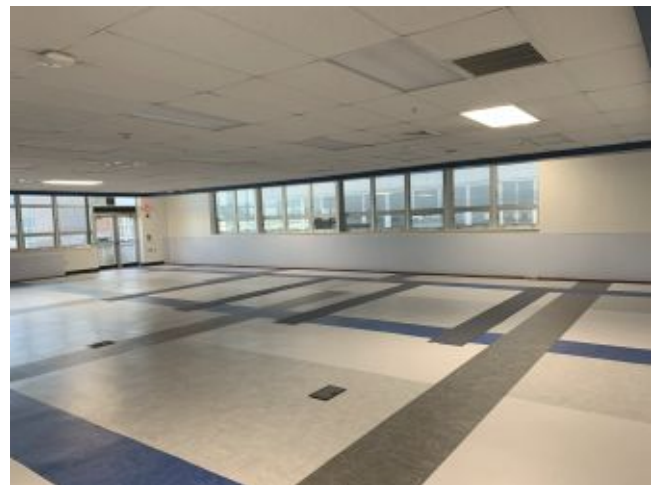
2026.06.16 – Media Center temporary carpet strips

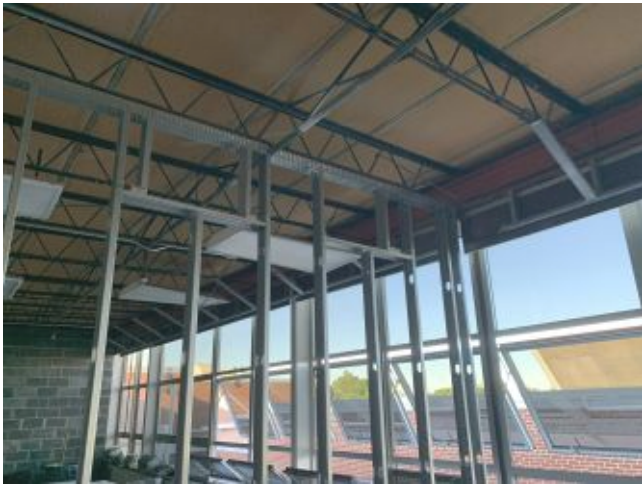
2026.06.16 – Framing between Classrooms #204 & #206

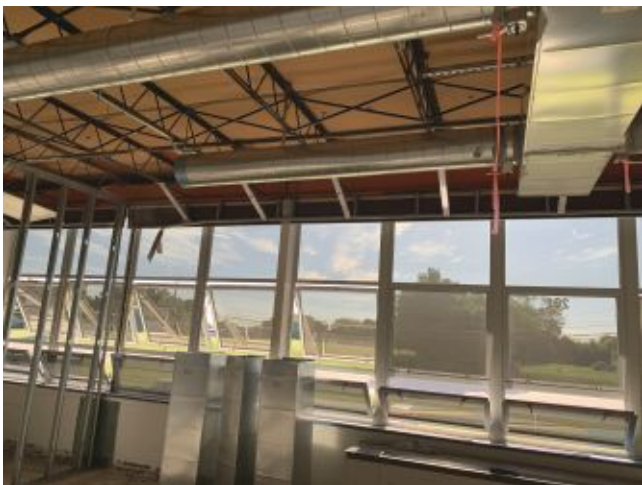
20-28.03: 2026.06.16 – Ductwork installation had begun in Area B of the second floor.

2026.06.16 – Ductwork installation in Classroom #201

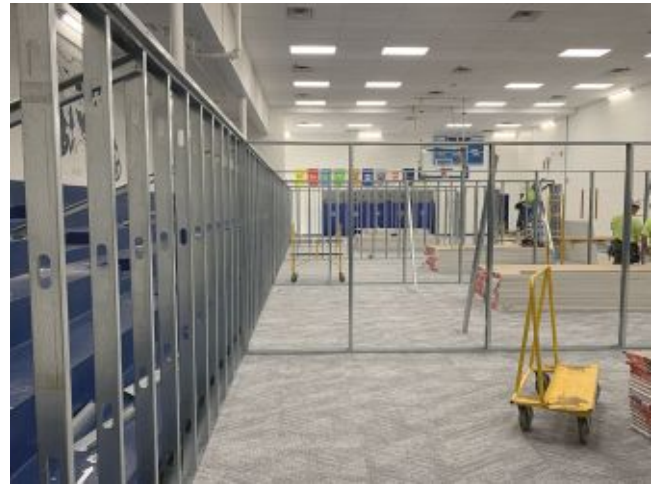
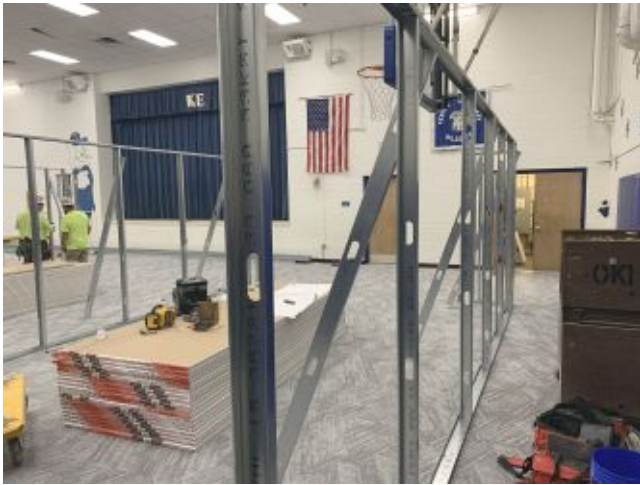
09.03: 2026.06.18 – Temporary wall framing was 50% complete in the gymnasium. Gypsum board was staged for installation.

2026.06.18 – Gym temporary classroom framing

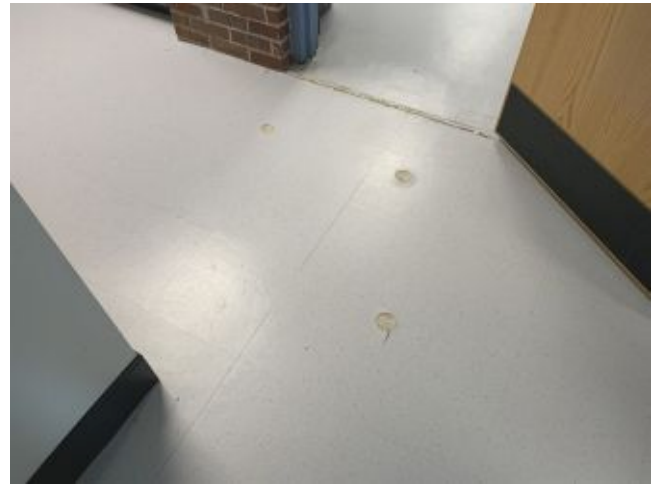
2026.06.18 – General office slab jacking locations
