## FIELD OBSERVATION REPORT #3

Powell County Elementary Vestibules, 202568.00 -CA8

Date: 8/25/2026 Time: 8:30 AM CT Weather: 70°/Sunny

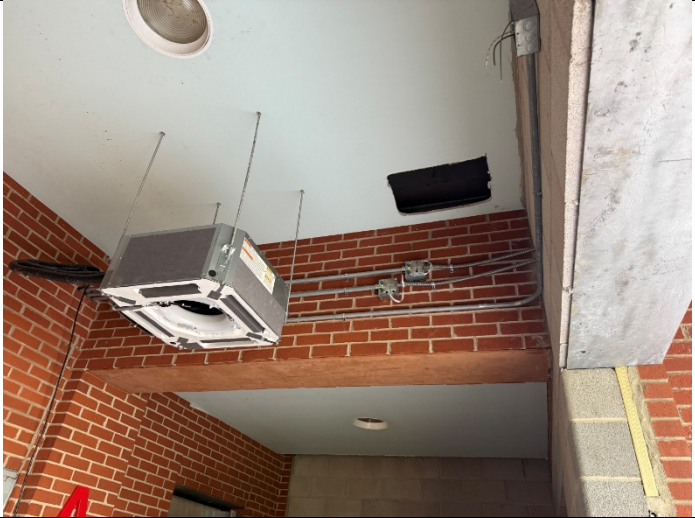
| Item No. | Location | Description | Image |
|---|---|---|---|
| 2.2. | CCES - Vestibule | Mechanical unit roughed-in in ceiling. Attic access hole cut into existing ceiling. Electrical conduit and boxes roughed-in. | |

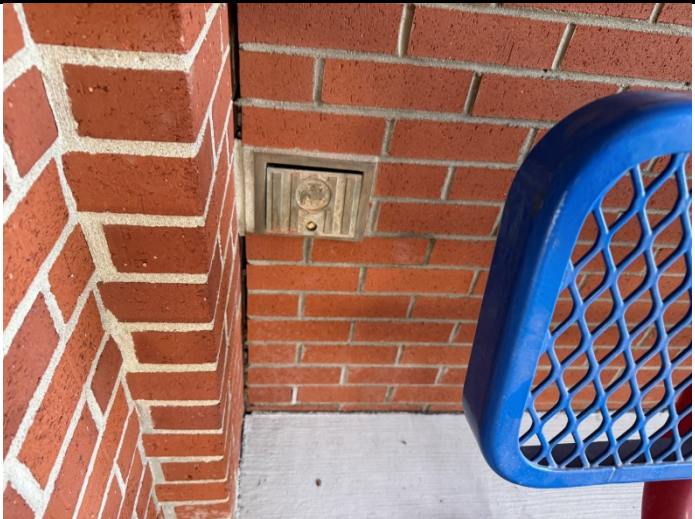
| Item No. | Location | Description | Image |
|---|---|---|---|
| 2.3. | CCES - Vestibule Exterior | Exterior hose bibb relocated to new side wall. At interior, CMU chase has been built | |

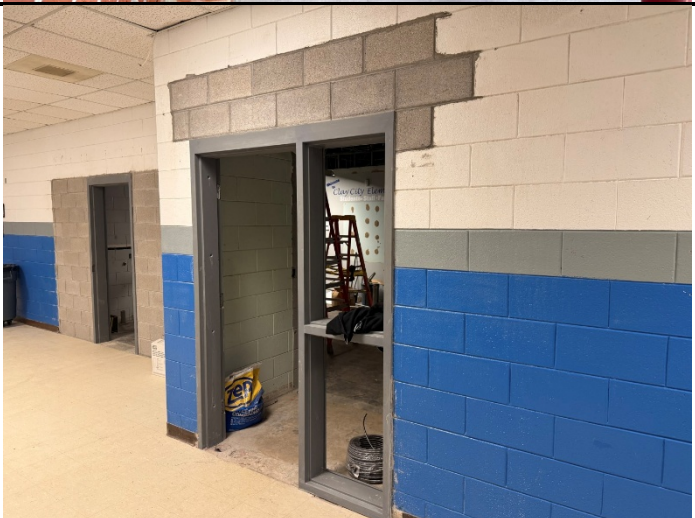
| Item No. | Location | Description | Image |
|---|---|---|---|
| 2.4. | CCES - Corridor | New Hollow Metal door frames set in place and CMU walls infilled. | |

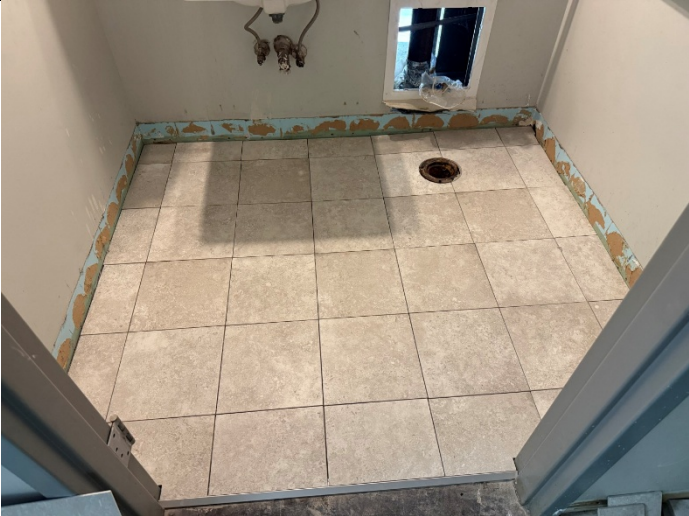
| Item No. | Location | Description | Image |
|---|---|---|---|
| 2.5. | CCES - Staff Restroom | Ceramic floor tile installed. Tile base to be installed followed by grouting. | A photograph showing a room with a floor covered in large, light-colored square ceramic tiles. The walls are white, and there is a small window on the right wall. A drain is visible in the center of the floor. |

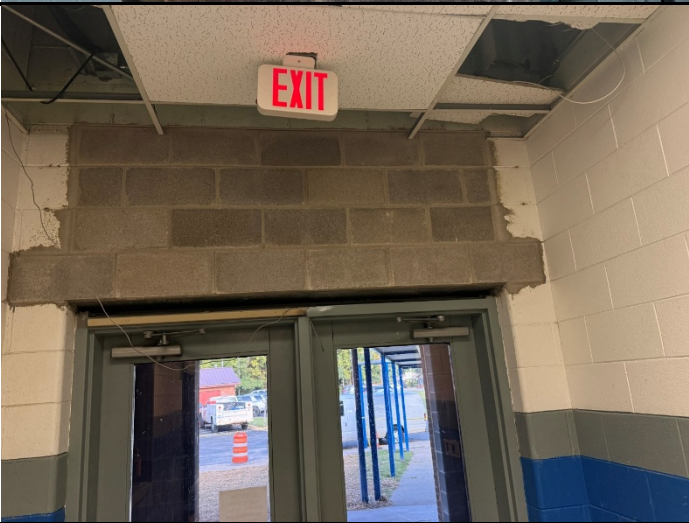
| Item No. | Location | Description | Image |
|---|---|---|---|
| 2.6. | CCES - Corridor | Transom of old front door has been removed and new lintel and CMU wall infill above for frame has been installed. Waiting on new exterior door to be installed before setting new HM door frame | A photograph of a doorway in a corridor. Above the door frame, a new lintel and CMU wall infill have been installed. A red "EXIT" sign is mounted on the wall above the door. The door is currently open, showing the exterior. |

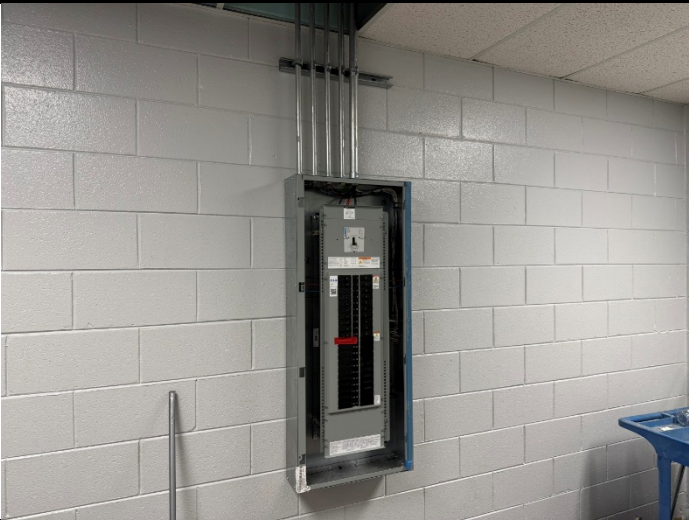
| Item No. | Location | Description | Image |
|---|---|---|---|
| 2.7. | CCES - Records Room/Office | New electrical panel set and wires run to it. | A photograph of a new electrical panel mounted on a wall. The panel is open, showing internal components. Wires are run to the panel. The wall is made of light-colored cinder blocks. |

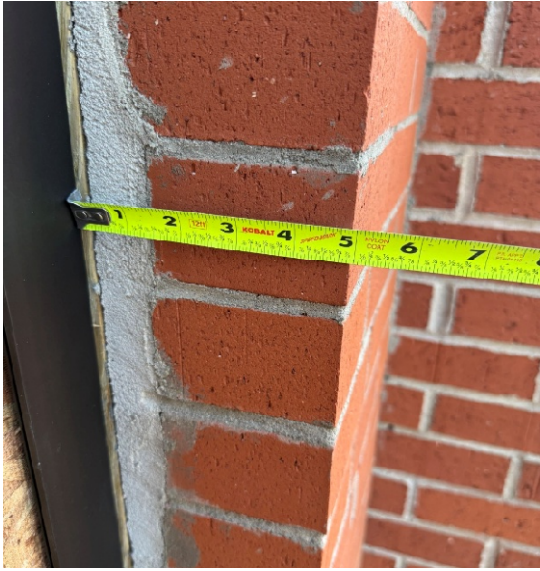
| Item No. | Location | Action Required | Image |
|---|---|---|---|
| 3.1. | CCES - Aluminum Windows | Aluminum window frames are set back from the front edge of brick too far at 5". Too much mortar and wood blocking showing. Reset all aluminum frame windows so they are a min. of 3" from face of brick and cover back edge of brock. | |

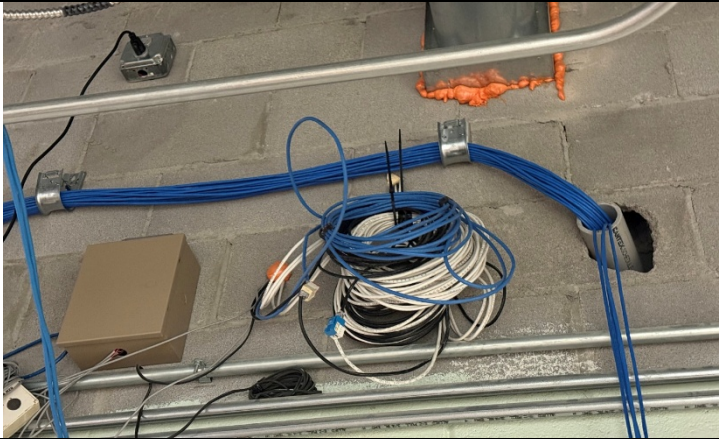
| Item No. | Location | Action Required | Image |
|---|---|---|---|
| 3.2. | CCES - Office | Any new penetrations oin CMU wall along corridor need to be fire caulked to pass building inspection | |

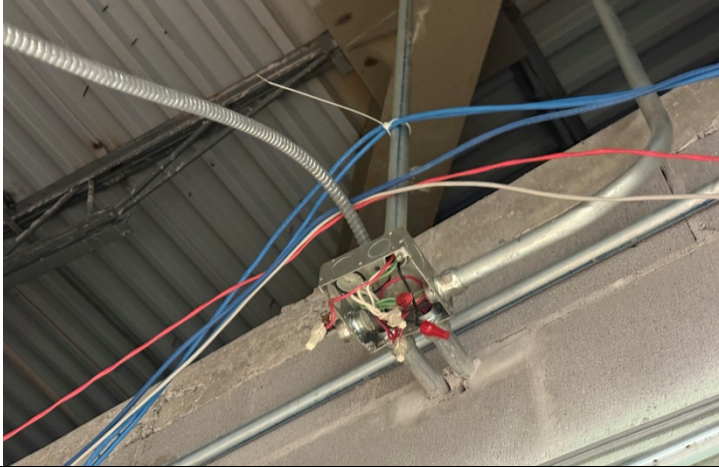
| Item No. | Location | Action Required | Image |
|---|---|---|---|
| 3.3. | CCES - Office space | Open electrical boxes above the ceiling need to ne address before ceiling grid is install at the end of August. Coordinate between electrician and district. | |

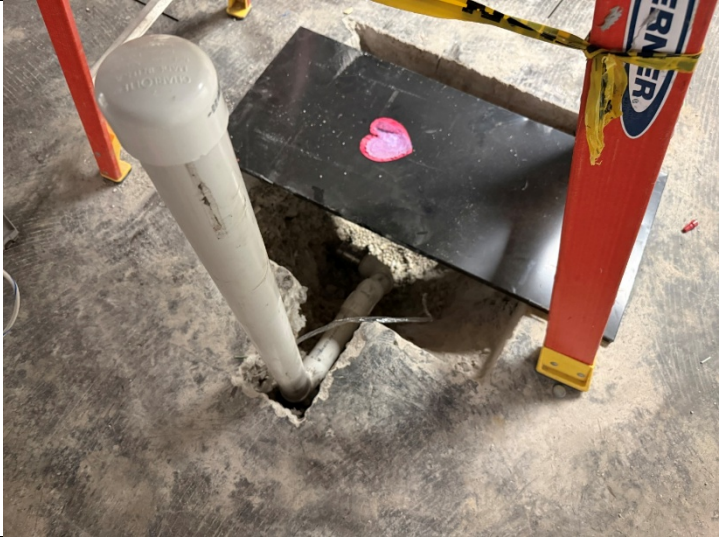
| Item No. | Location | Action Required | Image |
|---|---|---|---|
| 3.4. | CCES – Office | Once plumbing inspection has occurred, infill and r new concrete slab. Can start metal stud framing | |

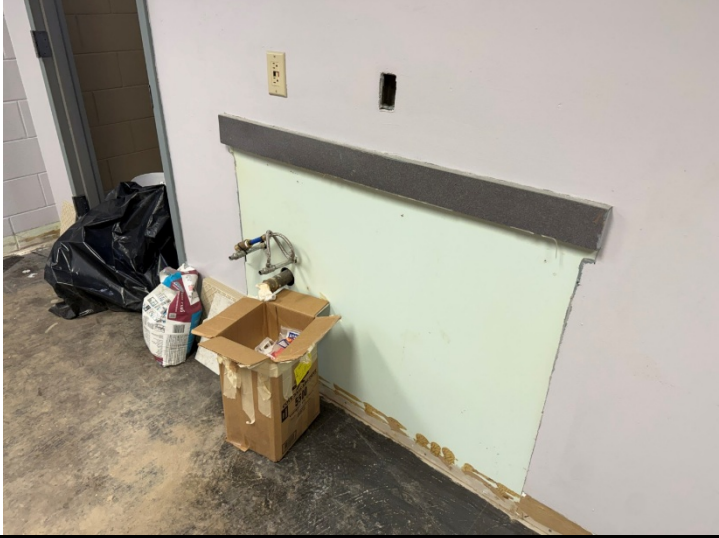
| Item No. | Location | Action Required | Image |
|---|---|---|---|
| 3.5. | CCES – New Principal's Office | Remove and cap water lines behind wall and remove backsplash at old sink cabinet location. | |

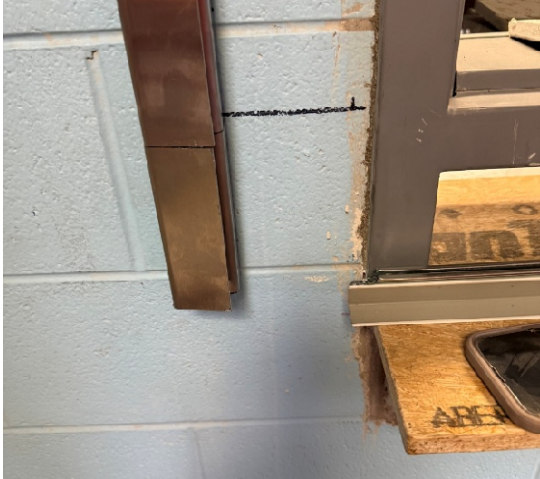
| Item No. | Location | Action Required | Image |
|---|---|---|---|
| 3.6. | BES - Vestibule | Small segment of stainless steel guide rail is not acceptable, replace entire track. | |

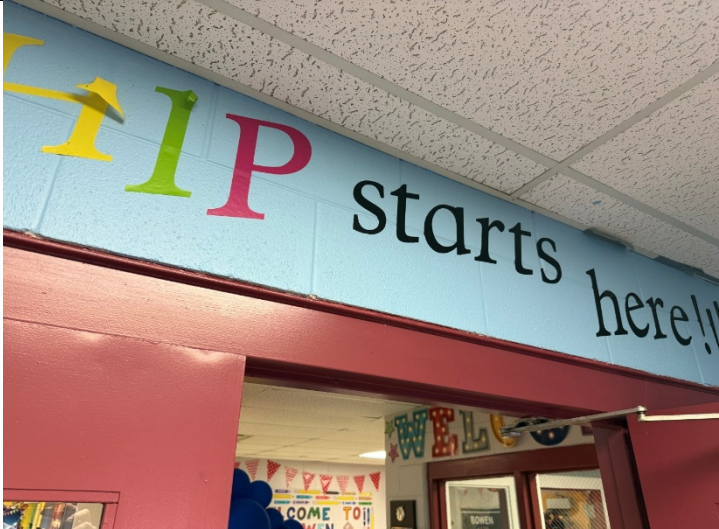
| Item No. | Location | Action Required | Image |
|---|---|---|---|
| 3.7. | BES – Vestibule | Door Access Controls at inner Vestibule doors are missing and need to be installed to make this a safe entry vestibule. | |

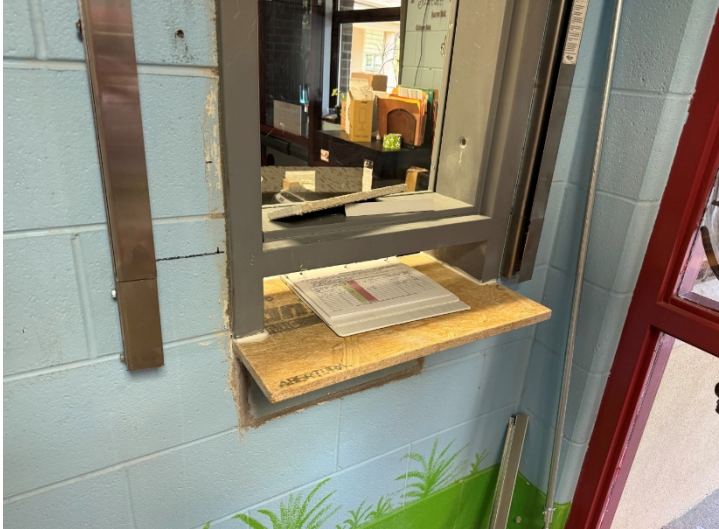
| Item No. | Location | Action Required | Image |
|---|---|---|---|
| 3.8. | BES - Vestibule | Size of pass-thru counter verified with owner 12" deep from face of HM frame and 1" pass the outer sides of track. Inside office, countertop to be flush with HM frame at face & sides | |

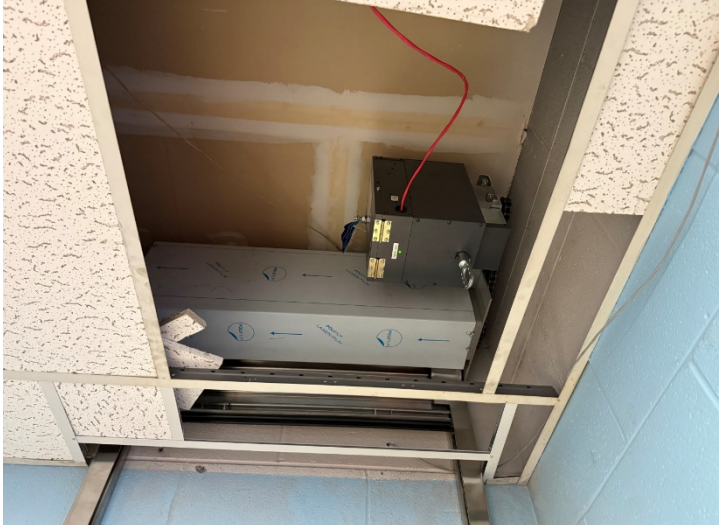
| Item No. | Location | Action Required | Image |
|---|---|---|---|
| 3.9. | BES - Vestibule | Owner would like a 4" dia. Grommet type of hole in ceiling tile so manual crank of rolling counter door can be reset without removing tile | |

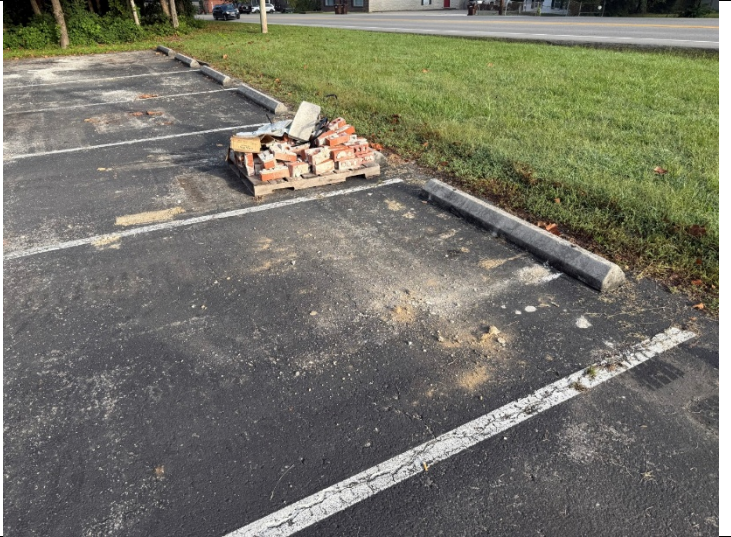
| Item No. | Location | Action Required | Image |
|---|---|---|---|
| 3.10 | CCES – Parking Lot | Pallet of original brick removed from brick piers to be turned over to owner for future repairs to be turned over to the owner. | A photograph of a parking lot showing a pallet of original bricks removed from brick piers. The bricks are stacked on a wooden pallet in the center of a parking space. The surrounding area is asphalt with some grass and a concrete curb. |
