CHANGE ORDER REQUEST

Project Name: West Hardin Middle School

DESCRIPTION OF CHANGE: **PR 3 – Unsuitable Soils at Pond**

West Hardin Middle School
Re: PR 003 - Unsuitable Soils at Pond

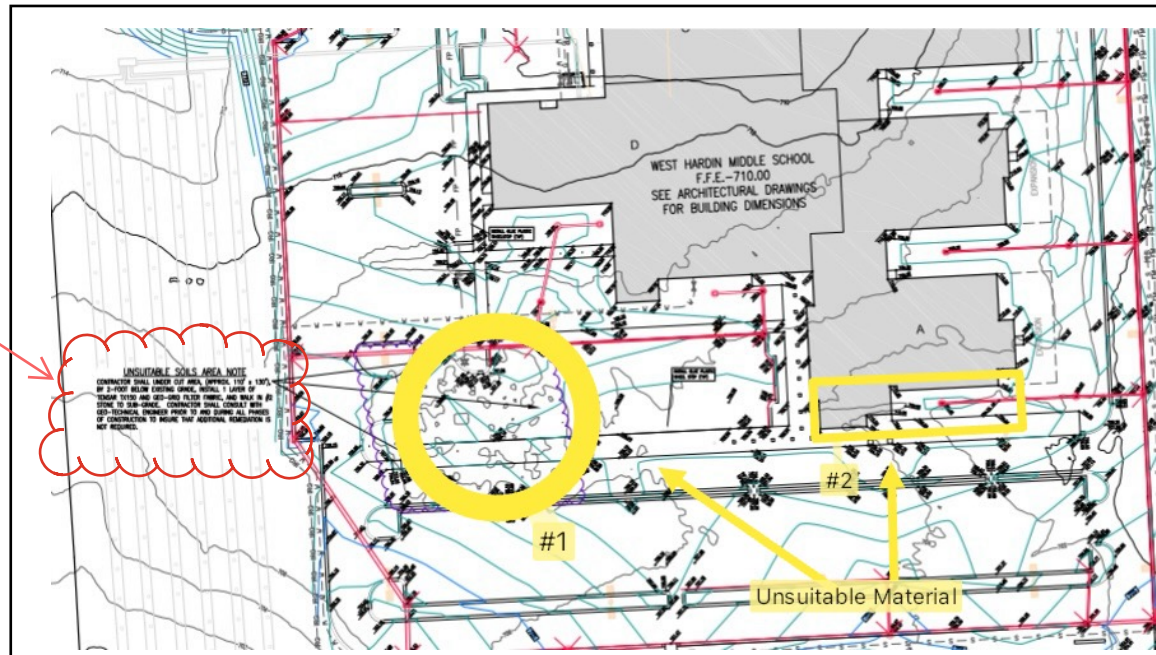
Reference Image from PR-003 and Solid Ground's Report

On site, Solid Ground Consulting Engineering, has identified that at the Pond Area, the proposed 2' undercut material to be inadequate for Tensar use. Added remediation needed to bridge over softer than expected material with high organics. Contractor to provide pricing for 2 options noted below.

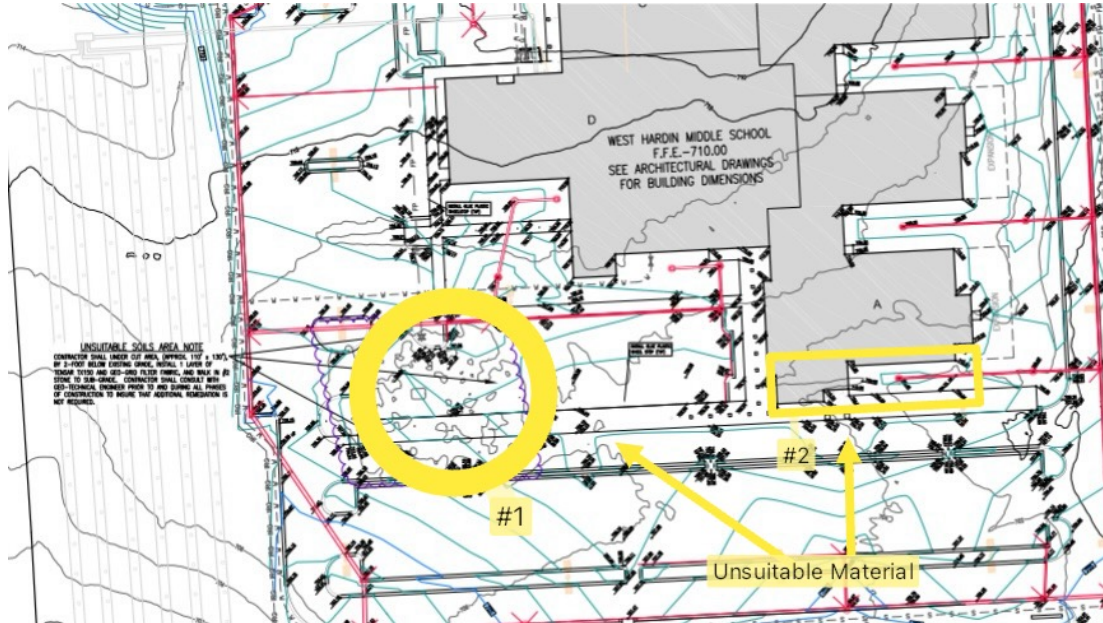
(1)

Solid Ground rep was on site today to observe two areas with unsuitable material, as highlighted in the drawings.

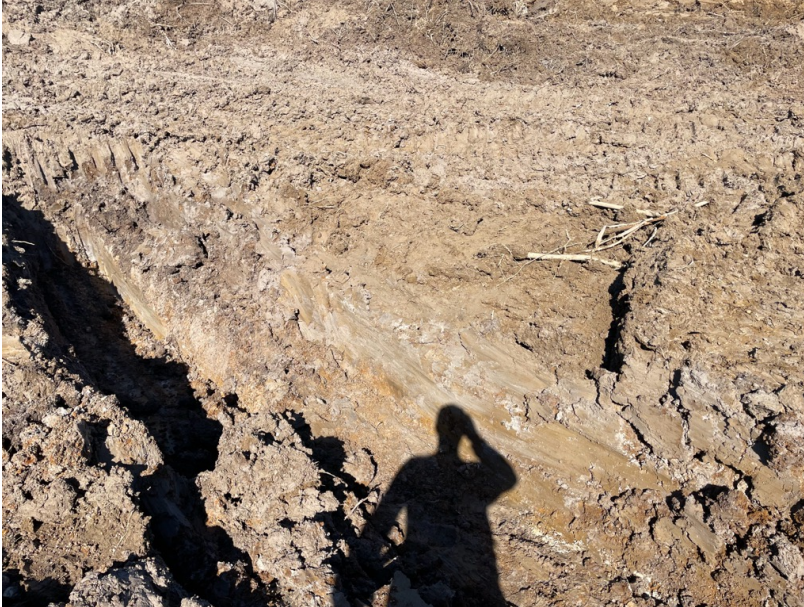
Pond Area Recommendation

Discrepancy	Corrective Action
DISCREPANCY (1)	Pond area proposed 2' undercut showed material to be inadequate for Tensar use. Added remediation needed to bridge over softer than expected material with high Organics.	Awaiting final approval
DATE:24-10-09		Date Resolved:
DISCREPANCY (2)	21'96" section of the southeast area of the building pad topsoil was observed at 2"x	Date Resolved:
DATE:24-10-09		
DISCREPANCY (3)	N/A	Date Resolved:
DATE:

701.50' material firm enough to hold a D6 dozer.
698' firm material with traces of reddish clays observed.

We recommend undercutting to elevation 698.0' where a firm red clay was encountered
Place engineered fill in a 12-18" loose lift at the bottom of the undercut (target compaction of 92%)
Place engineered fill in 8-12" loose lifts up to 5 feet below subgrade elevation (target compaction of 95%)
Place engineered fill in maximum 8" loose lifts to subgrade elevation at 98%.

Undercut to elevation 703.0' place channel liner to #2 stone in 6-8" lifts and walk into subgrade until the subgrade accepts no additional stone.
Place a layer of TX-130 geogrid, capped with 8" of DGA.
Place engineered fill in maximum 8" loose lifts to subgrade elevation at 98% compaction.

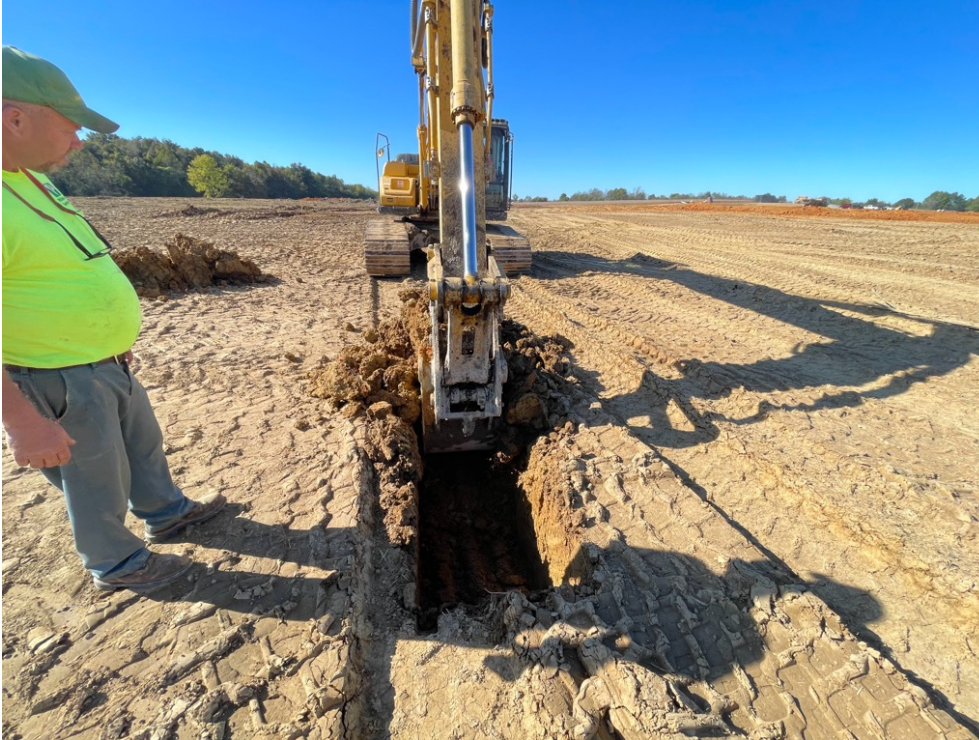
Southeast Section Of Building Pad

Top soil observed to be 2' deep.
Elevation of suitable material
observed at 700'.
