RE: Gallatin County Alternative School & Field House
Gallatin County, Kentucky
BG 12-133
RTA 0914

An observation was made Thursday, March 21st as noted below.

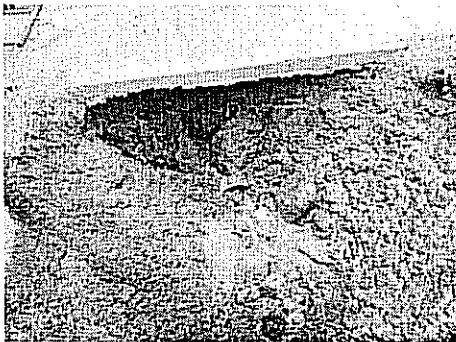
1. Weather consisted of light snow, wind, and temperatures in the high 20's to low 30's.

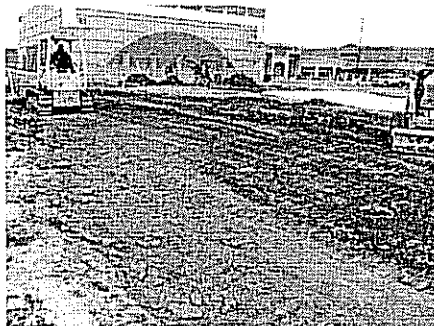
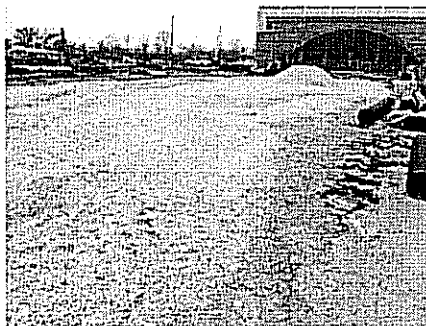
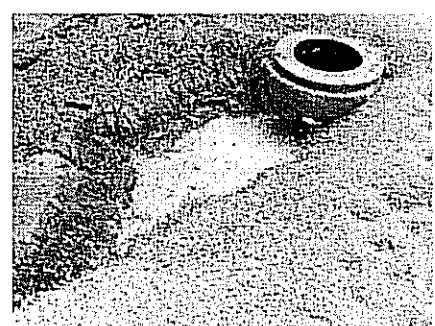
3. Building pad is still under construction as of this observation. Photos illustrate current work. The existing drywell is still to be abandoned and removed/filled.

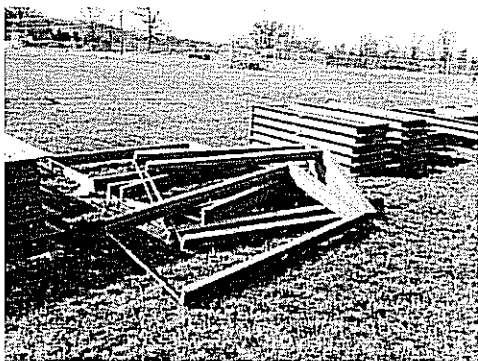
4. Door frames are to be stored to prevent corrosion per specifications. Contractor to protect as needed and get with manufacturer on proper storage for the hollow metal frames.

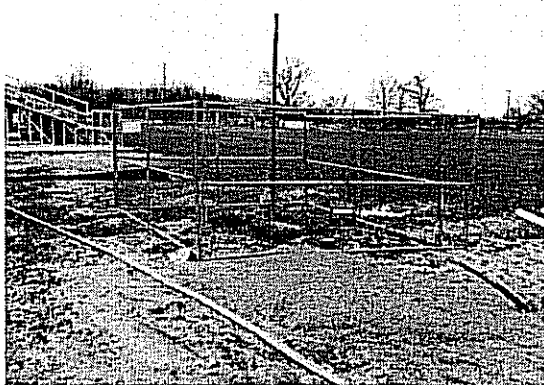
5. The abandoned geothermal well fenced off and awaiting the completion of being cut off, grouted, and abandoned.

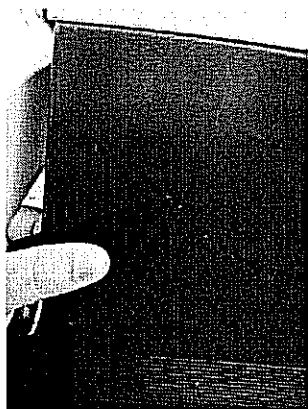
6. The manufacturer sample reviewed with Lenny Whalen as a match for the risers on the bleachers.

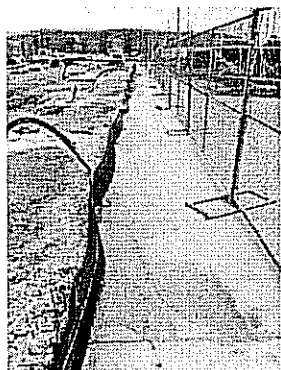
7. The silt fence along the pedestrian path is stretching and showing minimal failure. Contractor should address the cleaning of the sidewalk periodically and as needed.

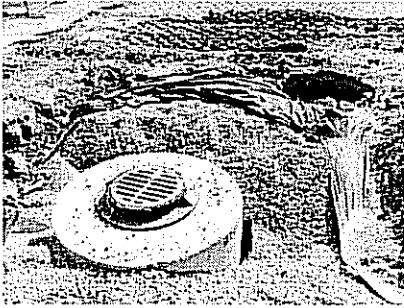
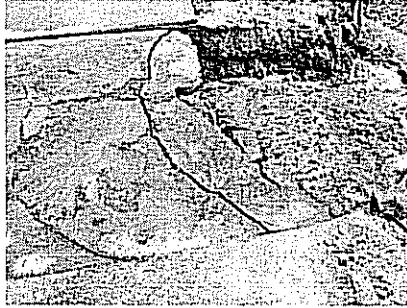
8. DS-6 and change order #4 and #6 drywell work shown above. Contractor must clean the gravel showing silting and dirt exposure prior to completing and covering the area. Photos of the cleaning and finishing were requested as they complete that work to maintain clean gravel in the drywell system. All sitling sho0uld be removed and verified.

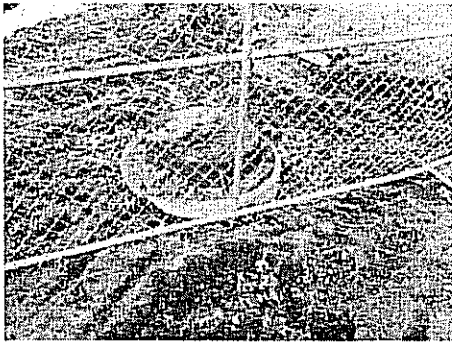
9. The manhole tying into the existing sanitary line conflicting with existing fencing. This line below ground is said to be a little different from the survey. Contractor to identify in record drawings the adjustment of location.

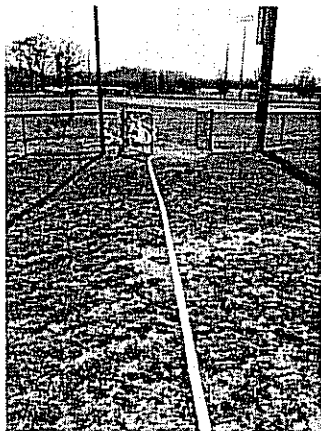
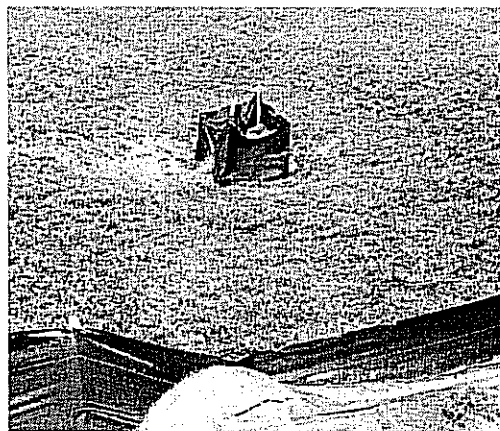
10. Contractor to continue to coordinate keeping hose work and the like off playing fields with the school district. Contractor is getting their water supply on the other side of the baseball field and running the line through the field during the day and then picking up out of the way during practice and game events according to field conversations with the Ken Jones. Also mentioned (not fully observed), the district will attempt to keep dirt and raking excess away from the fenced in storm drainage structures that are currently being installed and protected. Photo on the right illustrates an existing drywell attempting to be protected that should have fabric installed in the grate. This was requested in the field the day of the observation.

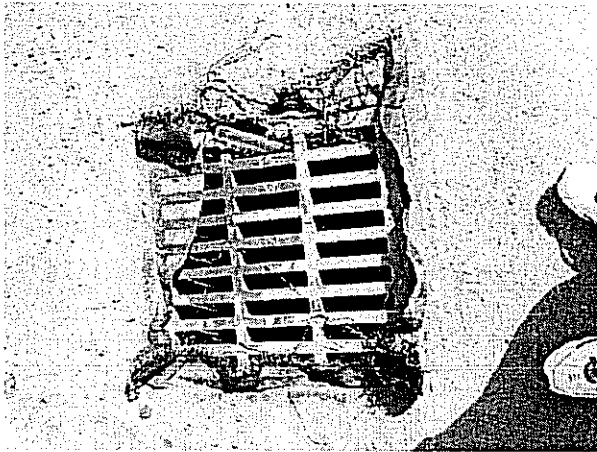
11. Contractor is periodically replacing drain fabric every two weeks or as needed with significant events in the project related structure areas.
