## **Hardin County Early College and Career Center**

### **Project Closeout Update**

### PROJECT REPORT

**Re: 1309 Hardin ECCC**

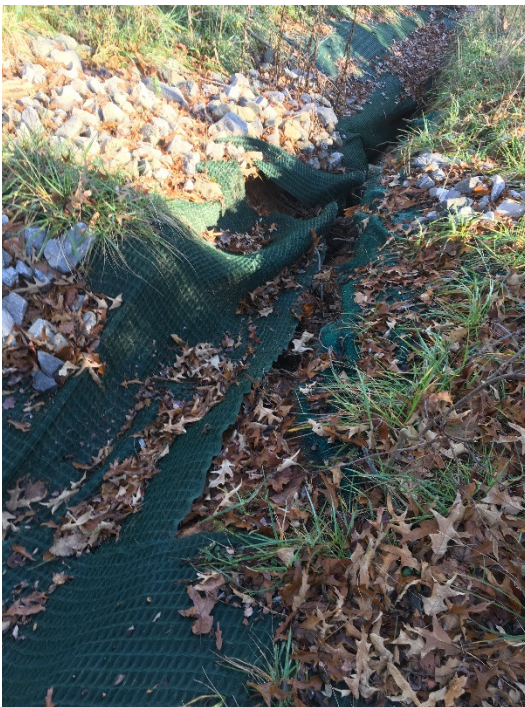
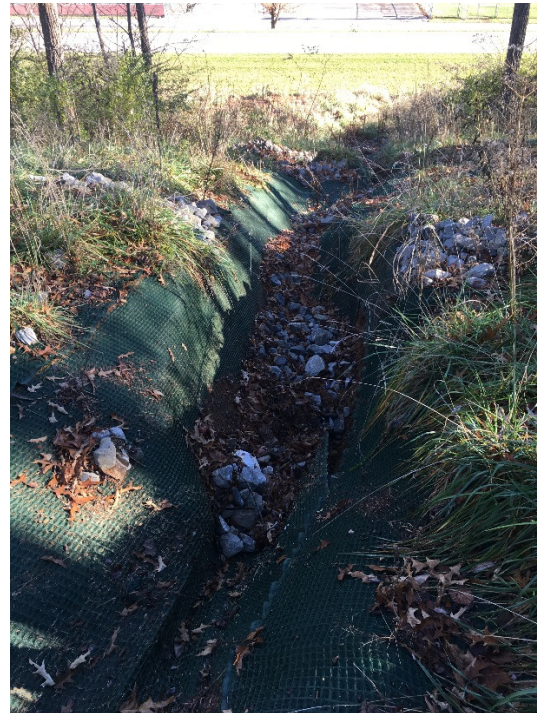
1. Erosion along the southeast ditch adjacent to the auxiliary parking lot.

- **ISSUE:** Water has managed to get in between the seams of the Turf Reinforcement Mat (TRM), causing erosion underneath. The TRM appears to be in good condition and properly stapled.
- **RECOMMENDATION:** AEI's recommendation would be to reshape the ditch and reinstall the TRM per manufacturer's protocol. Place CL 3 rip rap/shot rock on top and up the sides, grout (lean concrete infill) the bottom of the ditch to bond.

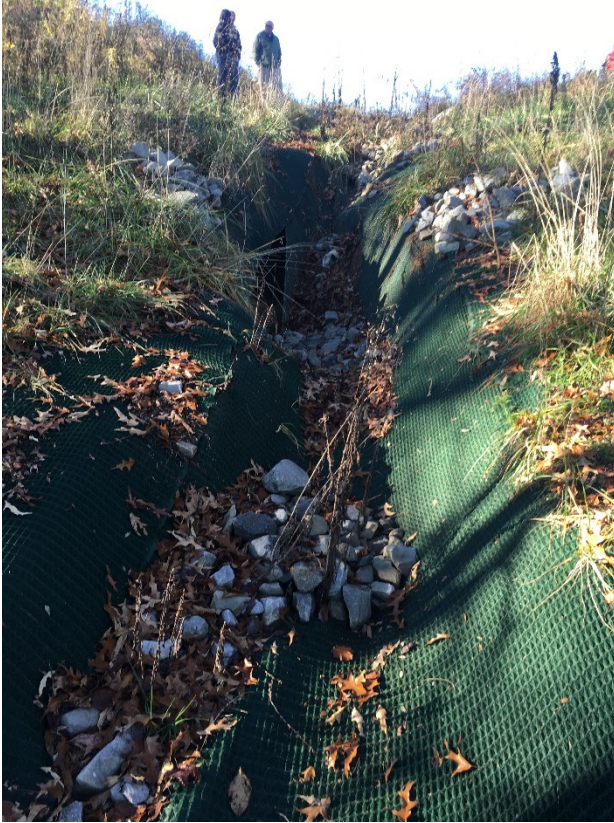
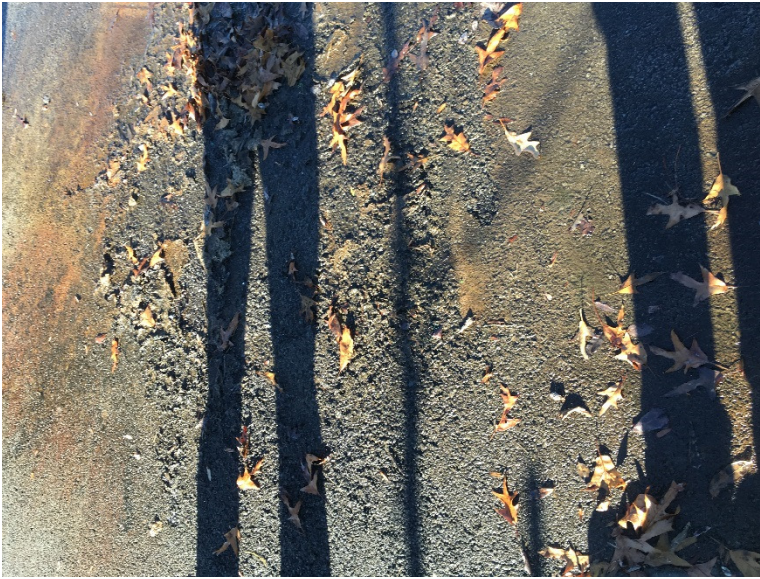
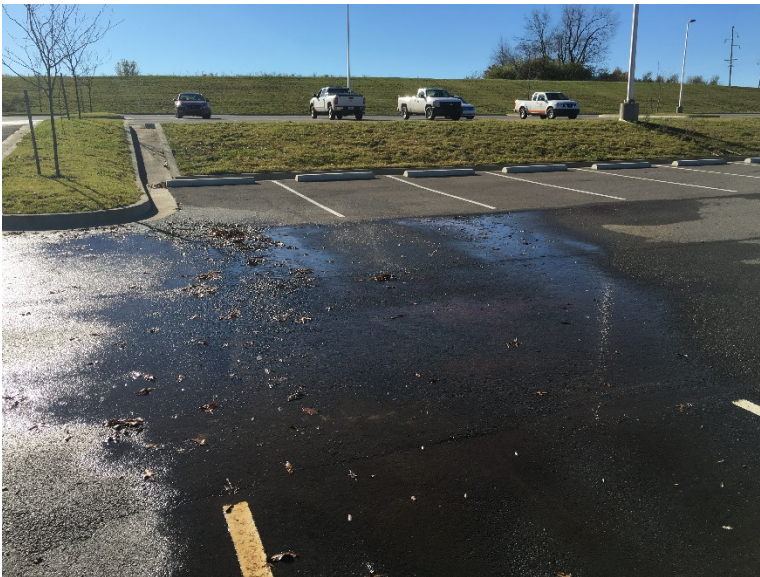
2. The auxiliary parking lot has an area where water is seeping up through the pavement seam.

- **ISSUE:** Water sheet flows down the flume, across the parking lot with a 4% surface grade. Surface sloping is not the issue. It appears water is seeping up through the pavement seam under pressure and causing the pavement to deteriorate and discolor.
- **RECOMMENDATION:** The contractor is going to dig test holes behind back of curb to see if it is wet. If it is, AEI recommends installing a trench drain behind curb to collect the water and cut across the pavement to daylight out. In addition, we would recommend installing finger drains in the deteriorated areas to collect as much water as possible. If the soil behind the back of curb is dry, then we would recommend cutting the pavement out along the seam and installing a trench drain and daylighting it out.

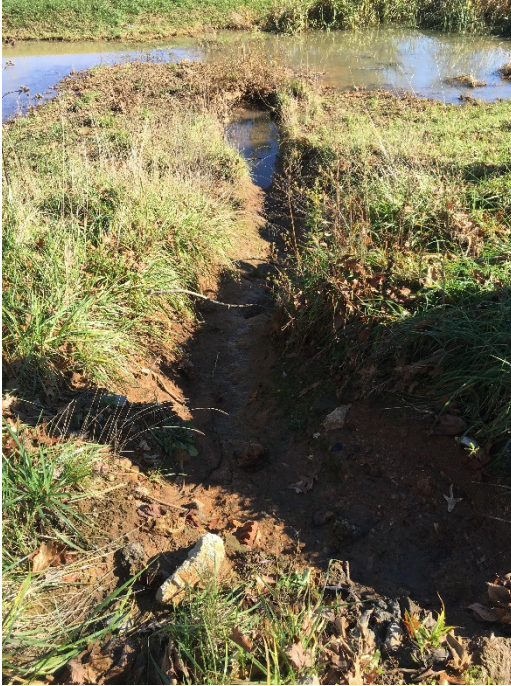
### 3. Erosion along basin.

- **ISSUE:** The CL 3/shot rock appears to have held up well, but erosion is occurring beyond the lining.
- **RECOMMENDATION:** AEI's recommendation is to reshape the ditch from the end of the rock and extend to the basin. We recommend continuing the CL 3/shot rock to 10' past the water surface elevation.

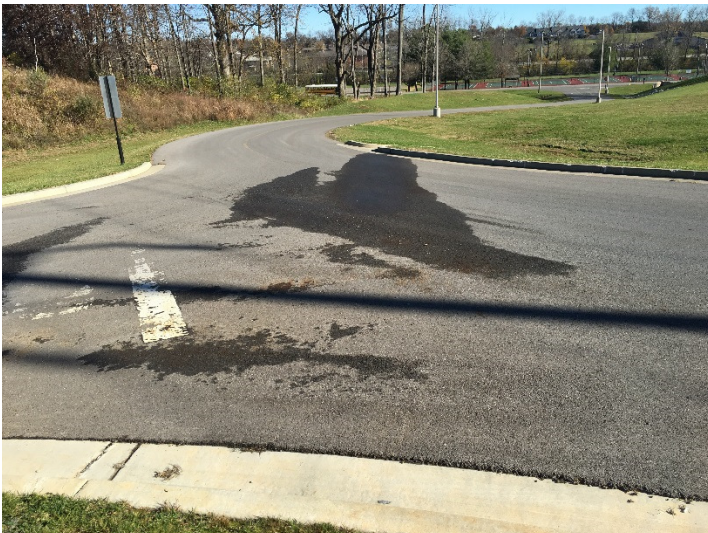
#### 4. Pavement in front of retaining wall.

- ISSUE: Water appears to be seeping up through the pavement seams and through the curb and pavement interface.
- RECOMMENDATION: AEI's recommendation would be to cut out around the pavement seams and install a trench drain to collect the water and daylight it out.
