Radcliff Elementary

Project Closeout Update

November 4, 2016

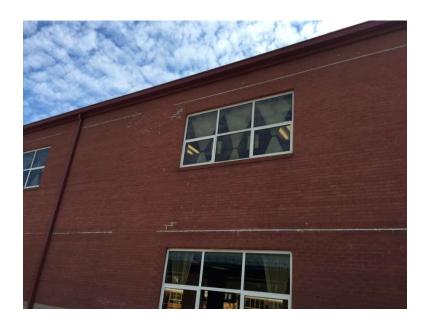
Image 1: Joints at head of infill previously completed were completely retooled and tuckpointed.

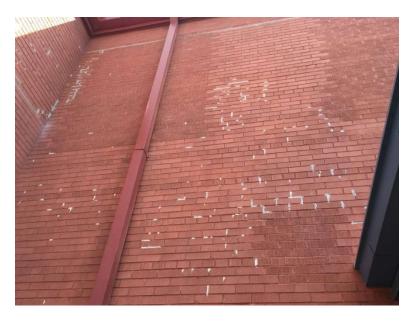
Image 2: Typical tuckpointing completed at the west elevation.

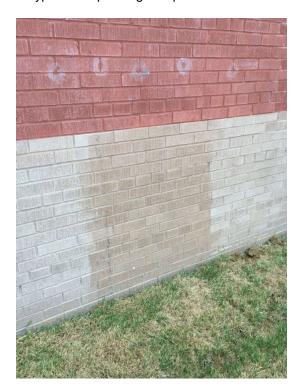
Image 3: Sample of sealer. Entire west elevation will be coated with sealer.
