Radcliff Elementary

Project Closeout Update

December 5, 2016

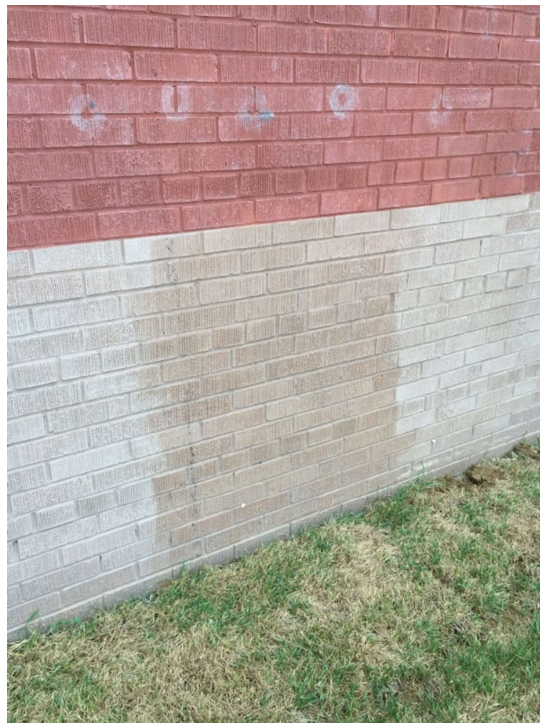
Image 1: Sample of sealer (prior to application at west elevation).

SCB met with Hardin County Schools and Morel Construction on site on December 1, 2016. Tuckpointing and masonry repair have been completed. Areas where repairs were completed were stained and the exterior west wall was sealed with Prosoco Block Guard & Graffiti Control II. Approximately 25 gallons of sealer were utilized. Per conversations with the school principal, no signs of leaks or water infiltration has been observed since remediation was completed.

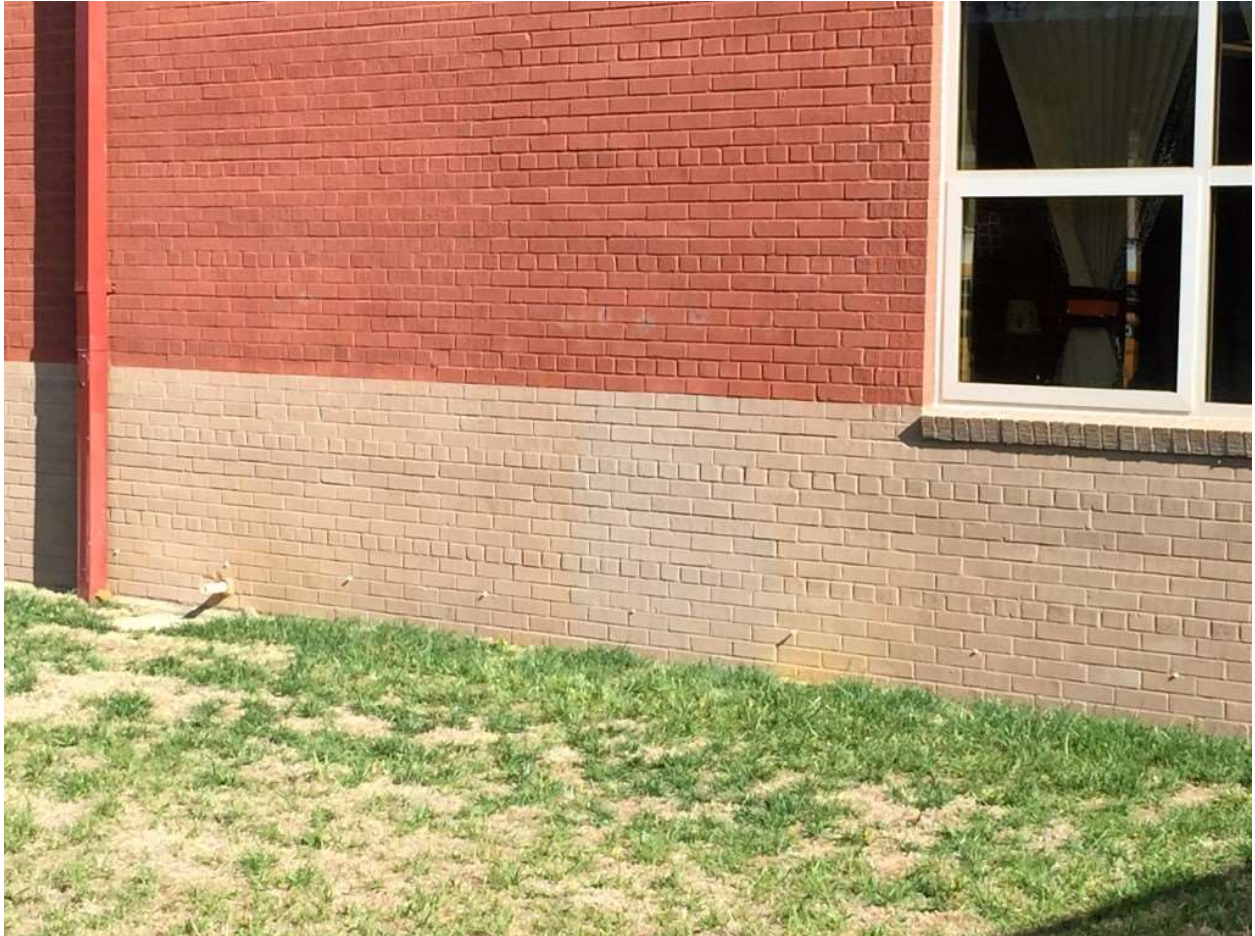
Image 2: West elevation following sealer application.
