Cecilia Valley Elementary

Construction Update

ARCHITECT'S FIELD REPORT

RE: Cecilia Valley Elementary School
Elizabethtown, Kentucky
SCB Project No. 1429

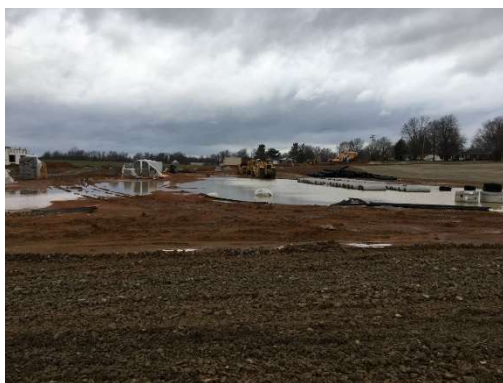
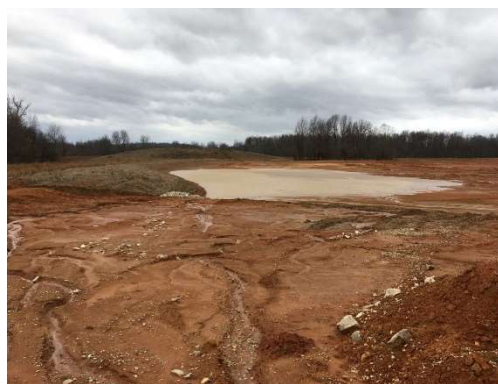
1. Due to the rain and wet conditions, the only work in progress this date is the installation of some overhead plumbing and hollow metal door frames being set.
2. Water was standing and has been for the last month at the front of the building due to the excessive amount of rain and at the rear of building at the retention basin, a large amount of water has been dammed up and is slowly releasing through the rock dam wall.

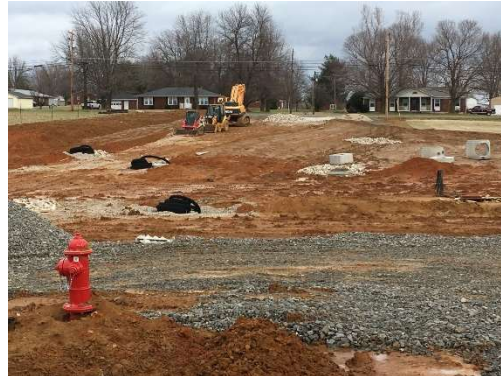
3. Jim Percy indicated to Tim Gupton the soil on the new bus entry from the road needs to be removed and only crushed stone is to be placed at this drive in particularly where the storm drain passes below the drive, as the drain pipe is plastic.

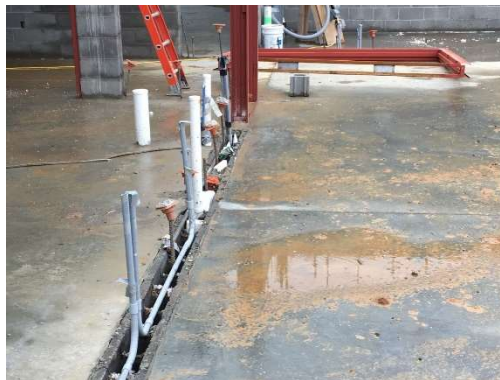
4. There are still some block masonry walls laid below the slab elevation that have not been grouted and are now accumulating trash and some have been filled with crushed stone. These need to have the trash removed and grouted up to the slab elevation.

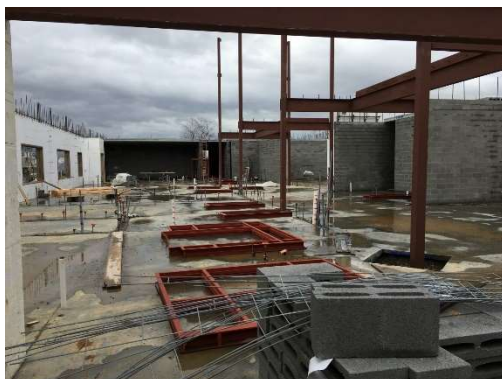
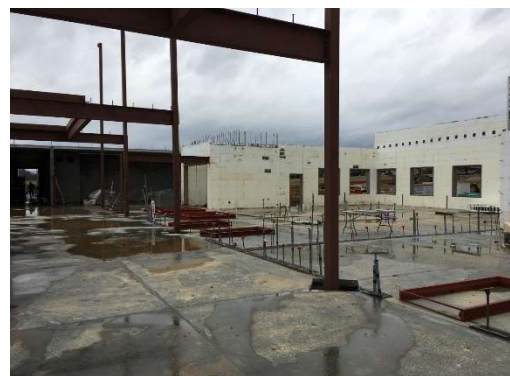
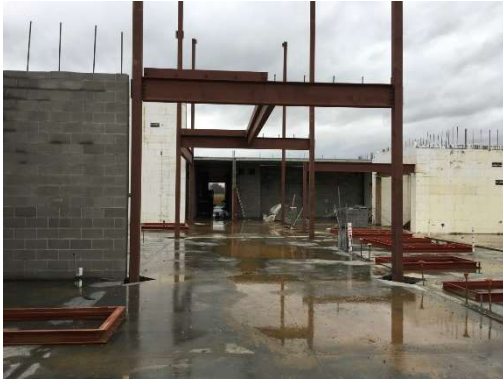
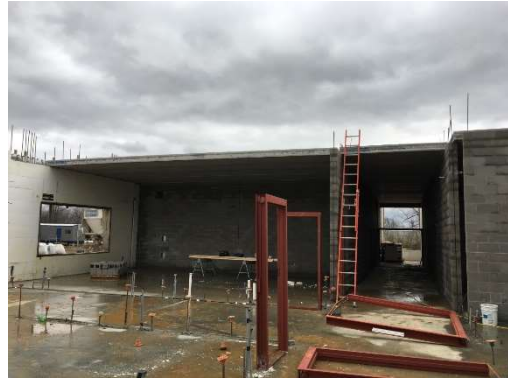
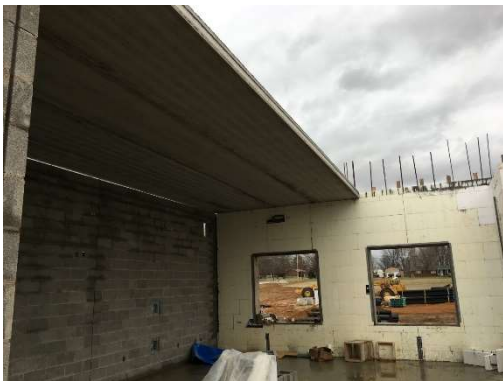
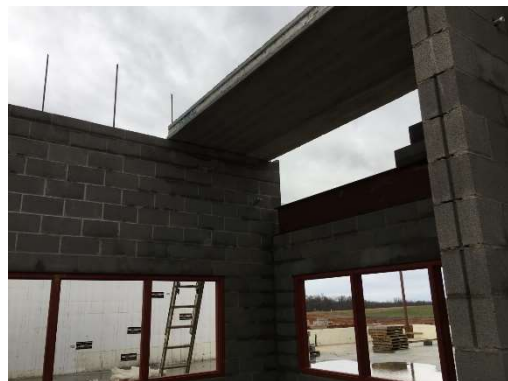
5. First floor structural steel has been set and hollow metal door frames are in the process of being set for the non-load bearing masonry walls and the concrete second floor structural floor planks are in the process of being set and the joints grouted.
