## FIELD OBSERVATION REPORT

### 2018-08 (Twenhofel)

■ TO:	Kenton County Board of Education 1055 Eaton Drive Ft. Wright, KY 41017	■ DATE:	2018.08.29
ATTENTION:	Mr. Rob Haney		
■ FROM:	Mark Perry mperry@pca-arch.com 1881 Dixie Highway, Suite 130 Fort Wright, KY 41011 V: 859.431.8612 • F: 859.431.8611	■ PROJECT:	Kenton County School District Twenhofel Bus Lot Phase 1
COPIES TO:	Mr. David Lloyd, Mr. Danny Mann, Ms. Carrie Hooten	PROJECT NO.:	2017-087

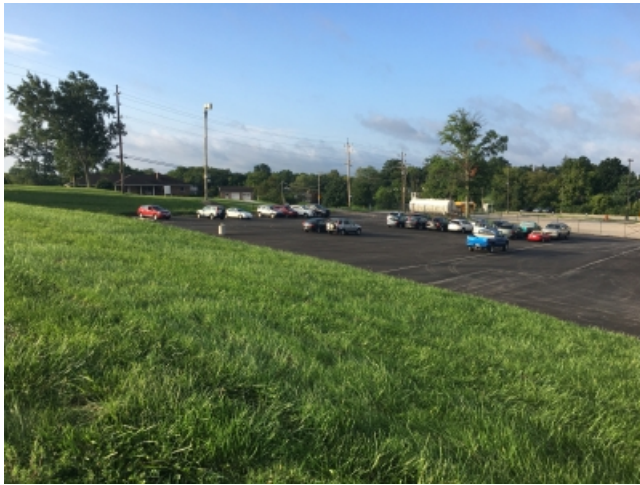
32.01: 2018.08.21 – The East lot had received base asphalt layers, leaving only the topmost wearing surface yet to be installed. Approximately 80% of base asphalt at the drives had also been installed. No base had been installed at the North lot.

2018.08.21 – East parking lot

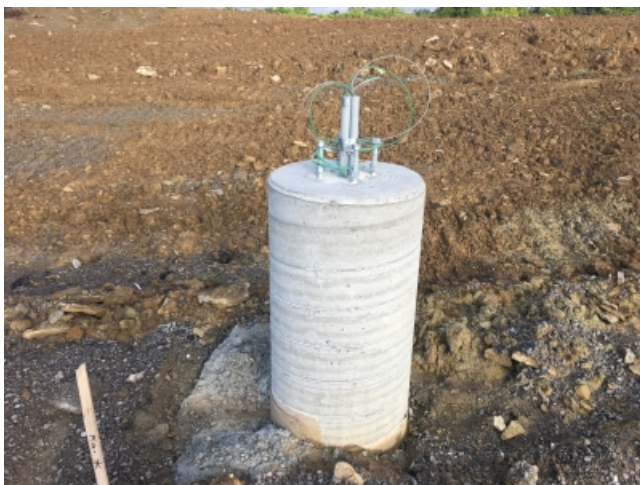
20-28.01: 2018.08.21 – Light pole bases had been installed and wiring had been pulled.

2018.08.21 – Installed light pole base.

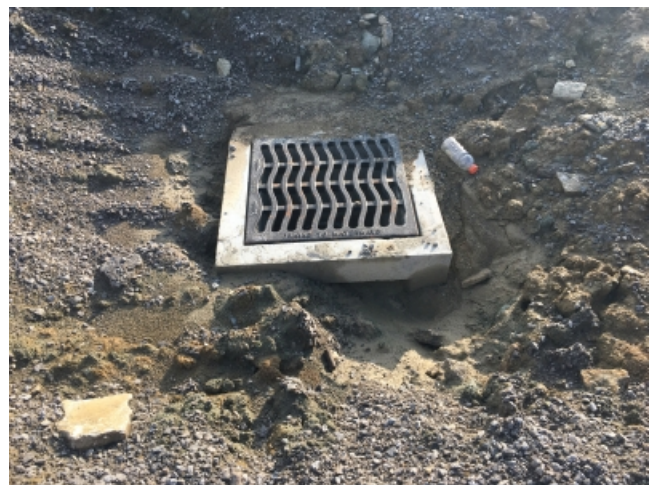
2018.08.21 – Storm structure missing erosion control measures.

32.02: 2018.08.21 – The contractor was directed to install missing erosion control measures called for in the construction documents.

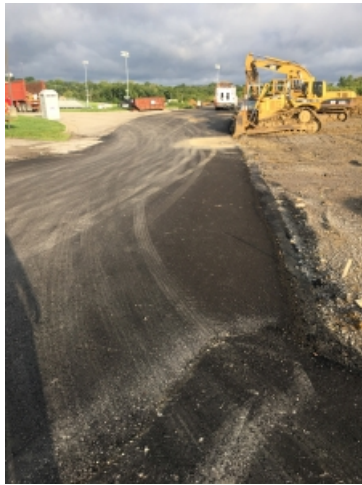
2018.08.21 – Drive along South side of former building.

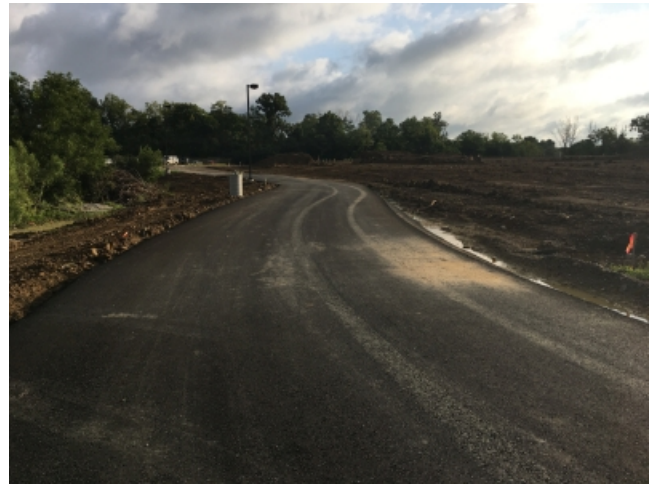
2018.08.21 – Drive along West side of former building.

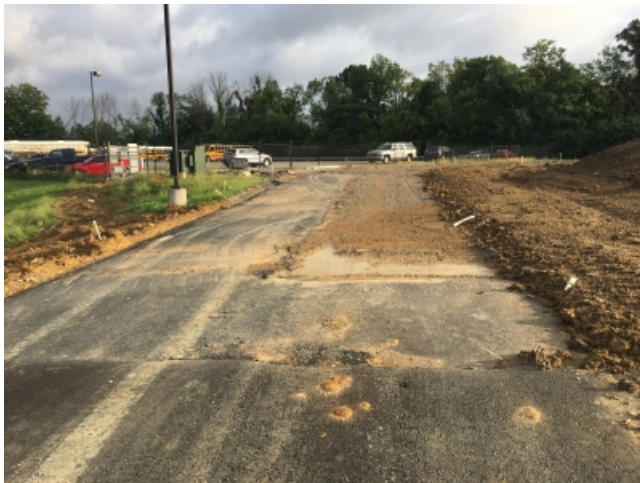
2018.08.21 – End of base pavement, looking towards West bus lot.
