## FIELD OBSERVATION REPORT

### 2018.05

■ TO:	Kenton County Board of Education 1055 Eaton Drive Ft. Wright, KY 41017	■ DATE:	2018.05.22
ATTENTION:	Mr. Rob Haney		
■ FROM:	Ralph Cooper rcooper@pca-arch.com 1881 Dixie Highway, Suite 130 Fort Wright, KY 41011 V: 859.431.8612 • F: 859.431.8611	■ PROJECT:	Kenton County School District Hinsdale Elementary
COPIES TO:	Mr. Danny Mann	PROJECT NO.:	2017-074

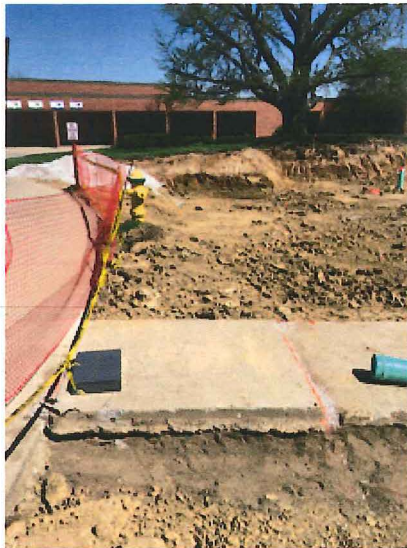
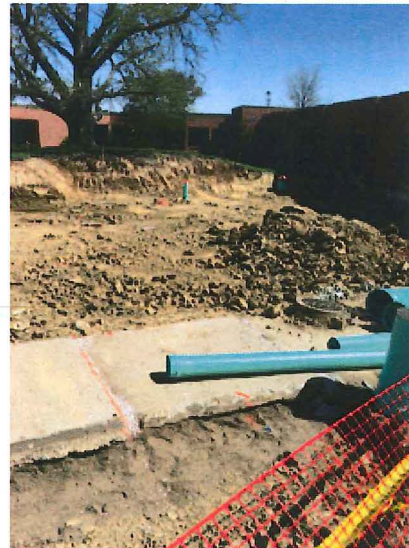
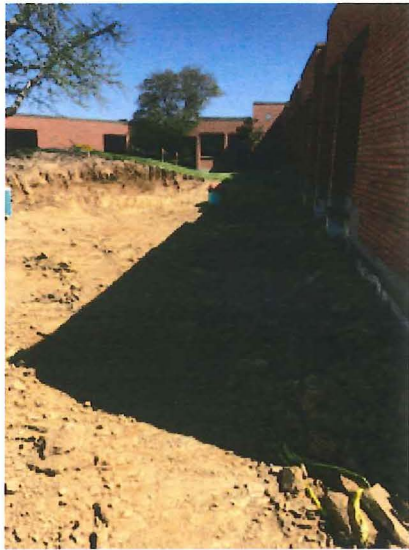
2018.05.01 – Excavation in the area of the new ramp and stairs.

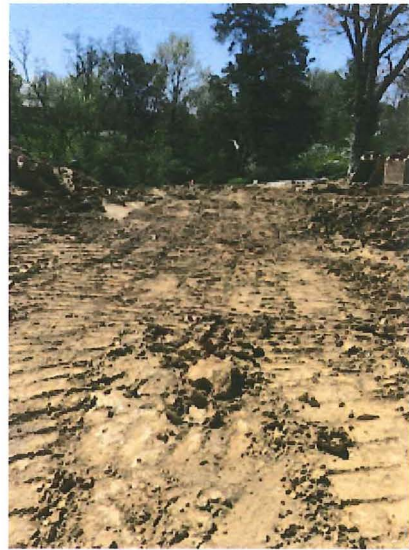
2018.05.01 – Excavation in the area of the new building pad.

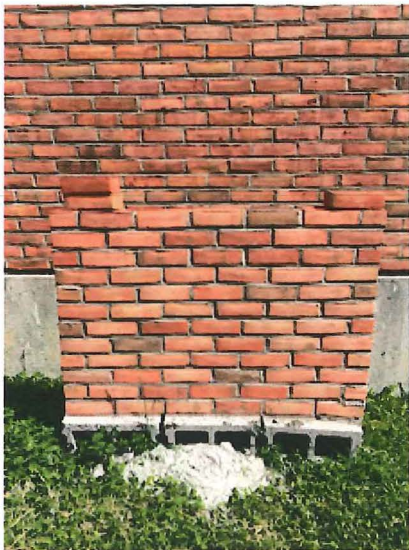
04.01: 2018.05.01 – A sample panel has been prepared with the proposed brick and mortar. The match is very good to the existing masonry.

2018.05.01 – Brick sample panel

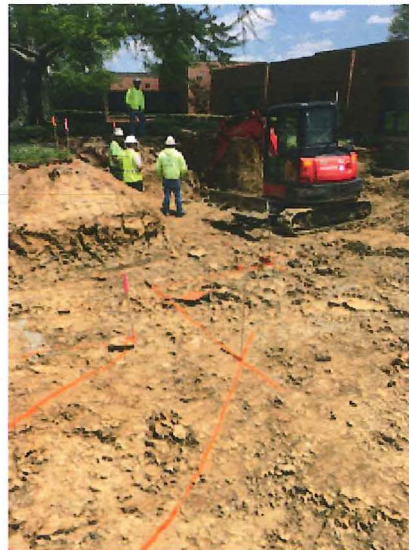
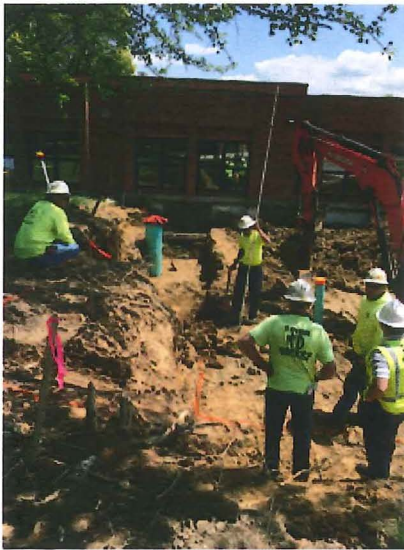
02.03: 2018.05.07 – Excavation has begun for the footings on the new retaining walls for the ramp. A conversation with the safety director for the concrete contractor indicated the height of the excavation at the west end of the ramp exceeds that permitted by OSHA. The contractor indicated they would need to cut further back into the area near the large tree. After consulting with the Owner's representative it was agreed to permit the additional excavation but the contractor was instructed to keep it to a minimum to reduce potential damage to the tree.

2018.05.07 – Excavation for the footings for the new ramp and stair is in progress.

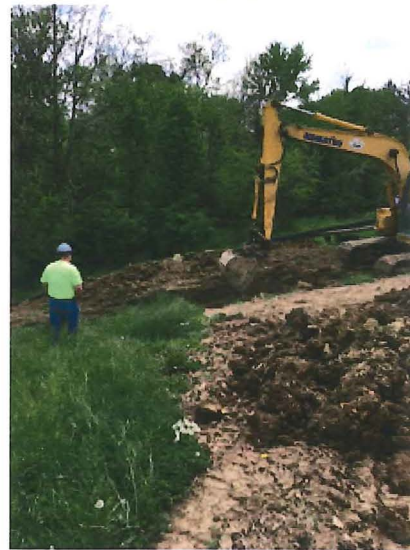
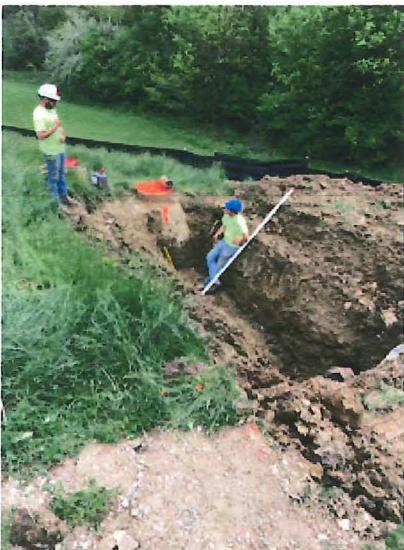
02.04: 2018.05.07 – Excavation for the underground sewer rerouting along the south side of the building is in progress.

2018.05.07 – Excavation for the relocated sewers south of the building is in progress.

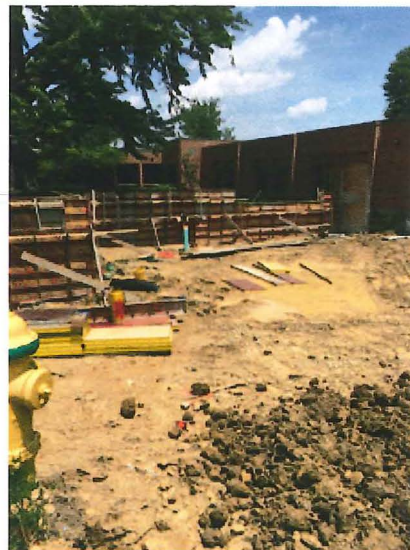
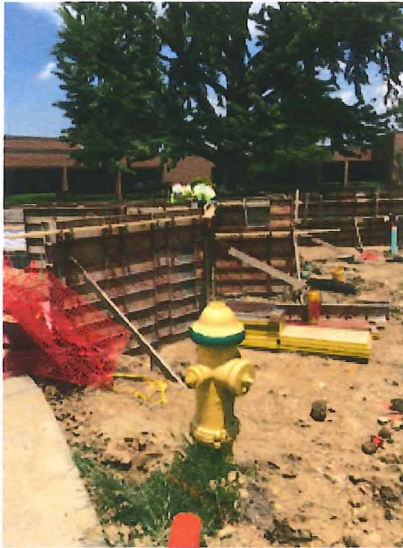
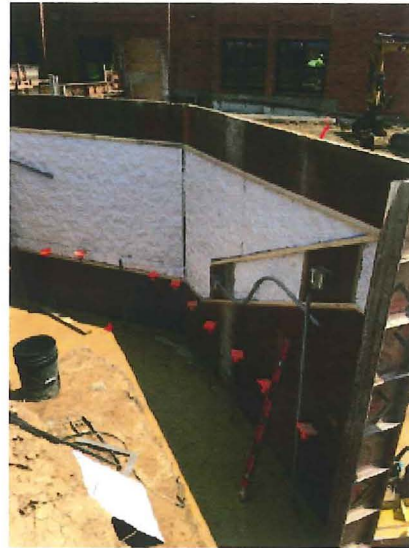
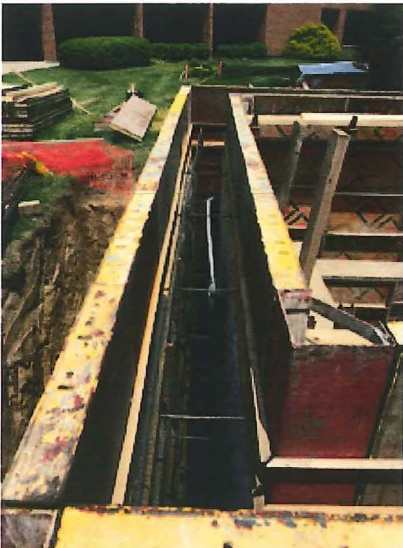
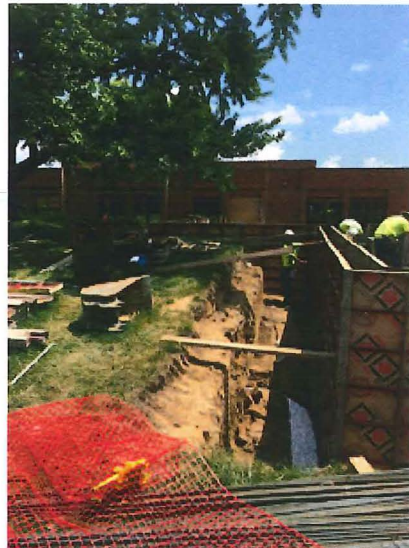
03.02: 2018.05.21 – Installation of the formwork for the new exterior ADA ramp is in progress. The form liners and reveals are being installed per the plan.

2018.05.21 – Construction of the form work for the new ramp and stairs is in progress.

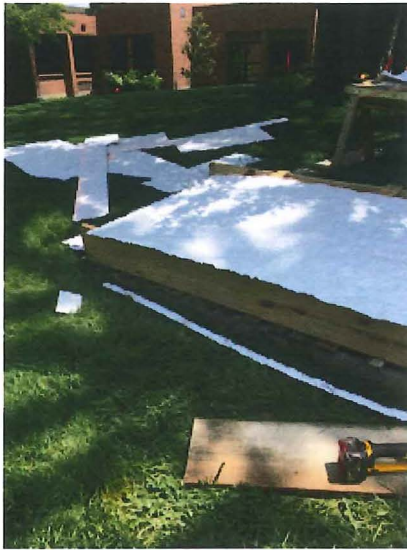
2018.05.21 – Formliners for the textured walls on the new ramp and exterior stairs.

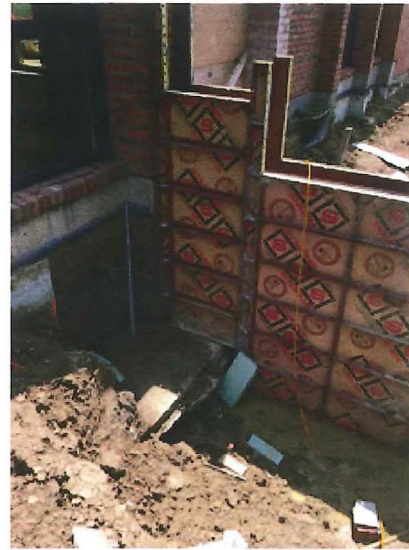
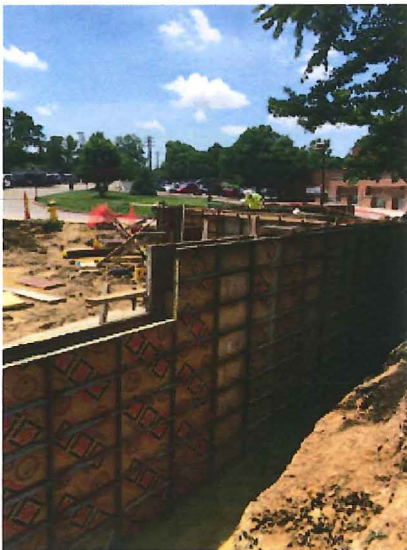
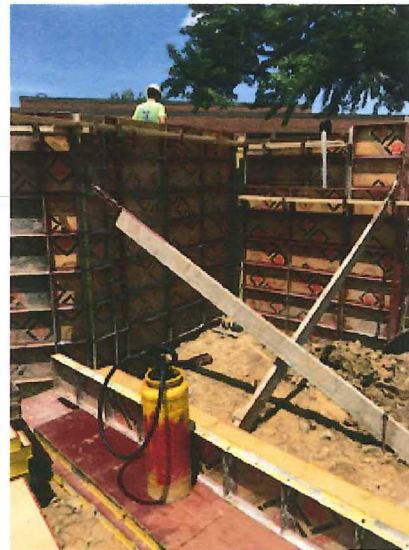
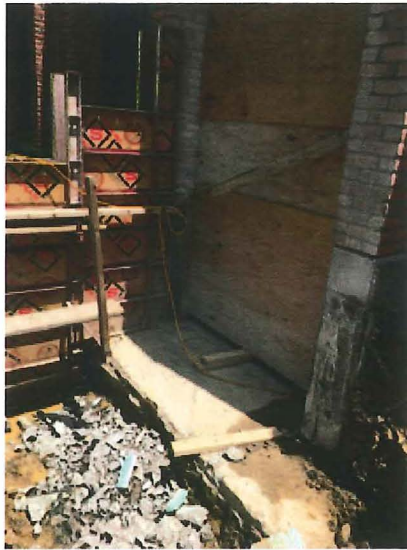
2018.05.021 – Construction of the form work for the new ramp and stairs is in progress.

2018.05.21 – Construction of the form work for the new ramp and stairs is in progress.

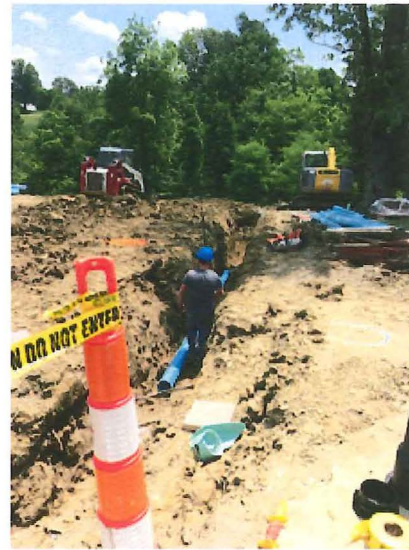
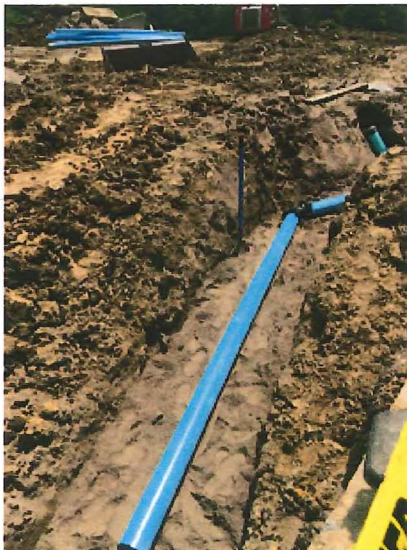
02.05: 2018.05.21 – Installation of the rerouted underground sprinkler line along the south side of the building is in progress.

2018.05.21 – Installation of the re-routed sprinkler main to the south of the building is in progress.
