# EXISTING HIGH SCHOOL: GYM UPPER BLEACHER MEZZANINE STRUCTURAL REPAIR

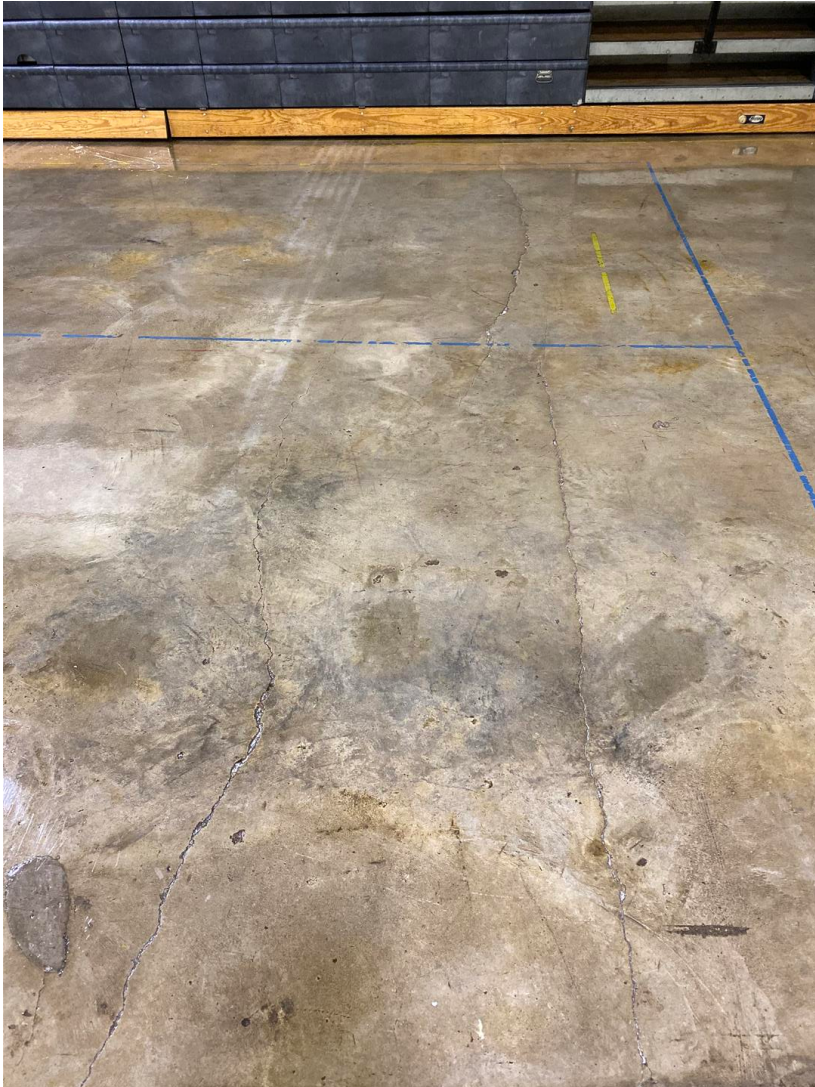
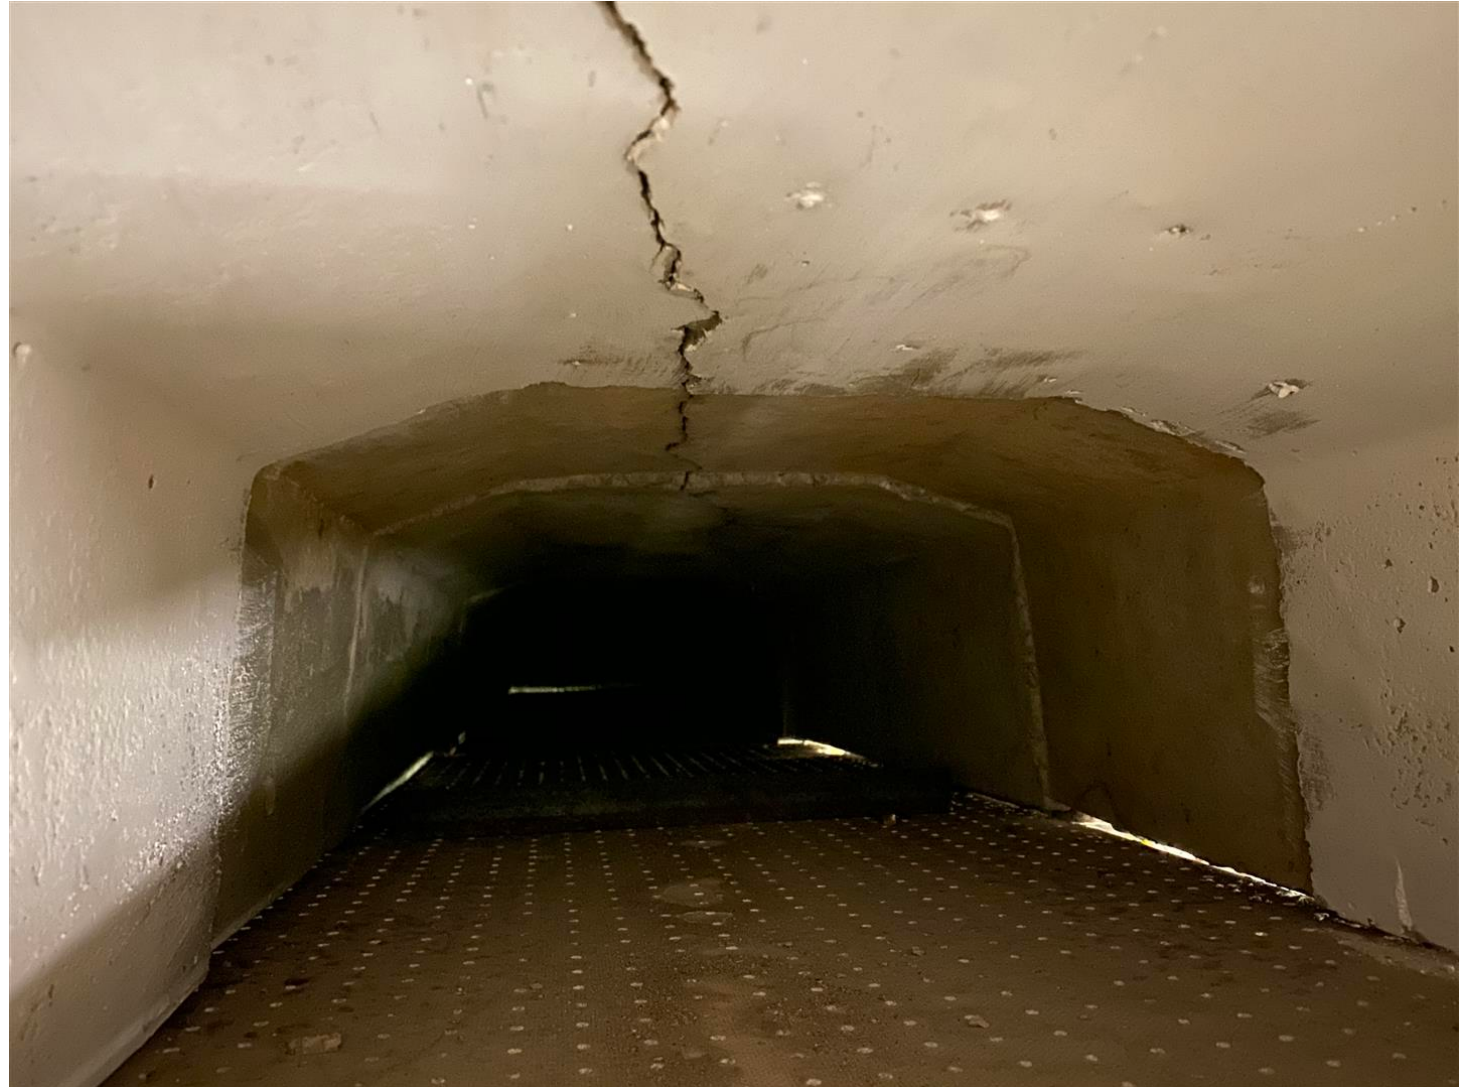
- 7/12/21: RTA received a call from district facilities staff alerting us to some cracking the gymnasium upper bleacher mezzanine slabs. Brian Buckner with RTA made a visit to WCHS that morning to observe and document the conditions. Photos were sent to structural engineer Charles Haynes with Structural Design Group as well as verbal communication describing the conditions over the phone. It was determined that Mr. Haynes needed to make a site visit to investigate. That afternoon, Mr. Haynes sent an email to RTA making the recommendation to keep the above-slab bleacher area and under-slab areas closed off until further notice. This was immediately communicated to district staff.

- 7/16/21: After running calculations and further analysis, Mr. Haynes recommended that the upper levels continue to be blocked off with zero occupancy and bleachers remain fully retracted, but that the district could begin using the weight room and storage spaces (spaces below the slab) again provided they adhere to the precautions above slab. The existing slab and joists were determined to be overloaded primarily due to the point loads from the wheels of the retractable bleacher system.
