FIELD OBSERVATION REPORT

Central Hardin High School, Cecilia, KY

2019111 -CA8

Report No: 2

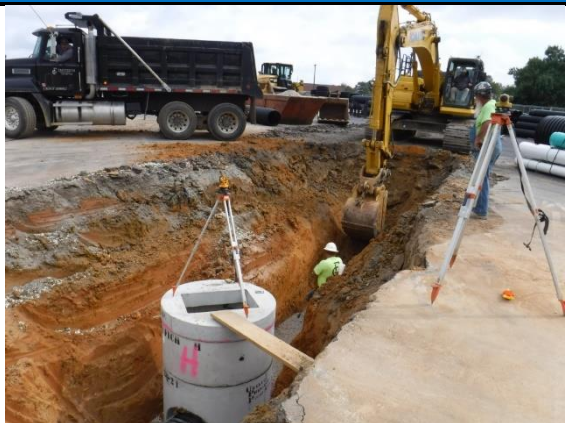
Item No.	Location	Description/Correction	Image	Action
1	Storm structure and piping at southwest side of Area B.	Trench was being excavated for pipe to next structure.

None

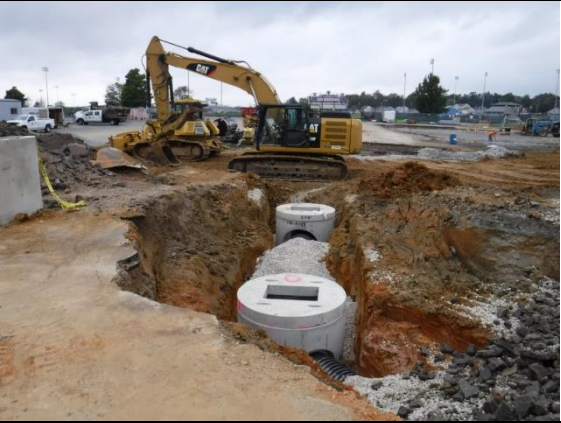
Item No.	Location	Description/Correction	Image	Action
2	Storm structures and piping to the west of Area B.	Piping was covered with concrete.

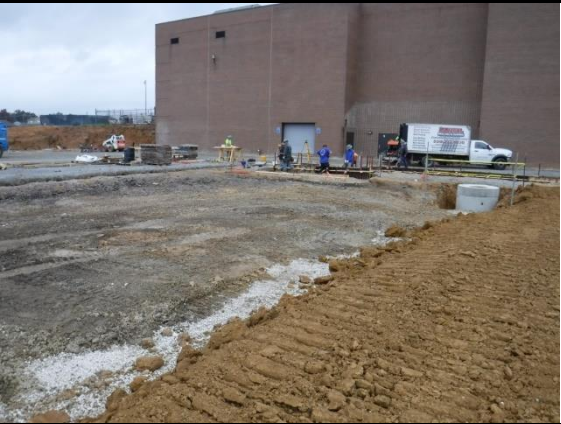
None
3	Area A	Parking lot has been excavated. Concrete work continues for foundations at Area A to the west of the existing gym.

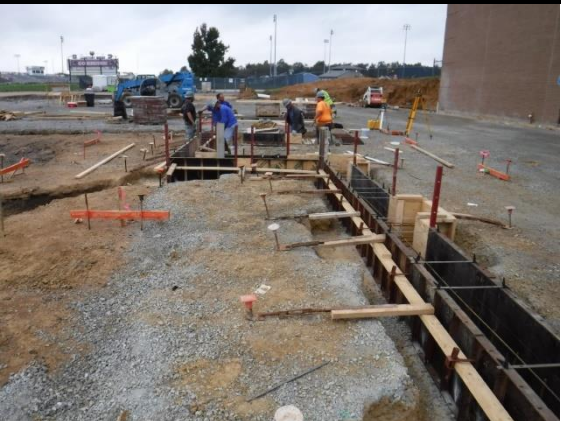
None
4	Area foundation	Alliance was building forms for the foundation stem walls in Area A. Revised dimensions for the area were received the day before.

Verify changes

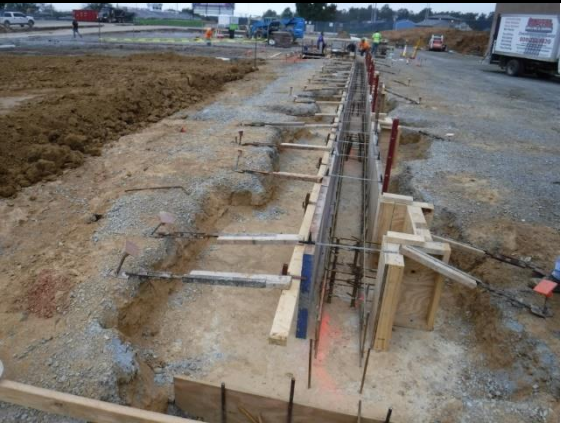
Item No.	Location	Description/Correction	Image	Action
5	Area A	Complete forms for stem walls for foundation.

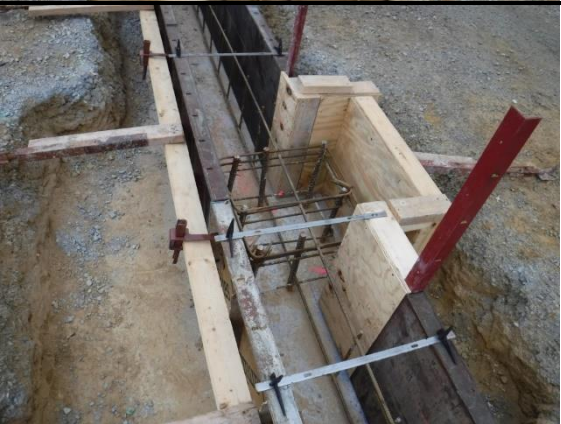
Verify changes
6	Area A	Foundation and reinforcement at column location.

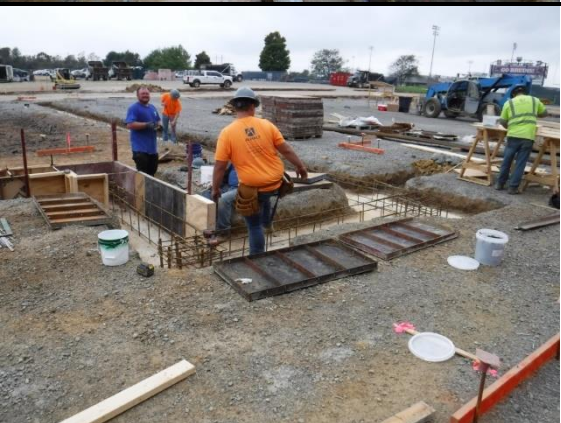
Verify changes
7	Area A	Alliance concrete crew building forms and reinforcing steel.

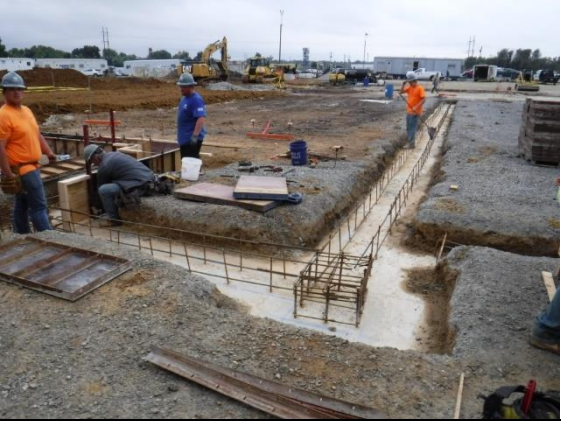
Item No.	Location	Description/Correction	Image	Action
8	Area A	Concrete footings in place with reinforcing steel for stem walls in place prior to placing the forms for the stem walls.

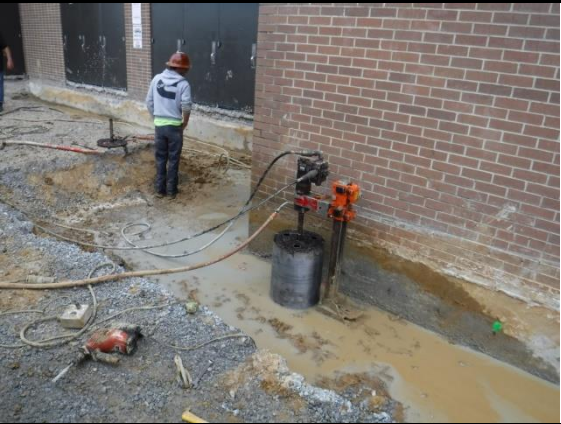
Verify changes
9	Area A beside gym wall	Drillers were core drilling through existing concrete footings to prepare for installing micro-piles.

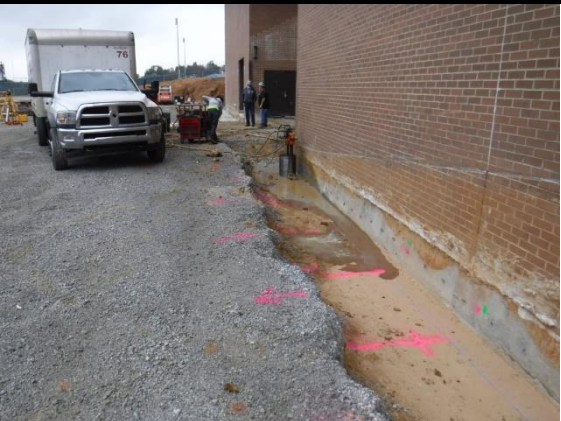
Verify changes
10	Area A beside gym	Existing concrete footing with cores drilled.

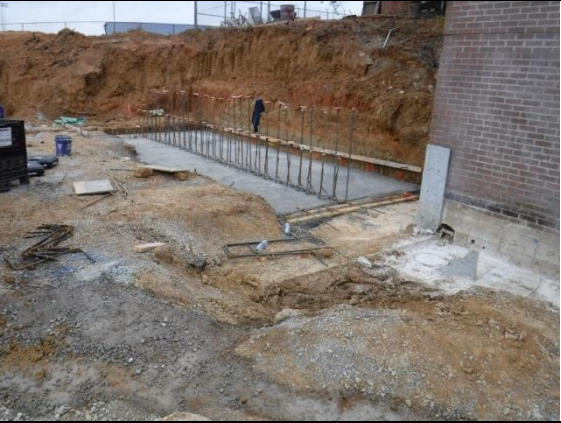
Item No.	Location	Description/Correction	Image	Action
11	Northwest corner of gym	Foundation and vertical reinforcing steel for retaining wall.

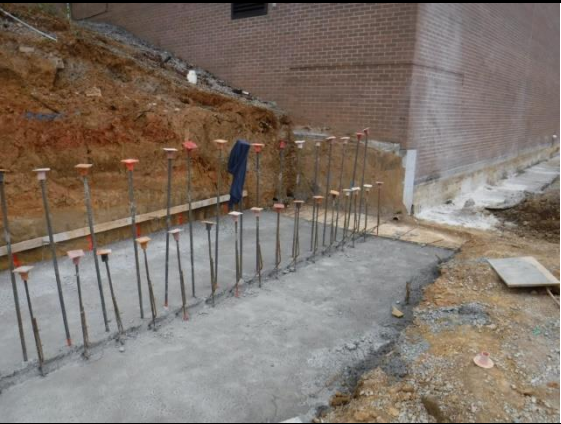
Verify changes
12	Northwest corner of gym	Reinforcing steel indicates relationship to gym wall.

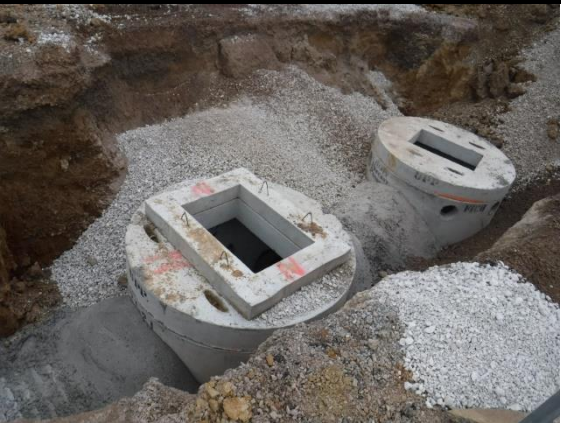
Verify changes
13	West of Area A	Storm structures connected with piping that is covered with concrete.

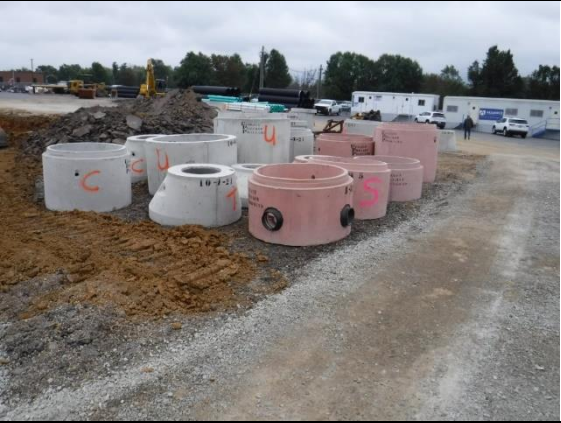
Item No.	Location	Description/Correction	Image	Action
14	Stored materials	Storm and sanitary structures. Note the pink concrete for the sanitary structures.

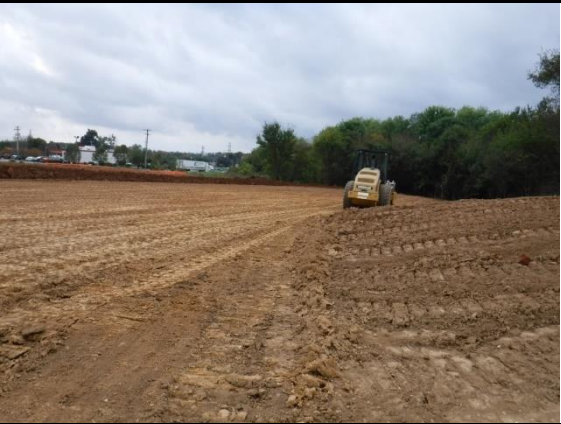
None
15	West side of site	Grading to set the rough grades for the new parking lot to the west side of the site.

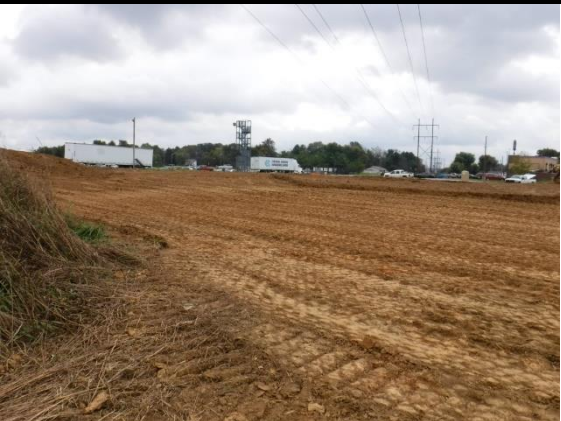
None
16	West side of site	Grading for new parking lot.

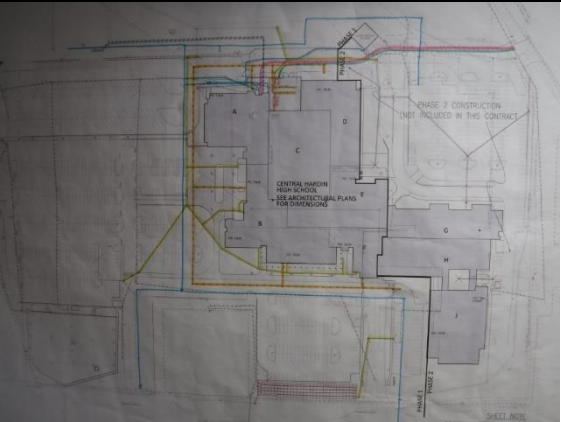
Item No.	Location	Description/Correction	Image	Action
17	Site Utility Plan	Gerald has formulated a plan to install the site utilities.

Submit plan for approval
18	Revised layout plan	Gerald has marked the foundation plan for Area A showing the revised dimensions resulting from the differences from the as-built drawings of the existing building and actual dimensions.
