FIELD OBSERVATION REPORT

2022-03 (Scott Phase V)

■ TO:	Kenton County Board of Education 1055 Eaton Drive Ft. Wright, KY 41017	■ DATE:	2022.03.23
ATTENTION:	Mr. Rob Haney		
■ FROM:	Mark Perry mperry@pca-arch.com 906 Monmouth Street Newport, KY 41071 V: 859.431.8612 • D: 859.578.6013	■ PROJECT:	Kenton County School District Scott Phase V
COPIES TO:	Mr. Kevin Pfefferman; Ms. Carrie Hooten	PROJECT NO.:	20-032

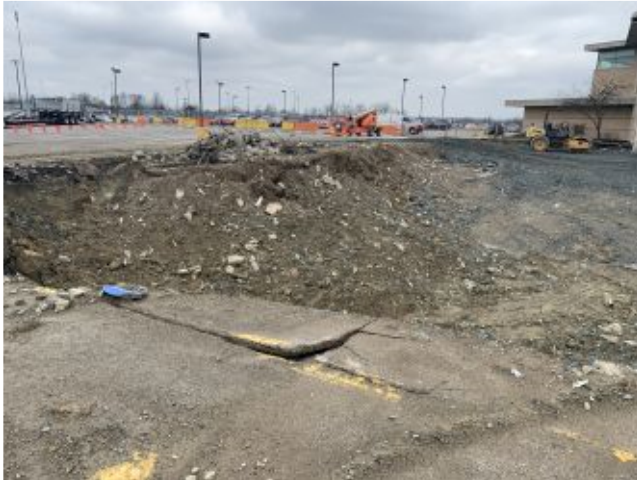
02.01: 2022.03.09 – The existing concrete pool shell had been completely removed. Selective demolition was on-going at the locker rooms nearest the gymnasium. Protective tarps had been installed along grid line K. Demolition of the water tower at the Taylor Mill site was actively underway.

2022.03.09 – The pool is gone.

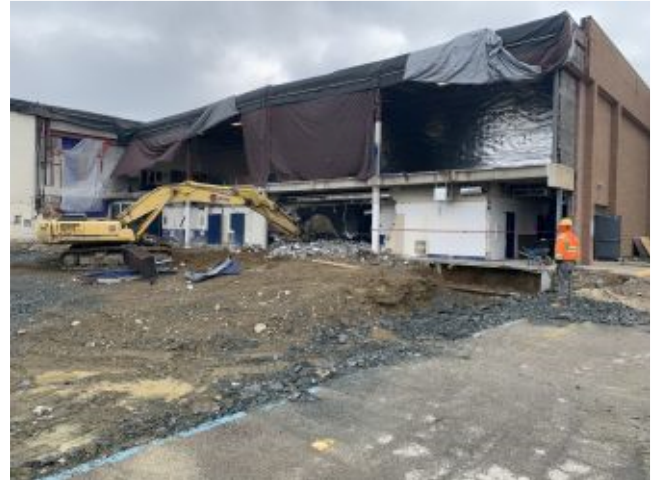
2022.03.09 – Demolition at locker rooms.

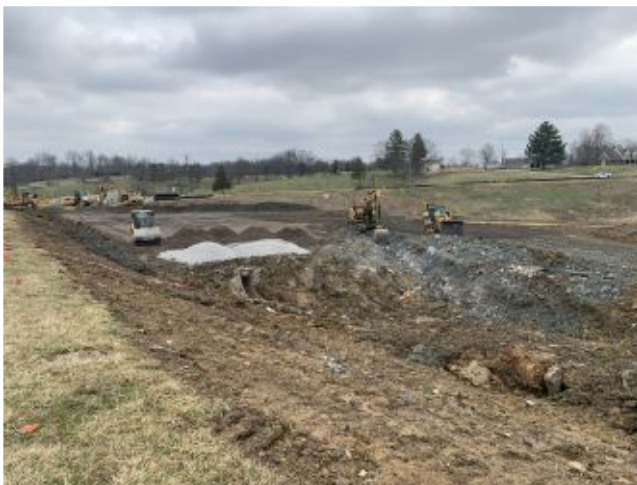
31.01: 2022.03.09 – Earthwork was active in the large fill portion of the site. Existing muck had been removed and set aside for drying and later incorporation into the fill. The contractor was actively working on installing a trench drain required by the geotechnical engineer to address an active spring/seep that had been uncovered during the work. An OSHA representative had just departed the site and had cited violations relative to the proceedings at that open trench. Milling of the asphalt paving at the former bus lot was actively underway.

2022.03.09 – Trench drain work.

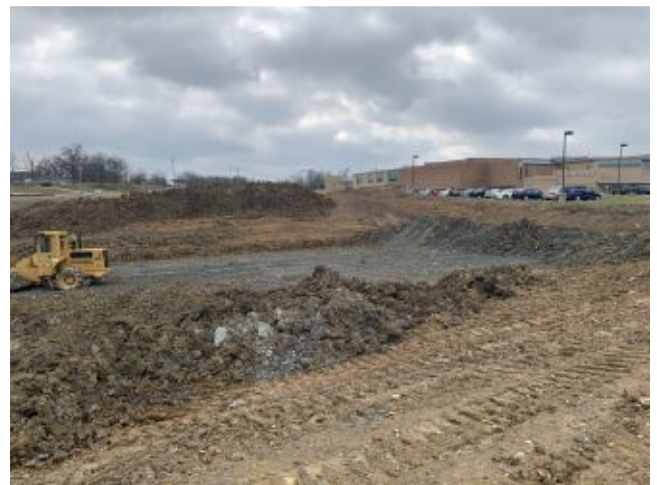
2022.03.09 – Active fill operations.

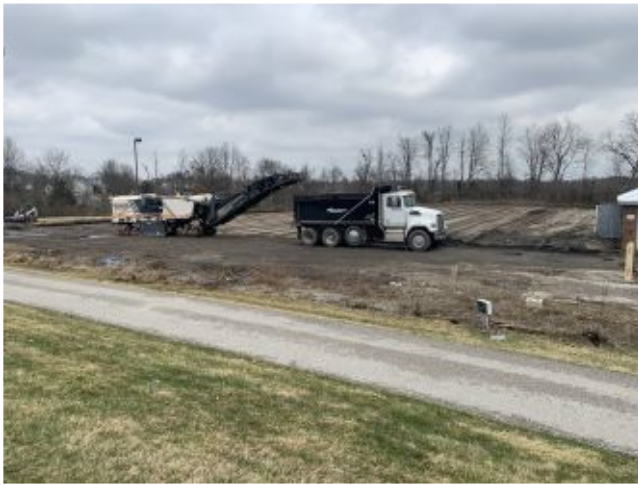
2022.03.09 – Asphalt milling at bus lot.

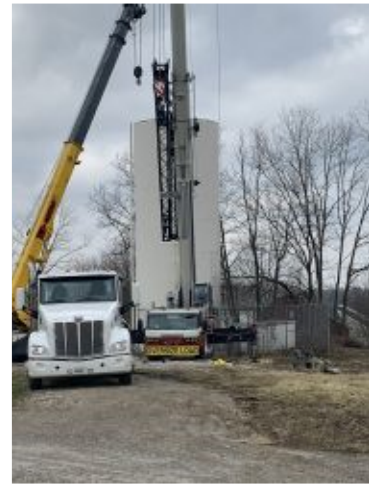
2022.03.09 – Water tower demolition.

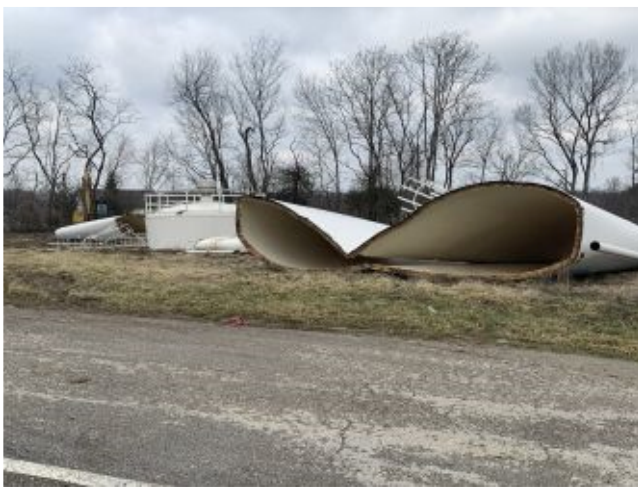
2022.03.09 – Water tower.

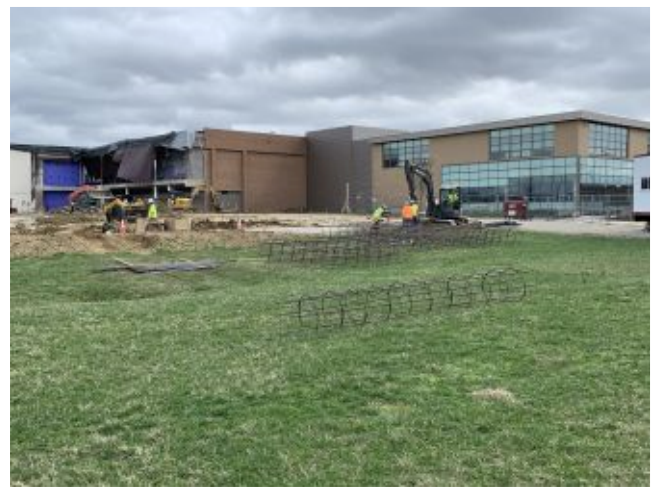
32.01: 2022.03.23 – Rebar cages were staged on site in advance of starting drilled piers. Site storm and sanitary work was on pause at the southwest corner of the practice gym due to conflicts with existing geothermal lines. A survey crew was on site actively surveying the existing conditions.

2022.03.23 – Rebar cages staged.

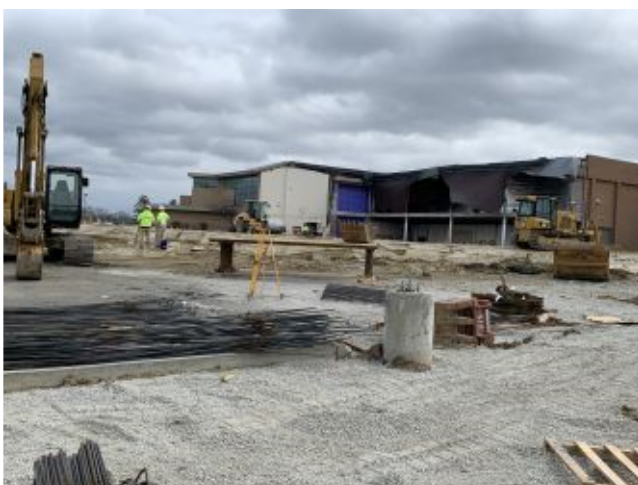
31.02: 2022.03.23 – The building pad at the new pool location was actively being brought to subgrade. The large fill portion of the site was close to subgrade close to Lonneman Drive and work was on-going. The muck previously set aside for drying had dried to the point of being incorporated into the fill. The stockpile had been reduced by roughly half.

2022.03.23 – Establishing subgrade at new pool.

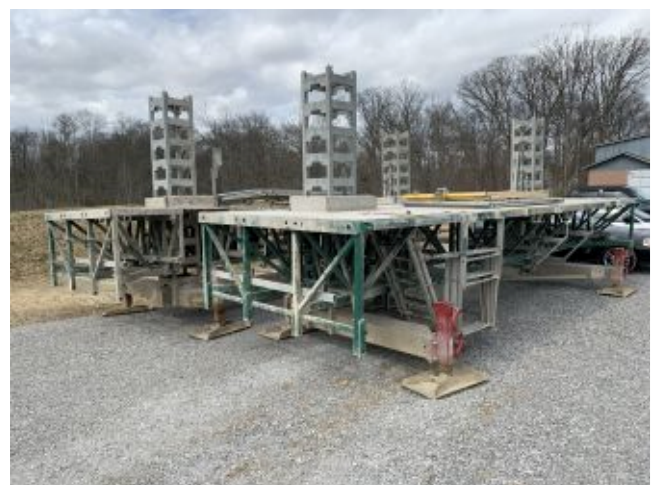
04.01: 2022.03.23 – The mason had staged scaffolding on the site in preparation to start work at the fire wall in Area C.

2022.03.23 – Mason's scaffold.

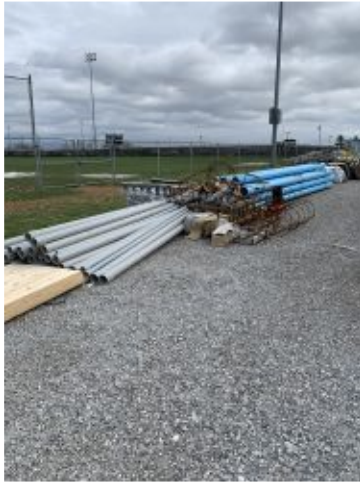
20-28.01: 2022.03.09 – Piping and conduit for assorted underground utilities had been staged around the site.

2022.03.23 – Staged conduit and piping.

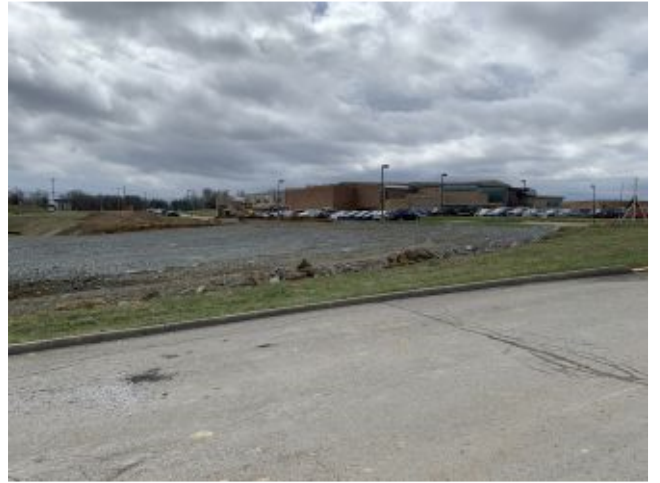
2022.03.23 – Fill progress.

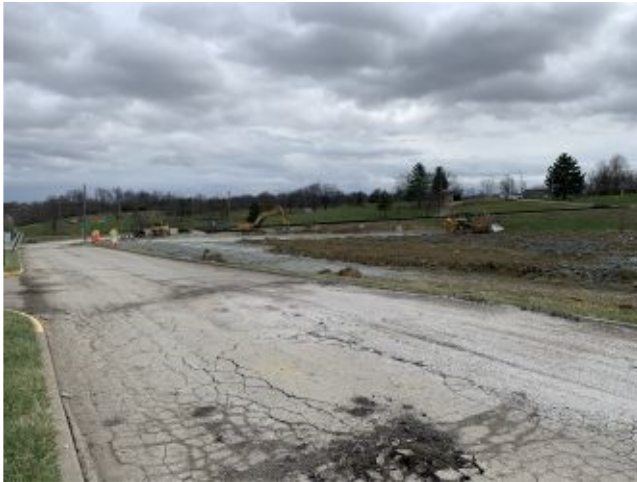
2022.03.23 – Fill progress.

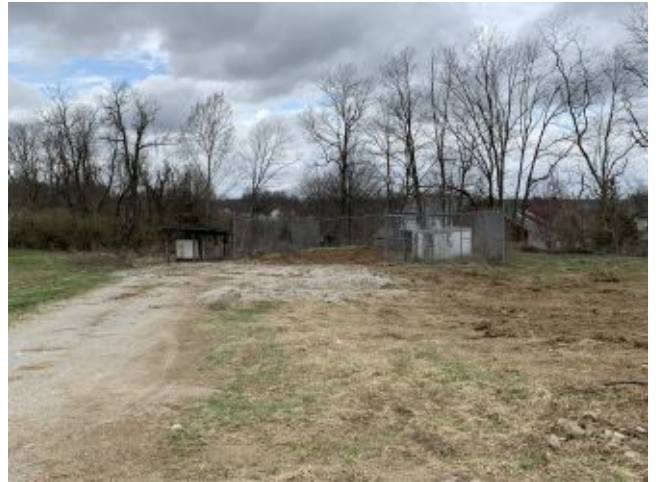
02.02: 2022.03.23 – The water tower at the Taylor Mill site had been removed, including the foundation.

2022.03.23 – Former water tower at Taylor Mill.
