## FIELD OBSERVATION REPORT

### 2022-05 (Scott Phase V)

| ■ FROM: | Mark Perry<br>mperry@pca-arch.com<br>906 Monmouth Street<br>Newport, KY 41071<br>V: 859.431.8612 • D: 859.578.6013 | ■ PROJECT: | Kenton County School District<br>Scott Phase V |

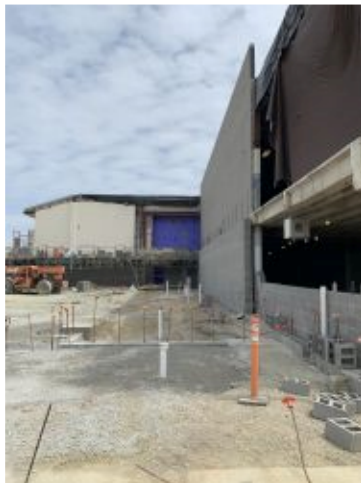
04.01: 2022.04.29 – Masonry fire wall construction was proceeding along line 11 and was approaching 2<sup>nd</sup> floor elevation. The southern face of the two-wall fire wall was complete along line K from 11 to 7.5, the northern face was complete up to 2<sup>nd</sup> floor elevation.

2022.04.29 – Looking along Line K

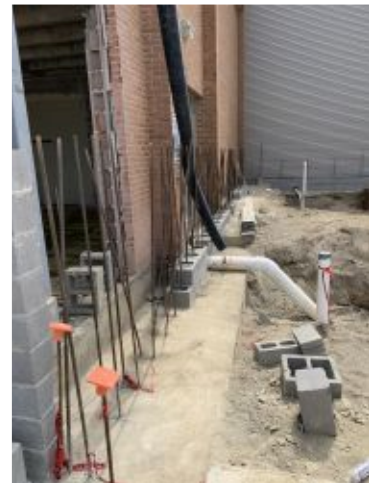
2022.04.29 – Looking along Line 6.4

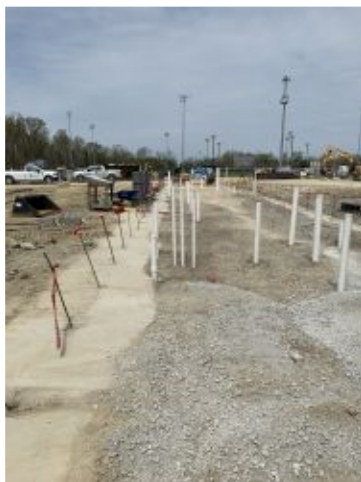
20-28.01: 2022.04.29 – Below slab rough-in was observed in the pool changing rooms north of line K and the pool locker rooms. Work was ongoing at the sanitary and storm lines outside of Phase 3.

2022.04.29 – Looking north – pool locker rooms

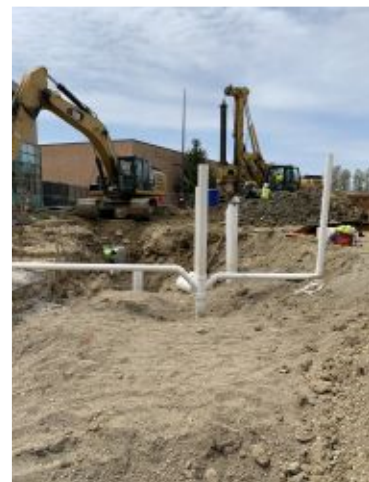
31.01: 2022.04.29 – A pier crew was actively installing the pier at (J.9, 1.9) and that appeared to be the last pier to be installed.

2022.04.29 – Installing sanitary/storm and pier

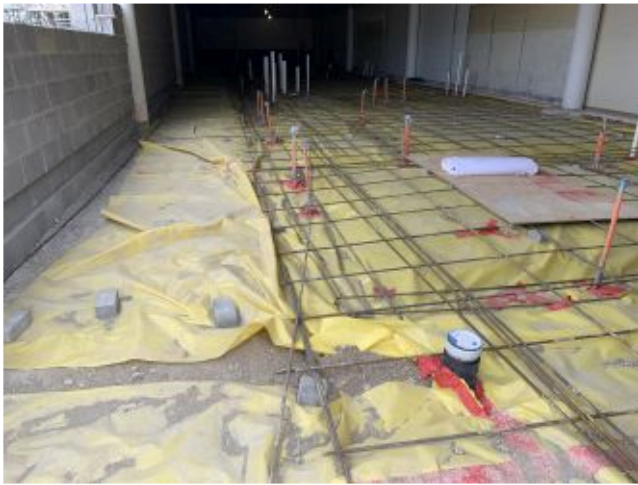
03.01: 2022.04.29 – Slab reinforcing was in place south of line K in the former gym locker rooms.

2022.04.29 – Former gym locker rooms

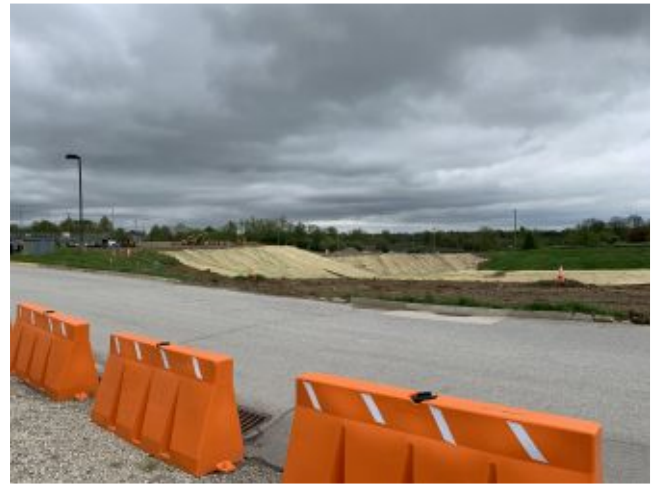
32.01: 2022.05.04 – Grass seed mats had been installed at sloped areas in the large fill out front.

2022.05.04 – Seed mats at fill area.

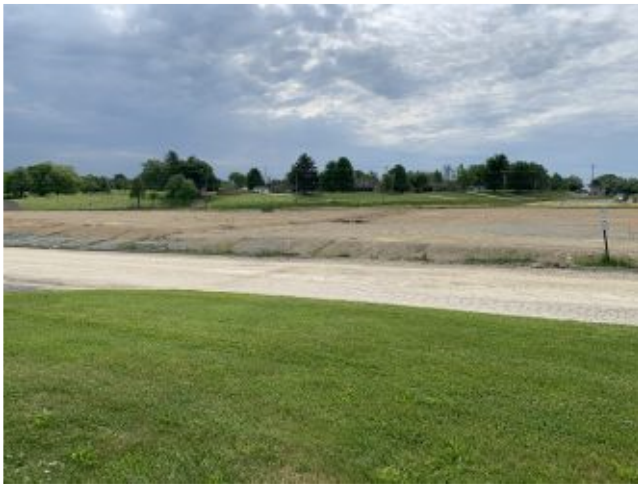
31.02: 2022.05.04 – Earthwork was complete up to subgrade out in front of the school.

2022.05.18 – Final subgrade at fill parking

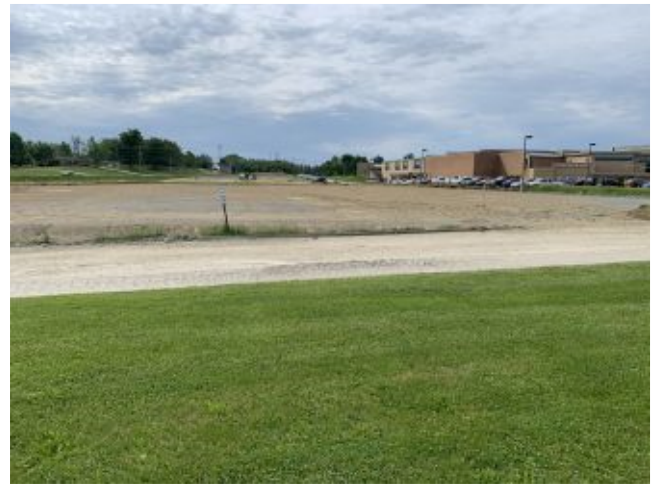
2022.05.18 – Final subgrade at fill parking

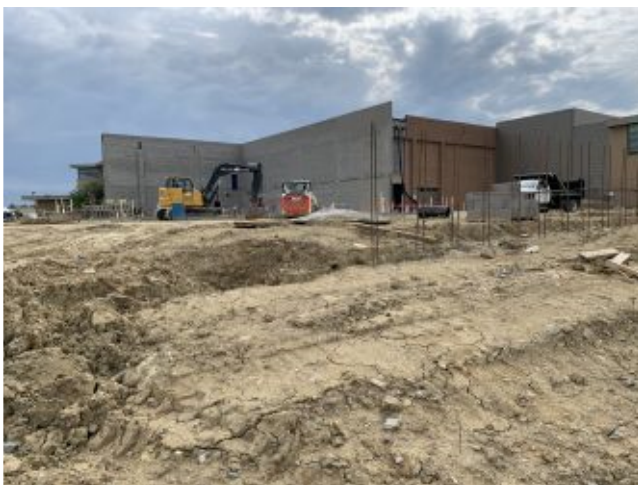
04.02: 2022.05.18 – Masonry fire wall was complete along line 11 and like K. The mason was actively working around the practice gym locker rooms (i.e. bearing walls). Mock up panels had been constructed and recently washed.

2022.05.18 – Looking toward fire wall

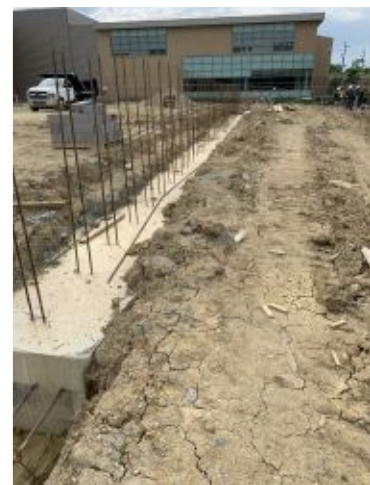
03.02: 2022.05.18 – Grade beam work along the west wall of the practice gym was in place. Slab reinforcing was in place at the swim locker rooms and corridor in advance of a scheduled pour. The slab pour at the former locker rooms had occurred. The pool pump pit and surge tank walls had been poured. Water stops were observed. The foundation crew was actively working on formwork for foundations from this location, south to the fire wall.

2022.05.18 – West wall of practice gym

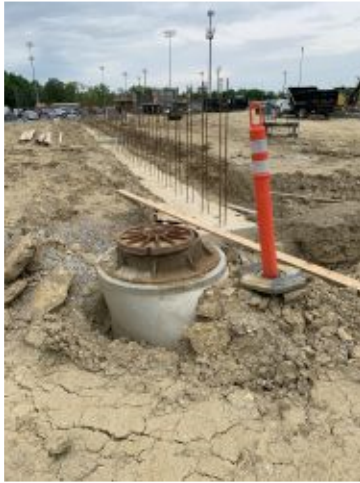
20-028.02: 2022.05.04 – The fire hydrant change on the north side of Woodland and Scott had been completed, though back fill was yet to occur. The sanitary manhole at the SW corner of the practice gym was in place.

2022.05.18 – Sanitary at SW corner of practice gym

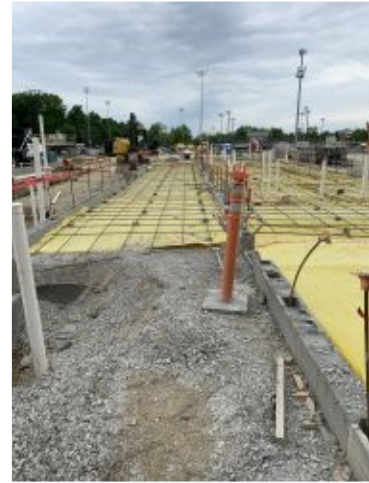
2022.05.18 – Pool locker rooms & corridor

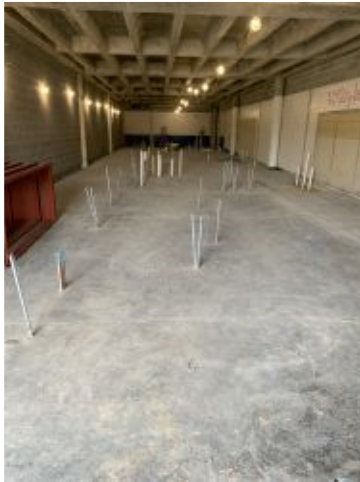
2022.05.18 – Former gym locker rooms

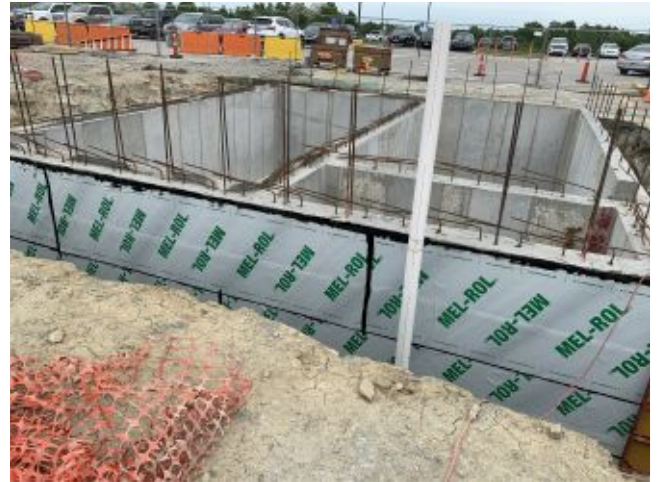
07.01: 2022.05.18 – Foundation water proofing was observed at the pool pump pit and surge tank walls.

2022.05.18 – Pool pump pit and surge tank
