FIELD OBSERVATION REPORT
009-Piner
2022-May/June

■ **PROJECT:** KCSD
Piner Elementary

PROJECT NO.: 2021-004

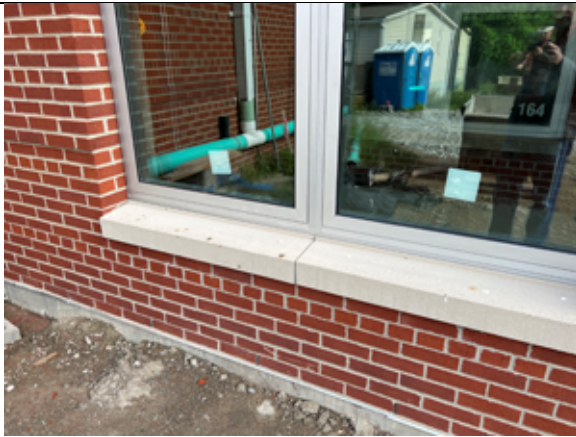
2022.5.24
Exterior windows have been installed.

08.01: 2022.05.24 – The windows have been installed in the new addition. The perimeter of the windows still need to be caulked. The piece of sill flashing that was supposed to lap over the new stone stool was not installed. This was brought to S&Z's attention and it will be added.

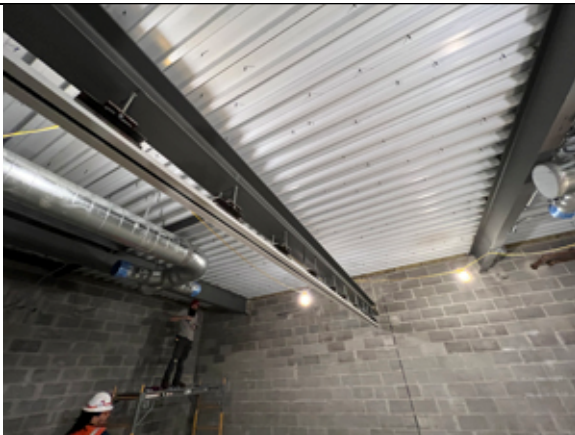
2022.05.31
The track for the folding partition has been installed.

10.03: 2022.05.31 – The track for the folding partition has been installed.

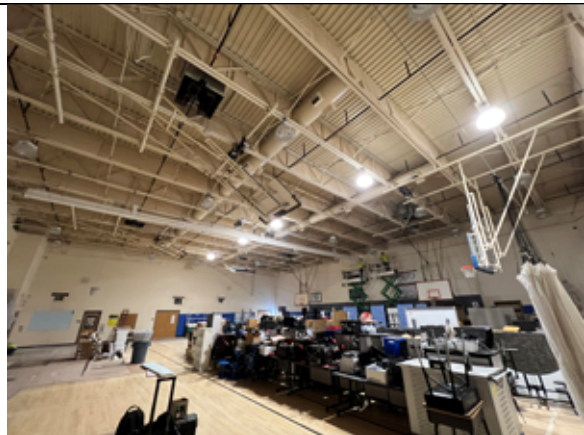
2022.05.31
Sprinkler piping has been installed above the bottom of the floor joists in the gym.

20-28.10: 2022.05.31 – Sprinkler piping has been raised to above the roof joists in the gym.

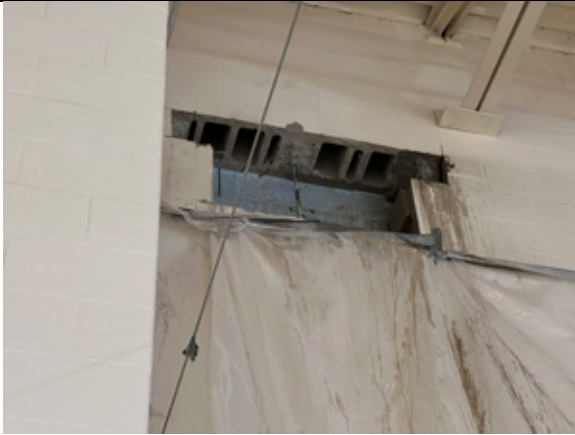
2022.05.31
New openings are being cut for the new ductwork in the gym.

04.02: 2022.05.31 – Mason is in the process of blocking up the old louver openings and cutting new louver openings in the gym.

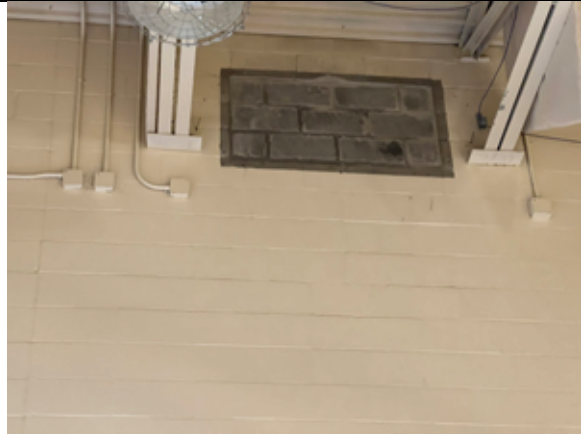
2022.05.31
Abandoned ductwork openings are being infilled.

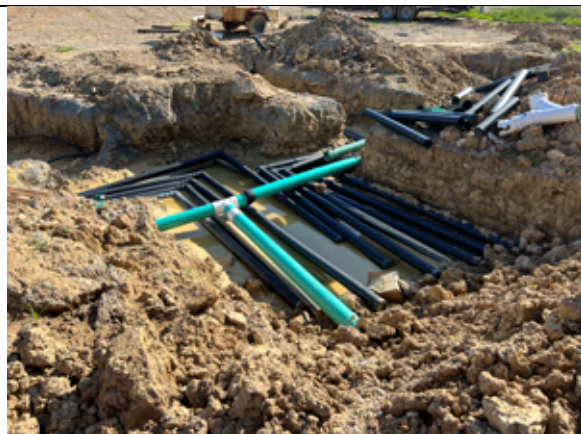
2022.05.31
Geothermal piping for the new mechanical room.

The steel reinforcing channel has been installed above the footing at the new mechanical room.

05.02: 2022.05.31 – The new channel reinforcing has been installed above the footing at the new mechanical room.

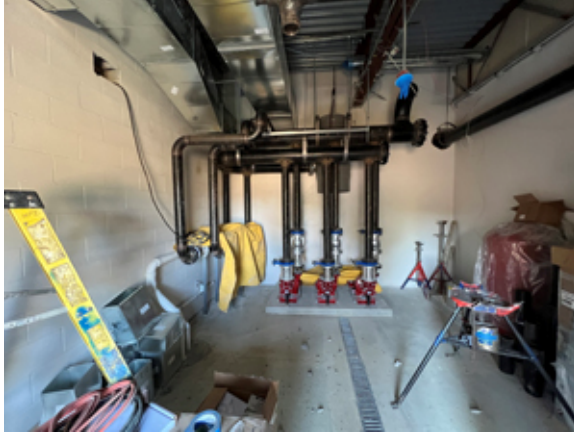
2022.05.31
Pumps for the new geothermal system have been installed.

20-28.12: 2022.05.31 – The geothermal pumps have been set in the new mechanical room. The new trench drain has been installed.

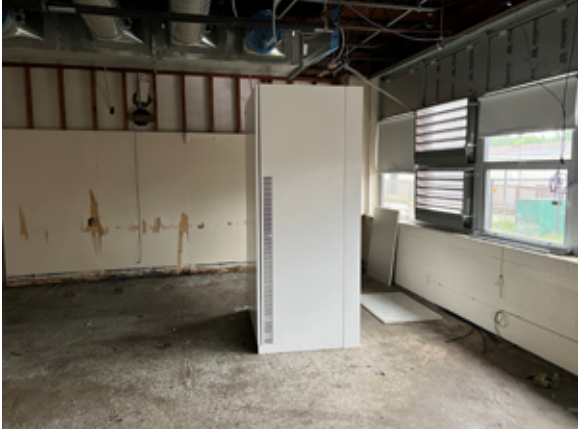
<p>2022.06.07 The HVAC unit have been set in the classrooms and the louvers set in the windows.</p>

20-28.14: 2022.06.07 – The HVAC contractor identified four locations where the new HVAC units in the classrooms will not interface properly with the HVAC louvers that were installed in the original window openings. A possible solution was discussed. CMTA will review the proposed solution with the

equipment manufacturer and respond back. Additional closure plates may need to be added to close off the unit to the window.

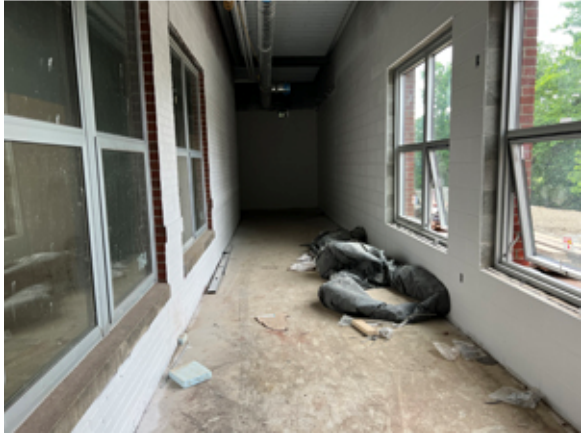
<p>2022.06.07</p> <p>Prime painting has started in the new addition.</p>

02.02: 2022.06.07 – The corridor walls in the new addition have been prime painted. The existing brick wall was not properly prepped with mortar droppings from the new construction still present on the wall surface. This was brought to the attention of the site foreman.

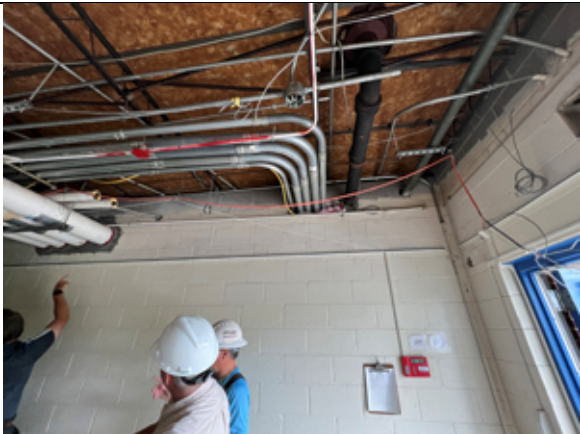
<p>2022.06.07</p> <p>The existing bearing wall between the Admin corridor and mechanical room has multiple existing penetrations that will conflict with the new ductwork penetrations. Steel reinforcing channels will be added to carry the roof load above.</p>

04.05: 2022.06.07 – A meeting was held with the MEP trades, the mason, and the structural engineer to discuss MEP penetrations at the corridor bearing wall separating the mechanical room from the corridor in the original building. There are multiple existing penetrations. Combined with the new penetrations required there was concern that the integrity of the wall could be compromised. The structural engineer identified a solution that will require adding additional channel reinforcing to the face of the wall in multiple locations.

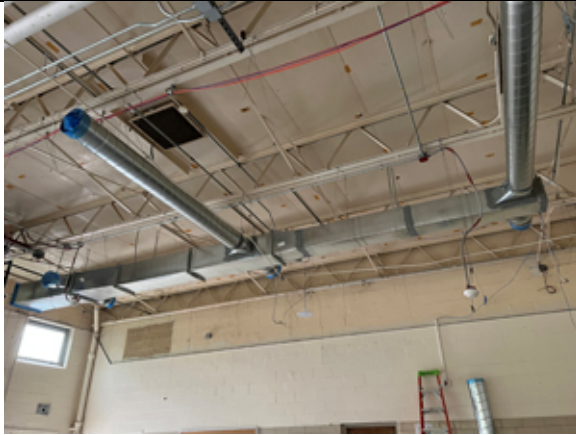
2022.06.07
Installation of HVAC ductwork continues with open ends being protected from dust.

20-28.13: 2022.06.07 – Ductwork is being installed throughout all areas. Dust protection is in place at the ends of all open ductwork.

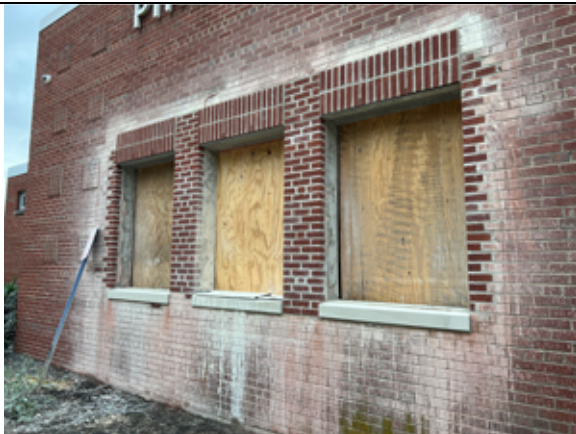
2022.06.14
Installation of the masonry openings at the new Faculty Lounge have been completed.

04.06: 2022.06.14 – The face brick and soldier course headers have been installed at the new Faculty Lounge.

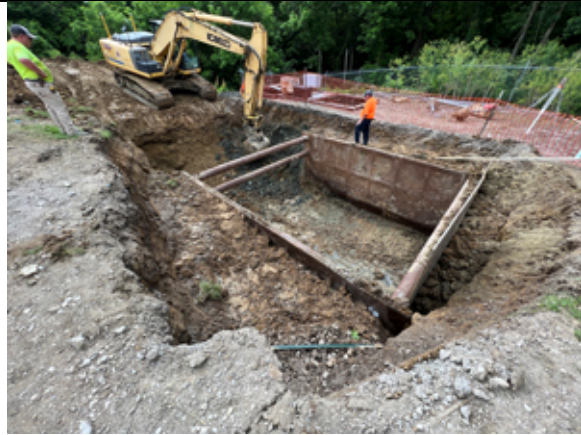
2022.06.14
Excavation for the new waste water treatment plant has started. Slab pour is scheduled for tomorrow.

32.02: 2022.06.14 – Installation of the new wastewater treatment plant has started.

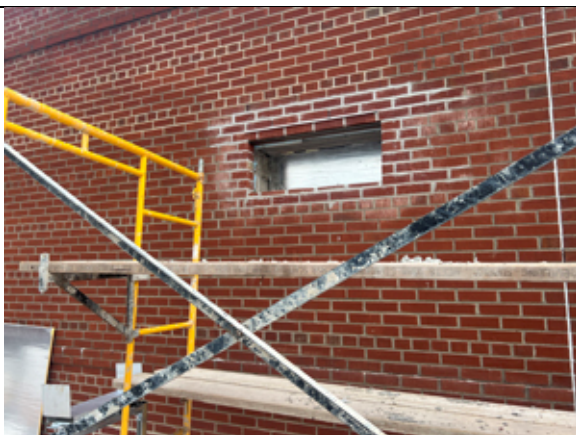
2022.06.14
Installation of the new HVAC louver opening in the gym.

04.07: 2022.06.14 – Installation of the masonry openings for the gym HVAC units was in progress.

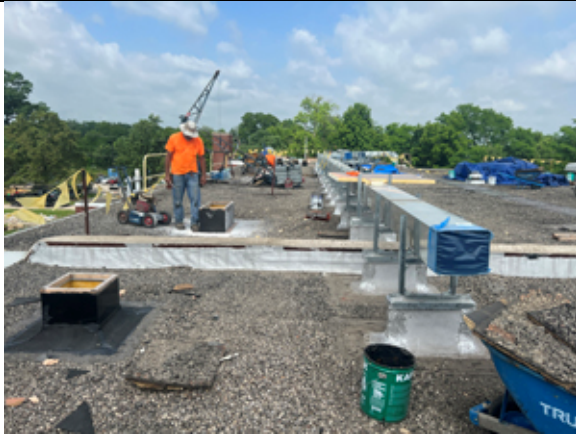
2022.06.14
Installation of equipment curbs continues on the existing roof.

07.07: 2022.06.14 – Installation of equipment curbs was in progress on the existing roof.

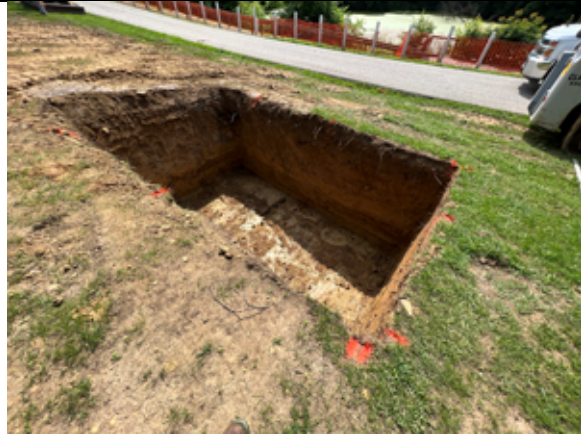
2022.06.14
Installation of the new fire vault has started.

32.03: 2022.06.14 – Excavation for the new fire-vault has started.
