**FIELD OBSERVATION REPORT**  
**010-Piner**  
**2022-June/July**

■ **PROJECT:** KCS  
 Piner Elementary

**PROJECT NO.:** 2021-004

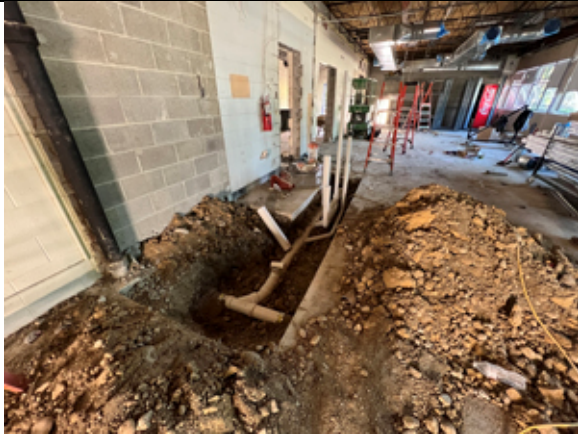
Installation of underslab plumbing in the Admin suite for the new toilet rooms.

20-28.03: 2022.06.21 – Installation of the underground plumbing has been started in the Admin suite for the new toilet rooms.

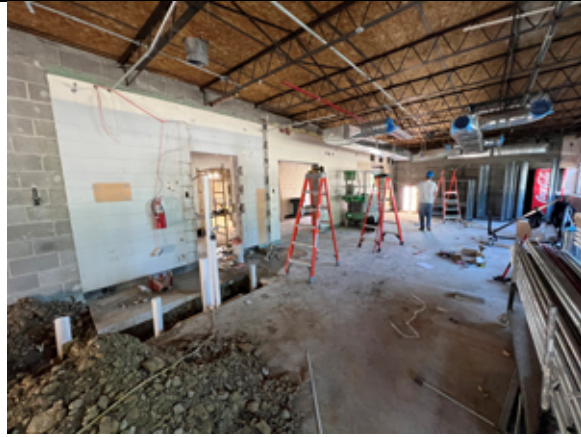
Installation of ductwork continues in the Admin suite.

20-28.04: 2022.06.21 – Installation of ductwork rough-in continues in the Admin suite.

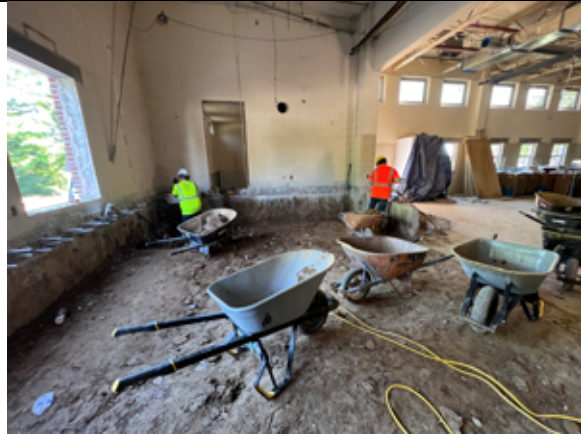
The stage slab has been removed. Workers were excavating excess soil to permit installation of the new floor slab.

*02.01: 2022.06.21 – The concrete stage slab has finally been removed. The slab was heavily reinforced complicating its removal. Workers were in the process of digging out the subgrade to permit installation of the new floor slab for the Faculty Lounge.*

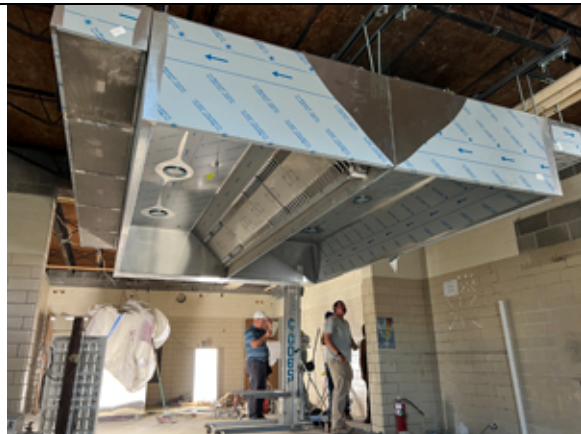
The new kitchen exhaust hood has been set.

11.01: 2022.06.21 – The kitchen exhaust hood has been set. The extremely tight working conditions and lack of available space overhead will require that some existing plumbing piping be relocated to permit the exhaust ductwork to be installed. All the trades were meeting to discuss how to route the multitude of items in this area.

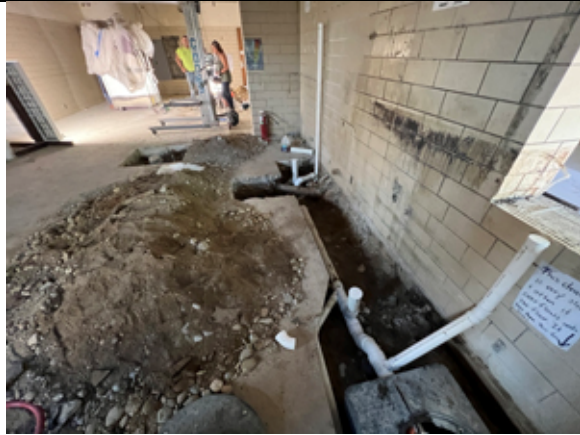
Underslab plumbing for the new equipment is being installed in the kitchen.

20-28.05: 2022.06.21 – Installation of the underslab plumbing for the serving line floor drain, dishwasher, and grease trap was in progress.

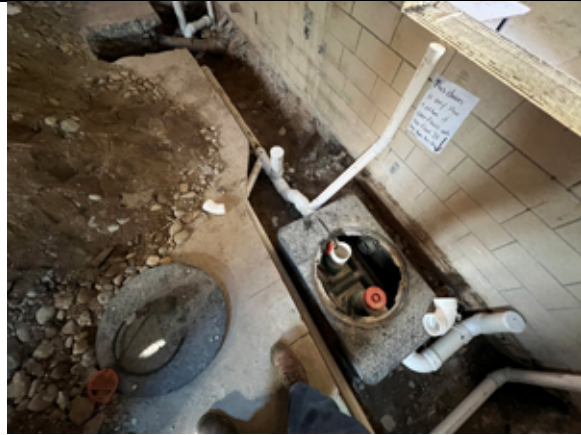
Underslab plumbing for the new equipment is being installed in the kitchen.

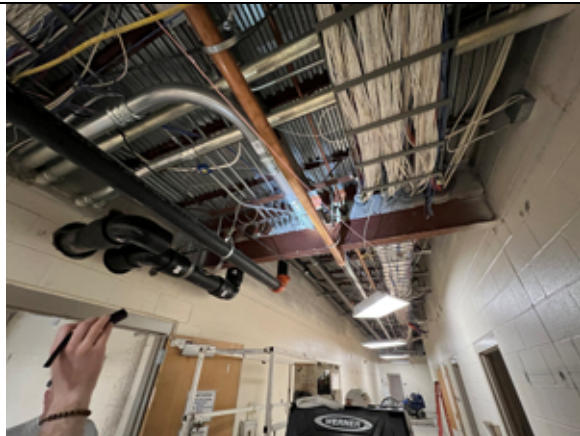
An existing masonry wall was compromised by previous MEP penetrations. These will be corrected per the structural engineers direction.

04.03: 2022.06.21 – We reviewed the existing masonry wall at the corridor connection between the original building and gym/media center addition with the structural engineer. The bearing wall has multiple existing penetrations from previous MEP work. The new MEP work will require additional penetrations that would compromise the structural integrity of the wall. The structural engineer will provide recommendations on how to reinforce the wall. An adjacent bearing wall was also identified and having been compromised with previous MEP work. The structural engineer directed the mason on how to repair the wall. After S&Z receives the structural engineers written recommendations they will prepare a change order proposal.

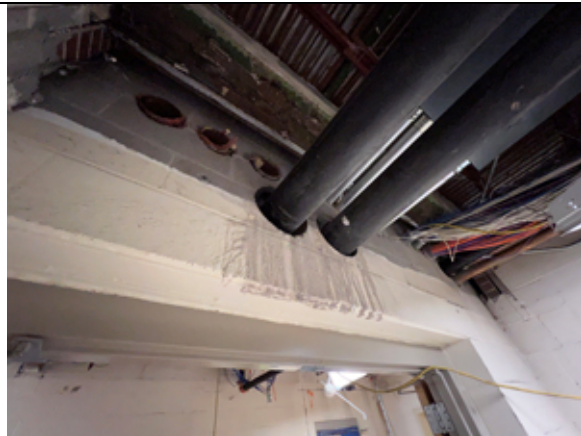
Existing and new MEP penetrations at the corridor wall between the original building and gym/media center addition have compromised the integrity of the bearing wall. The structural engineer will provide direction on how to reinforce the wall.

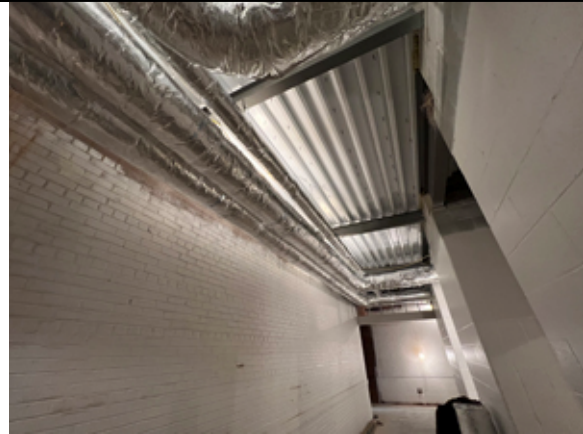
Ductwork is being insulated in the new addition.

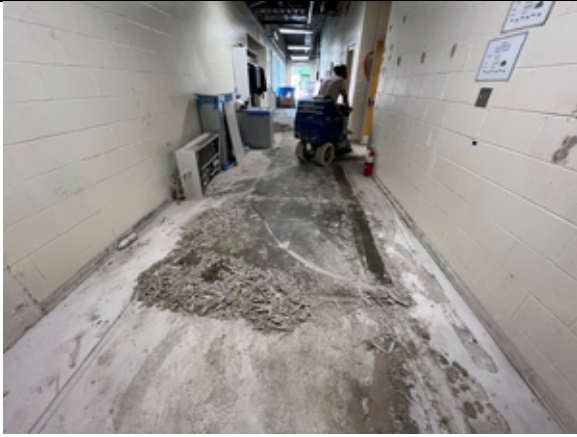
Removal of the existing VCT flooring is in progress.

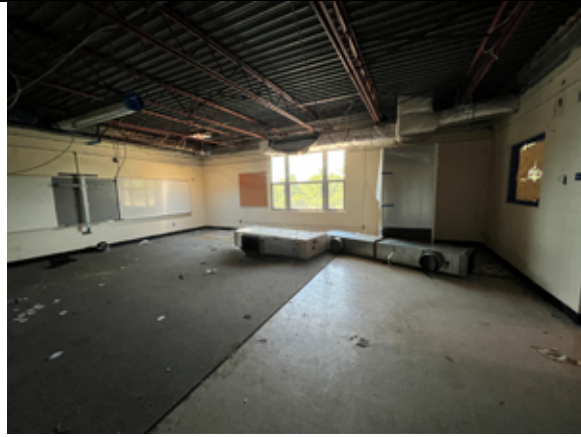
Removal of the existing HVAC equipment is in progress on the second floor.

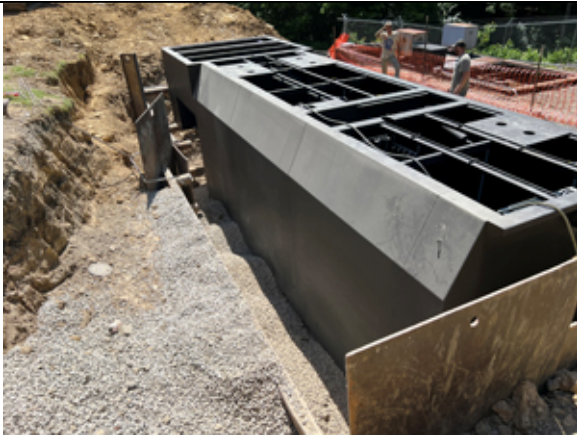
Installation of the new wastewater treatment plant is in progress.

32.02: 2022.06.21 – The new waste water treatment plant has been set in place. Workers were in the process of starting to backfill around it. The existing plant will remain operational as long as possible.

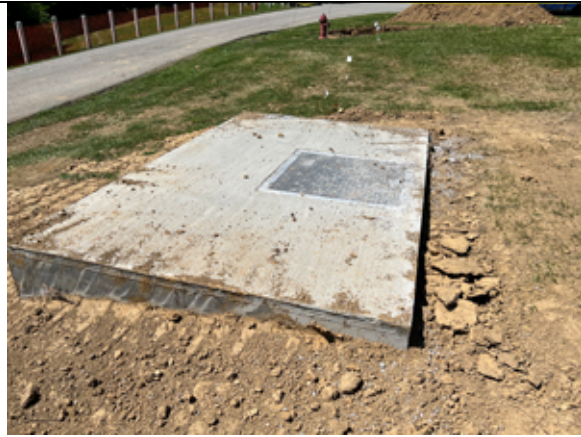
The new fire vault installation is complete.

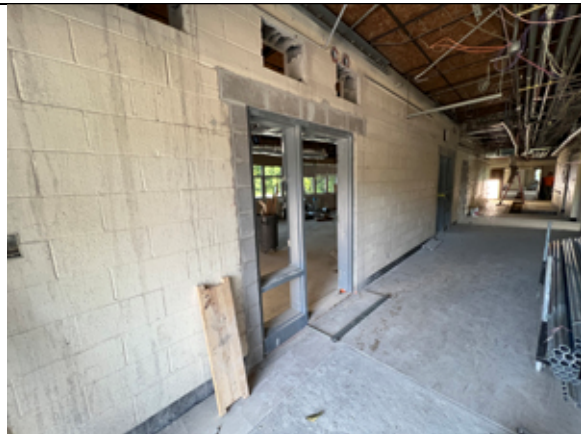
The new openings into the Admin Suite have been completed.

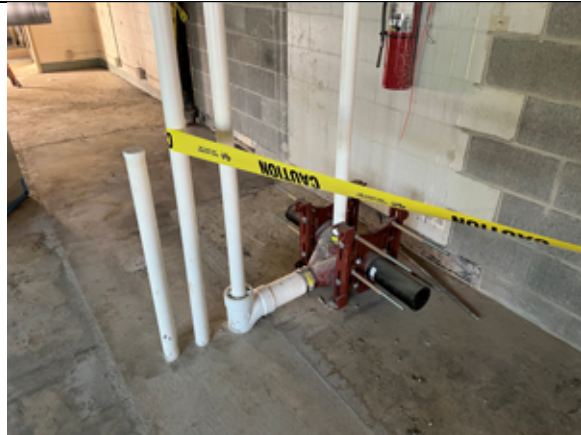
Carriers have been set for the new toilets in the Admin Suite.

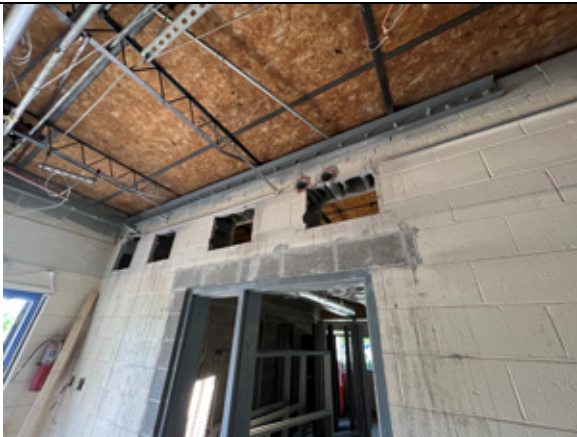
The steel channel reinforcing has been installed over the new MEP penetrations.

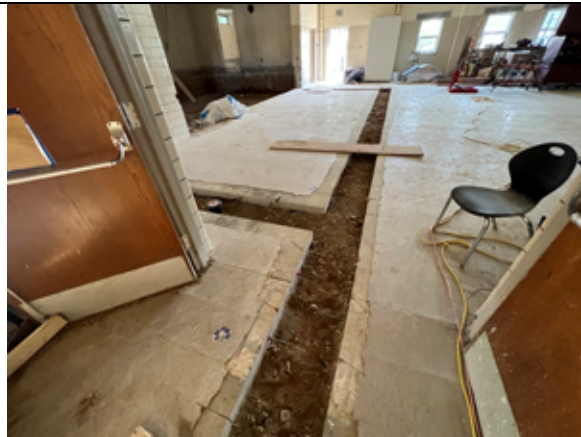
The floor slab for the new plumbing from the Faculty Lounge has been cut and the plumbing installed.

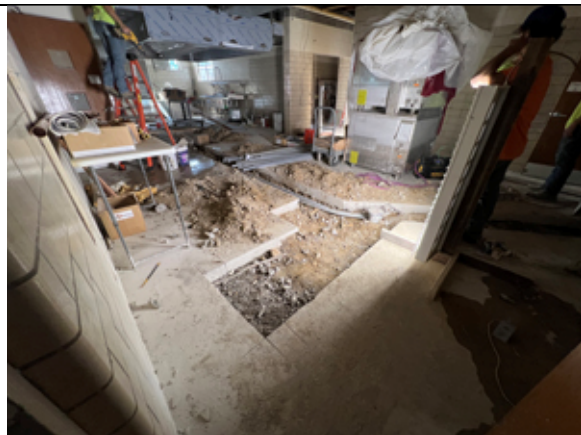
Installation of underslab utilities continue in the kitchen.

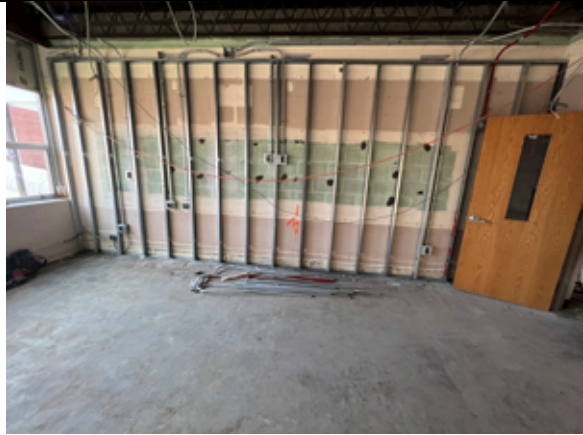
The classroom presentation wall framing and electrical rough-in has been completed.

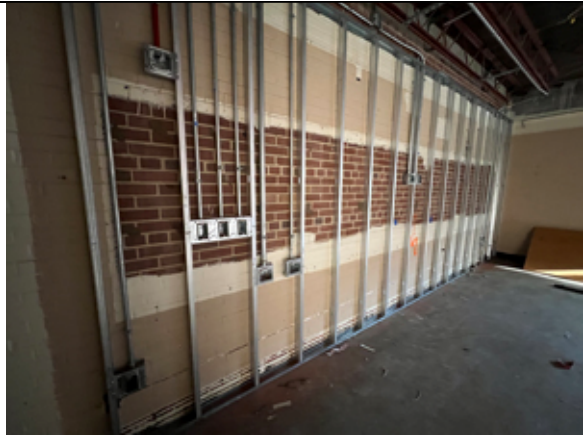
The classroom presentation wall framing and electrical rough-in has been completed.

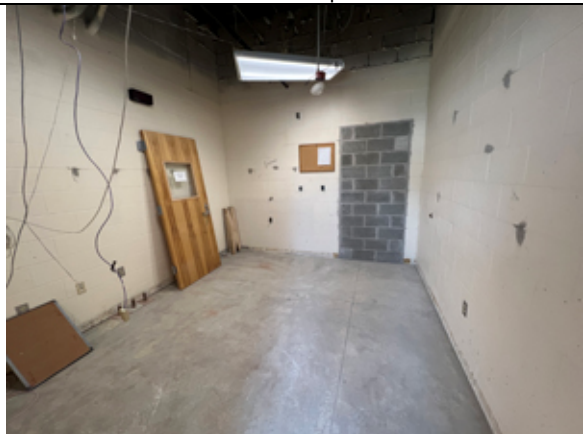
Opening have been infilled.

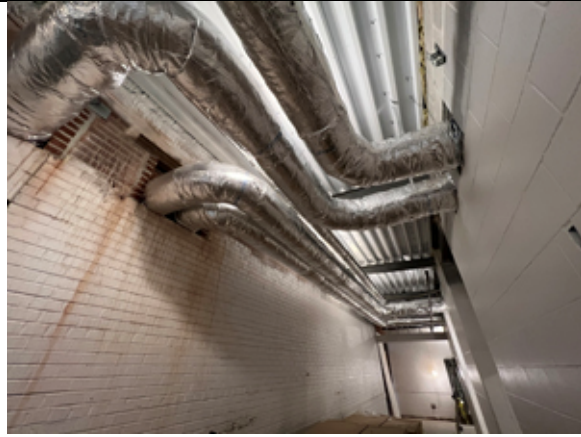
Ductwork is in the process of being insulated.

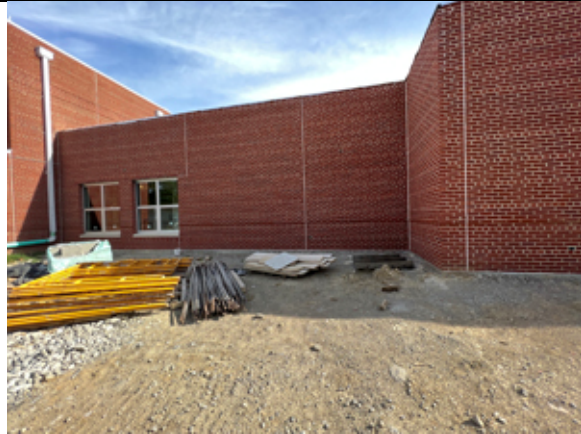
The brick on the new addition has been cleaned and the control joints caulked.

04.06: 2022.06.28 – The exterior brick of the new addition appears to have been cleaned. The control joints have been caulked.

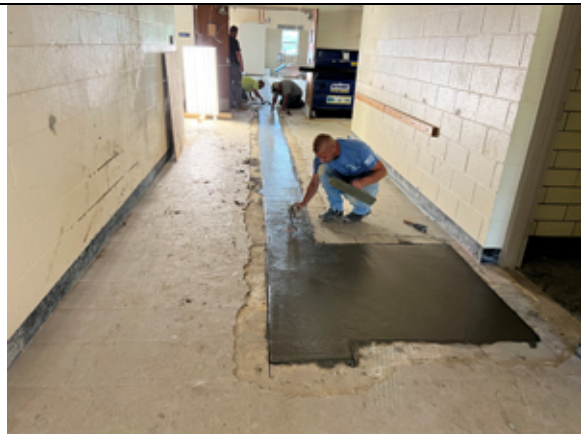
The concrete floors are being patched where the new underslab plumbing was installed.

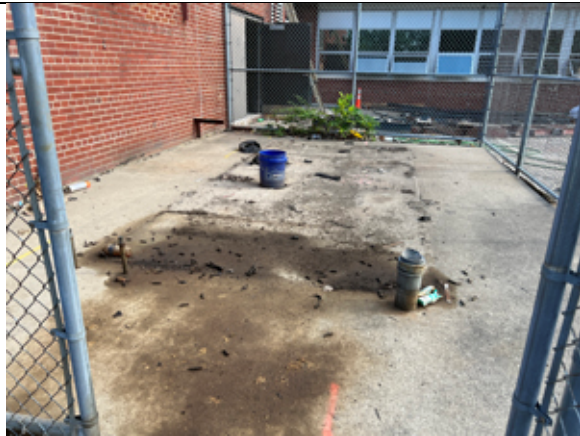
The old chiller has been removed.

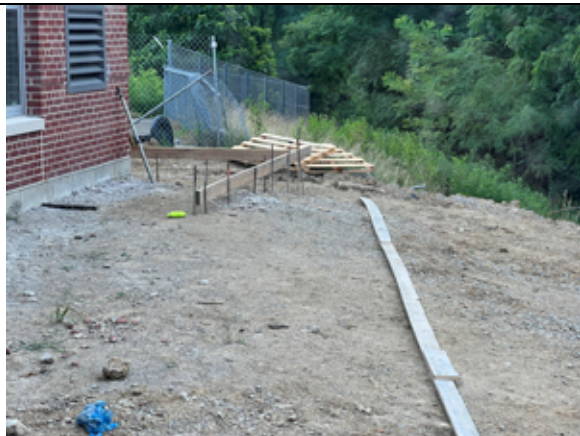
Formwork is being installed for the walks outside the new Pre-K classrooms.

03.02: 2022.07.05 – Formwork was being installed for the new walks at the addition. Adjustments needed to be made at the tie-in with the tyke track due to grade differences.

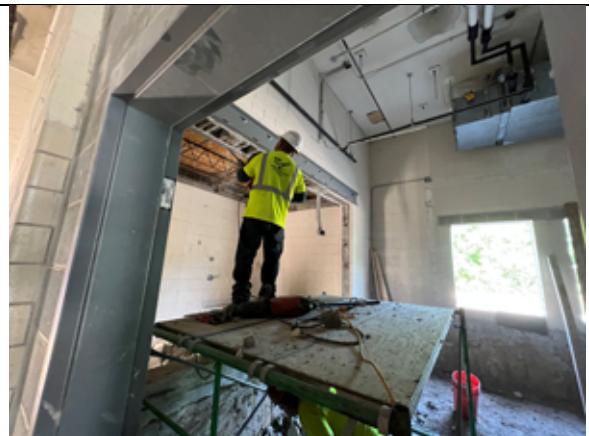
View of new reinforcing channel installed between the SRO office and Faculty Lounge.

05.02: 2022.07.05 – The channel reinforcing for the masonry wall between the SRO office and Faculty Lounge has been installed. Workers were in the process of removing the wall below the new channel.

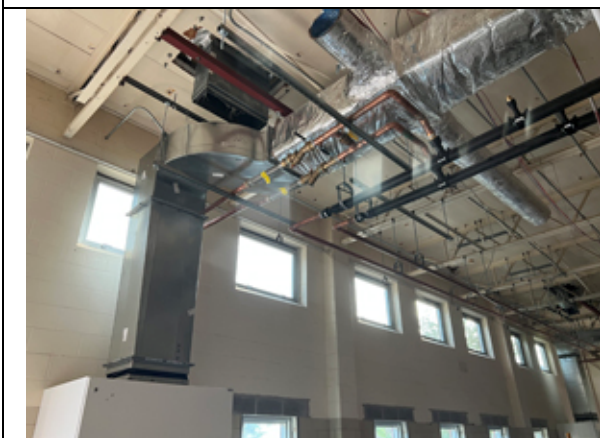
MEP connections are being made to the new HVAC units in the Cafeteria.

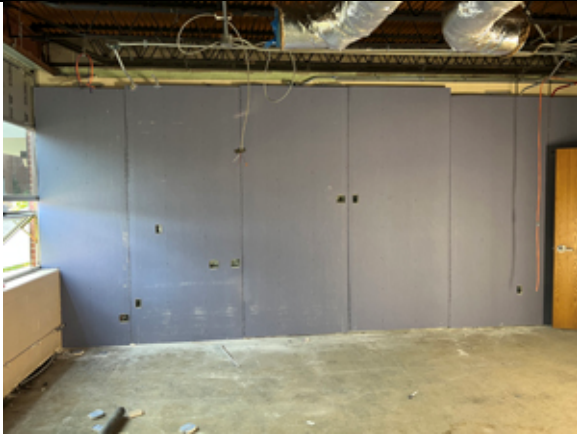
Gypsum board is being installed on the presentation walls in the classrooms.

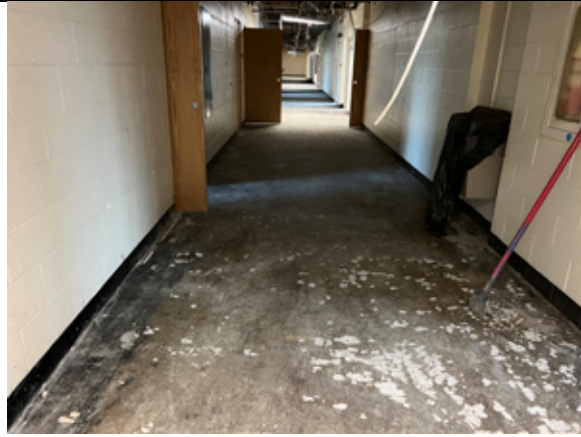
The original VCT has been removed from the second floor floors.

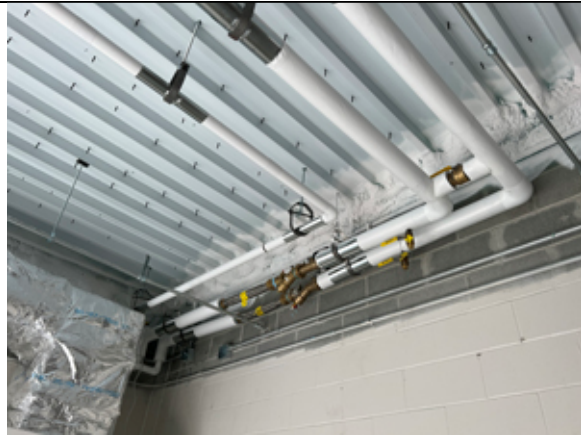
Piping is being insulated in the new addition.

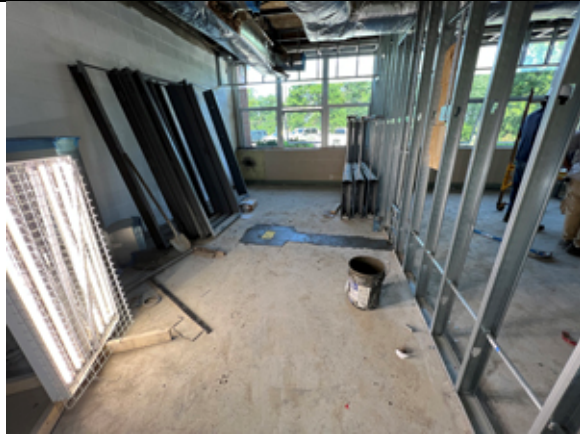
Recessed floor outlet for the Admin Suite Conference Room has been set and the concrete patched.

20-28.21: 2022.07.12 – The electrical floor box has been installed in the Admin Suite Conference Room and the concrete poured.

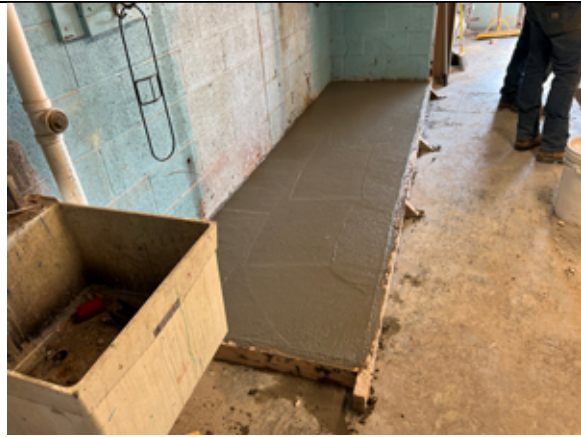
A housekeeping pad has been poured in the Mechanical Room.

03.04: 2022.07.12 – The housekeeping pad has been poured in the mechanical room and was in the process of being finished.

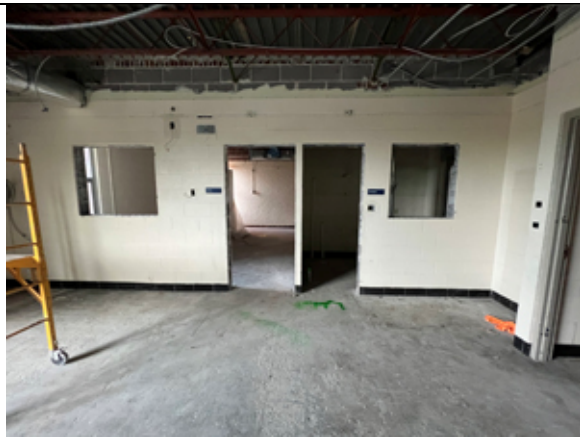
Existing openings to be infilled on the second floor.

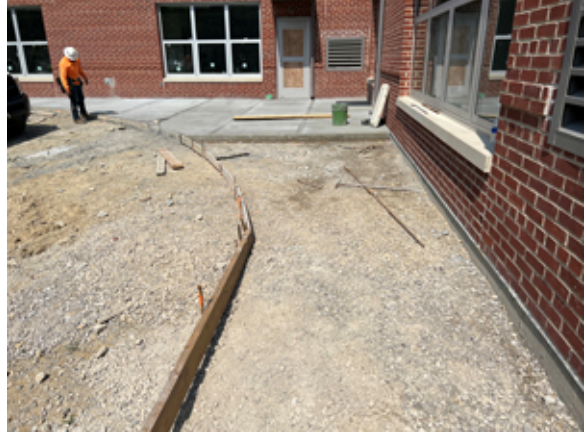
Installation of the new concrete paving at Pre-K classrooms is in progress.

03.05: 2022.07.12 – A portion of the concrete walk outside the Pre-K Classrooms has been poured. Workers were in the process of forming the remaining walk. I met with the sub-contractor to discuss how the grades need to work.

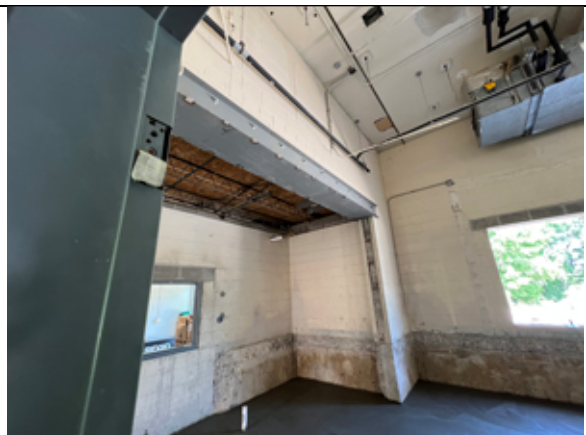
The steel channel lintel has been installed at the wall between the SRO office and Faculty Lounge.

05.03: 2022.07.12 – The installation of the channel reinforcing wall between the SRO office and Faculty Lounge has been completed.

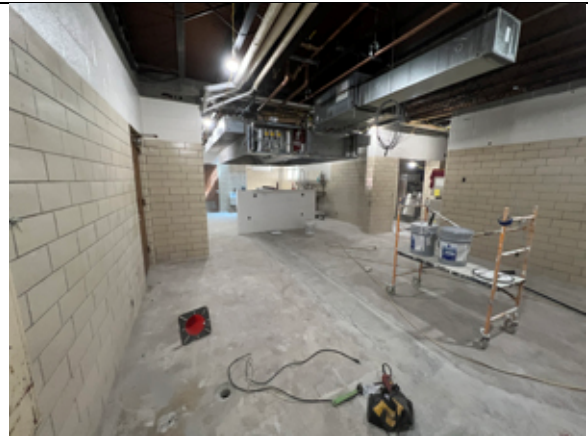
The Kitchen floor is being prepped for installation of the epoxy flooring.

09.07: 2022.07.12 – Kitchen floor is being prepped to permit installation of the epoxy floor coating. Removal of the ACT is scheduled for tomorrow.

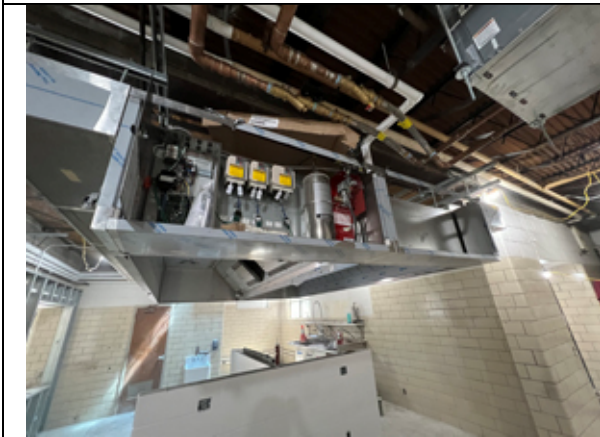
The Ansul system for the kitchen hood.

09.10: 2022.07.12 – A meeting was held to discuss the ceiling height in the kitchen. A bulkhead will be installed at the serving line to permit the ceiling to be installed at 8'-2" at the electrical panel and 8'-0" at the remainder of the Kitchen. The grid that crosses over the Ansul control access panel will be screwed in to permit removal for inspection of the Ansul system.

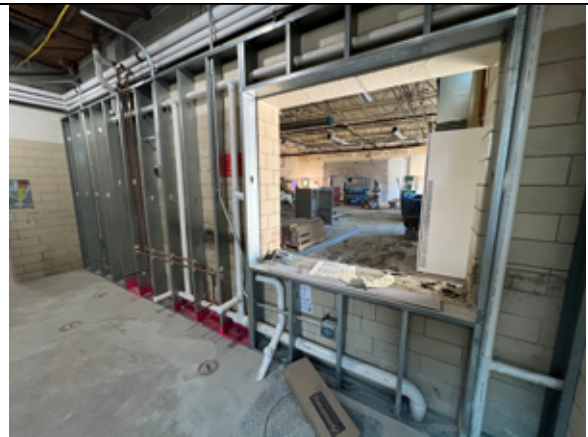
The new furred wall behind the dishwashing equipment.

09.11: 2022.07.12 – MEP rough-ins have been completed at the 6" furred wall for the dishwashing equipment. Installation of the gypsum board is scheduled to start.

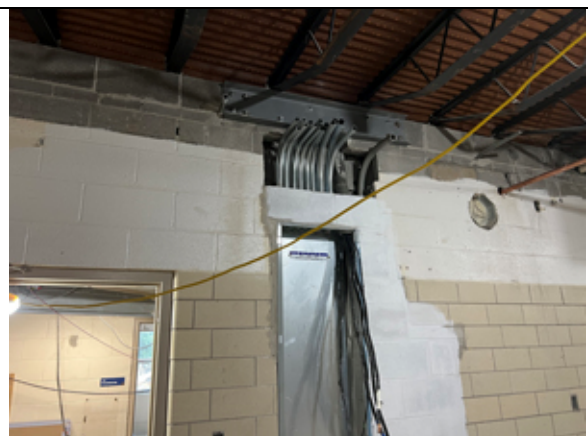
The steel reinforcing channel has been installed over the new electric panel.

04.09: 2022.07.12 – The steel reinforcing channel has been installed over the new kitchen electrical panel.

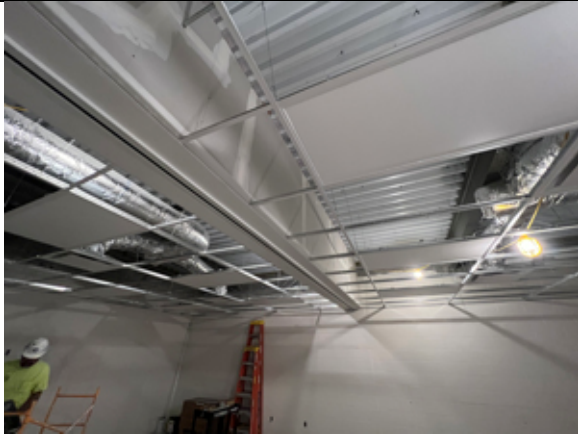
The gypsum board partition has been installed above the folding partition track in the Resource Rooms.

09.13: 2022.07.12 – The gypsum board divider has been installed above the folding partition track in the new Resource Rooms.

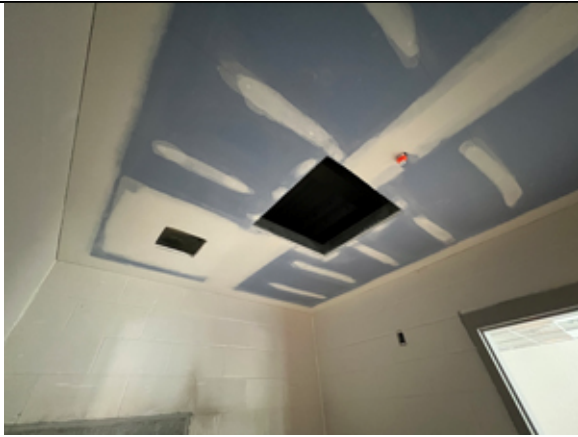
The gypsum board ceiling has been installed in the toilet rooms of the new addition.

09.14: 2022.07.12 – The ceilings have been installed in the new addition toilet rooms.

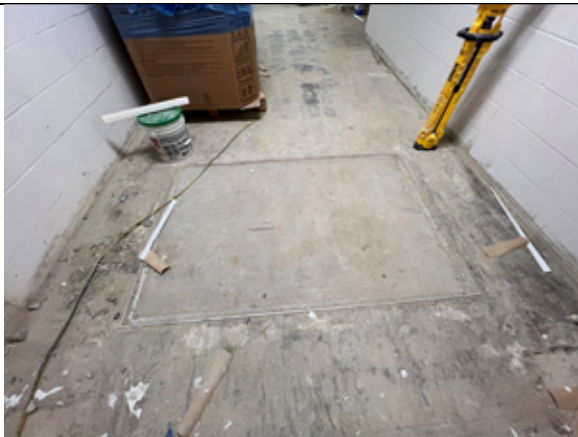
The existing frames for the recessed mats in the original building will be removed and the depression infilled with concrete patching compound.

02.12: 2022.07.12 – The existing recessed floor mat frames will be removed and the recess infilled with concrete patching compound.

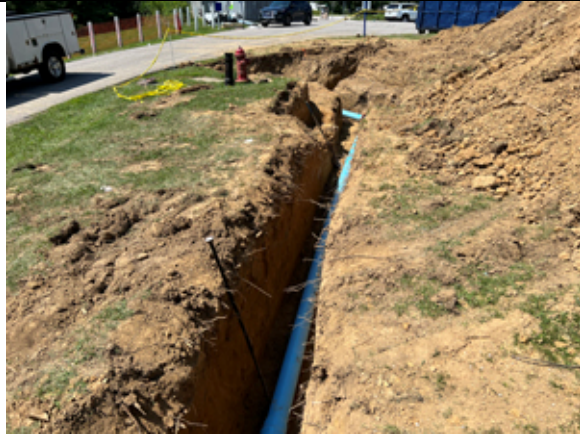
Installation of the water line for the fire vault is being installed.

32.05: 2022.07.12 – Installation of the new water line for the fire vault was in progress. The excavator ran into and old building foundation.
