## FIELD OBSERVATION REPORT

Central Hardin High School – Phase 2, Cecilia, KY

2019111 - CA8

Report No: 09

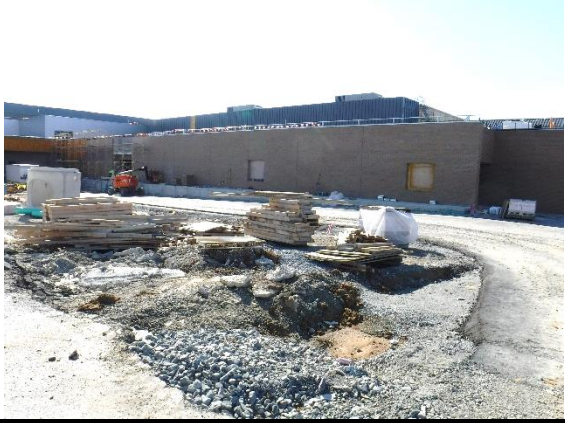
Item No.	Location	Description/Correction	Image	Action
1	East Side of Exterior of Area D	Bricks were installed on the east side. Light gauge metal framing was being installed for the parapet.

Complete wall and parapet so roofing can begin.
2	Entrance to Gym Lobby Area D	Masons were completing the brickwork at the entrance. Metal panels will be installed above the doors.

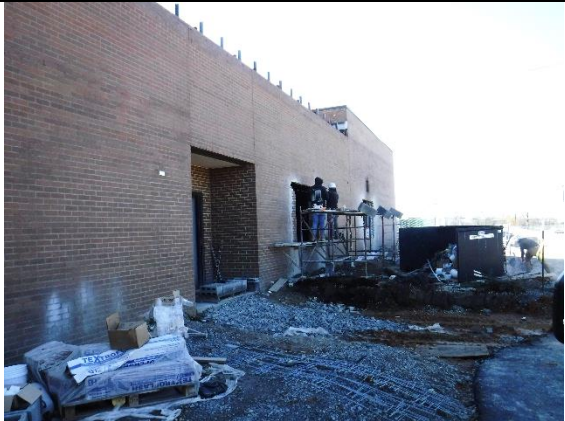
Coordinate metal panel work with the surrounding construction.
3	Area D North Elevation	Masons were installing new brick in the existing wall at the openings.

Blend existing and new brick and mortar.

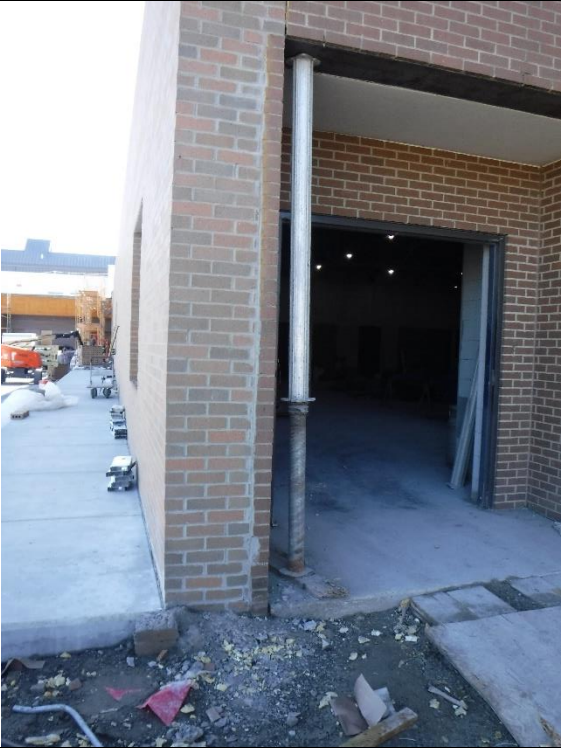
Item No.	Location	Description/Correction	Image	Action
4	North Entrance Area D	New brick tied into the existing brick. This had not been cleaned to see how the finished joint will appear.

Clean the brick and detail the joint.
5	Area D Ag Shop Exterior	The former overhead door opening was infilled with concrete block. Brick will cover the block. A new canopy will be installed at the man door.

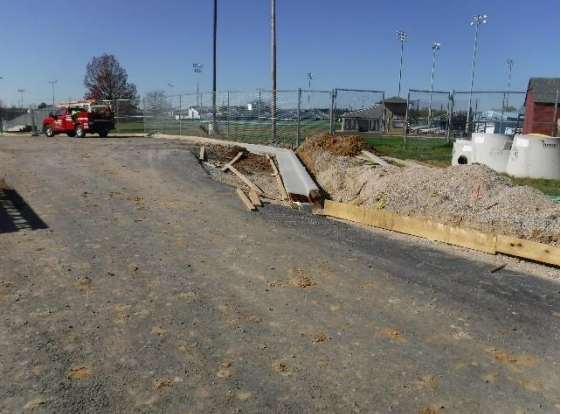
Replace the canopy. Evaluate the appearance of the existing brick under the existing canopy when it is removed.
6	North Site	The paving was modified to work with the new curb poured under Phase 1.

Complete the curb under Phase 1.

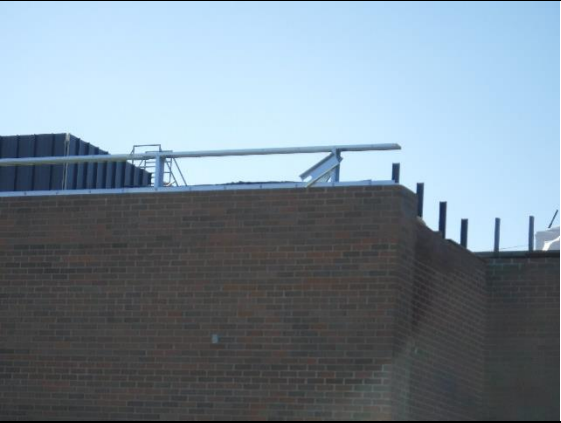
Item No.	Location	Description/Correction	Image	Action
7	Area D Parapet	Light gauge metal framing was being installed for the new parapet which will be covered with metal panels.

Confirm the backing requirements with the metal panel installer.
8	Band Room Area D	The openings in the wall at the office and practice room were be infilled for the new arrangement.

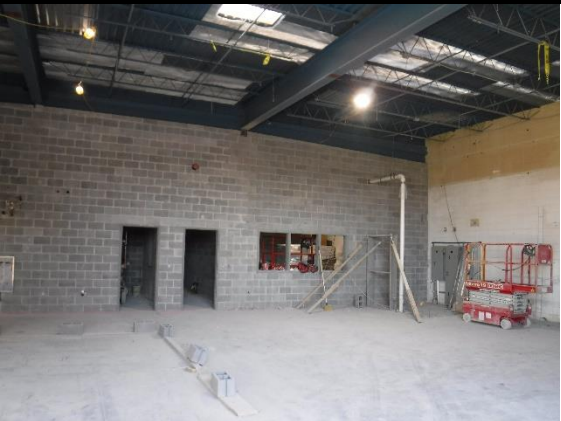
Prepare new block with block fill to minimize the appearance difference between the existing and new block.
9	Ag Shop Area D	The new concrete block wall was completed.

Detail walls for a paint finish.

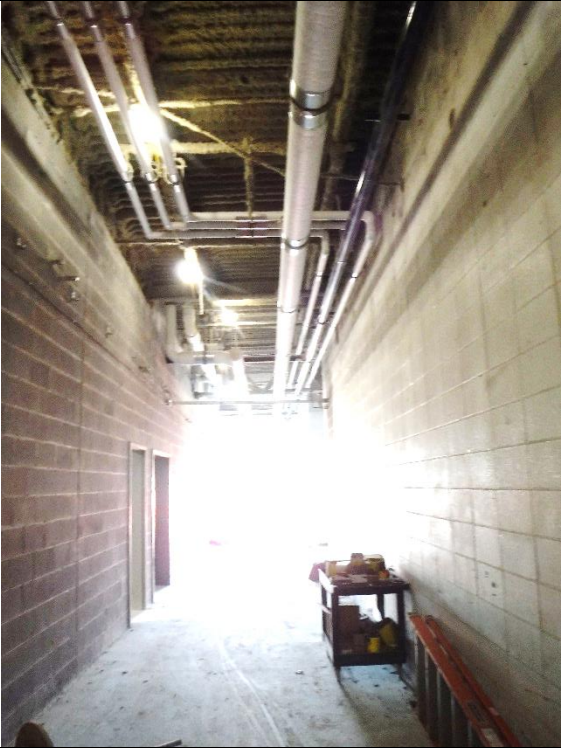
Item No.	Location	Description/Correction	Image	Action
10	Corridor Area D	Utilities were being installed over the proposed ceiling.

Complete above ceiling work so that ceilings can be installed.
11	Area D Gym Lobby	The Phase 1 mason laid additional concrete block to the roof deck. This provides a fire and acoustical separation.

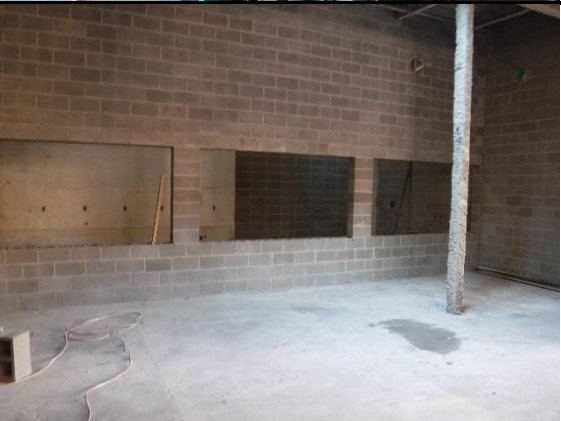
Phase 1 needs to address the top of wall condition.
12	Area D Gym Lobby Concessions Area	The concrete block walls were laid at the concession's windows.

Coordinate the installation of the counter doors with the openings.

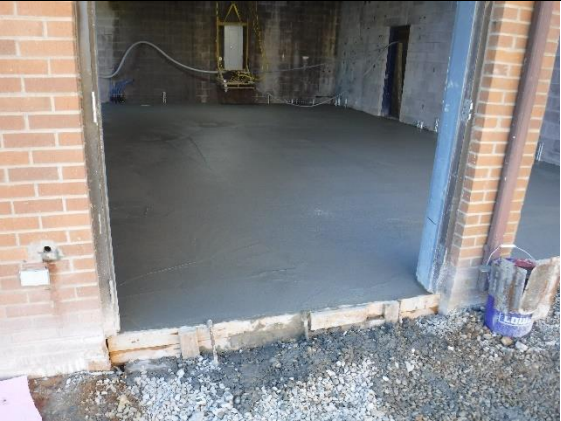
Item No.	Location	Description/Correction	Image	Action
13	Area J Mechanical Room	The new concrete slab had been poured and was being finished.

Confirm the layout of the room with the equipment to be installed.
14	North Corridor Area J	The concrete slab had been restored over the new sewer lines.

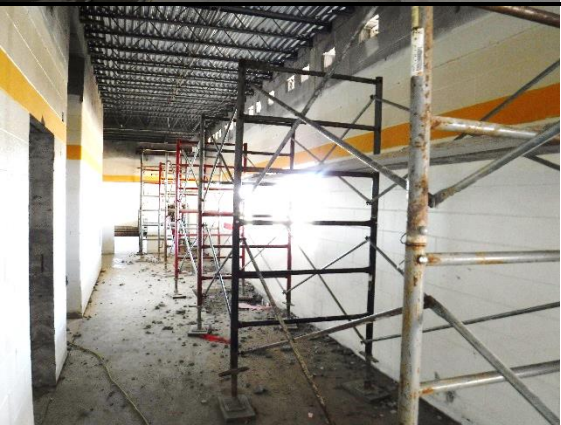
Grind the repair so it has no effect on the floor finish.
15	Area J First Floor West Corridor Temporary Shoring	The shoring was being moved to the east corridor for the installation of new steel beams.

Refer to the SPIN report for the installation of the new steel beams.

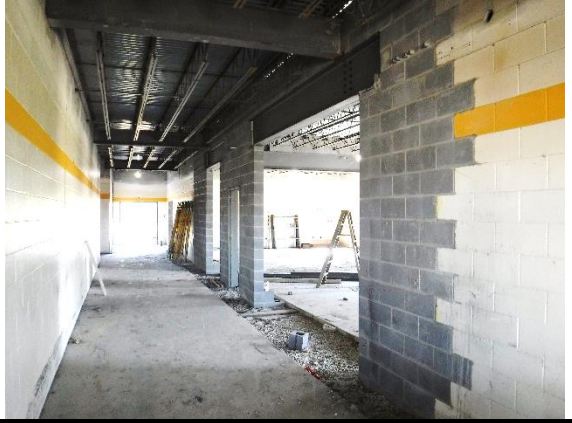
Item No.	Location	Description/Correction	Image	Action
16	Area J First Floor South Corridor	With the new steel beams in place, concrete blocks were laid for the new classroom arrangements.

Blend the paint textures of the existing and new block for a consistent finish.
17	Area J First Floor New Steel Beam	The new steel beam was in place and sitting on its bearing wall.

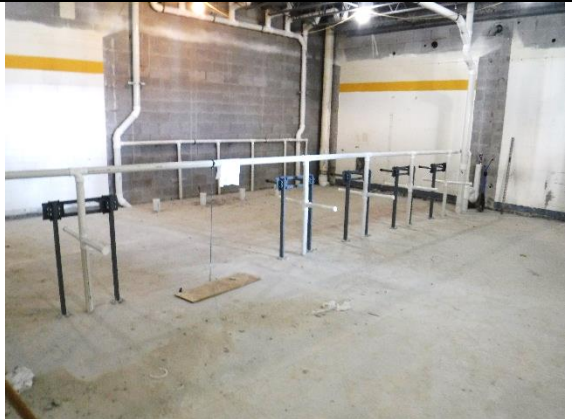
Repair the interior and exterior wall to prevent moisture from entering the building.
18	Area J Toilet Rooms	The plumbing waste and vent piping and carriers were in place for the new fixtures arrangement.

Coordinate fixture locations with finishes, toilet stalls and accessories.

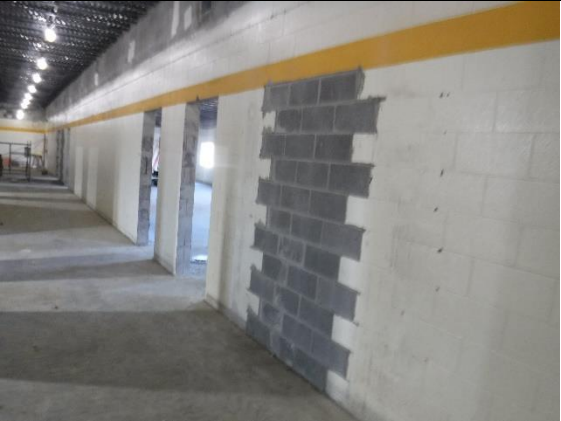
Item No.	Location	Description/Correction	Image	Action
19	Second Floor Corridor Area J	Door openings that will no longer be required were infilled with concrete block.

Blend new and existing block and mortar joints to minimize the difference when the walls are painted.
20	Student Toilet	The new piping and carriers were in place for the new fixture arrangement.

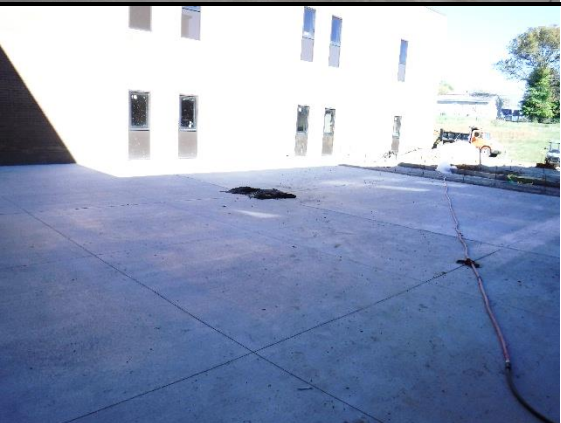
Install fixtures to meet the clearances required by the ADA and the dimensions shown on the G Sheets.
21	Area J and H Courtyard	The courtyard slab had been poured.

Protect the slab as the new connector is constructed.

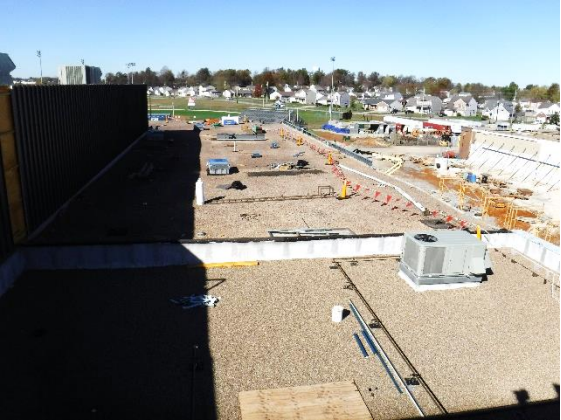
Item No.	Location	Description/Correction	Image	Action
22	Area D Roof	Mechanical work was underway. The roof will be covered with additional insulation and a new roof membrane. The roof will tie into the new parapet along the east edge of the roof. An additional wall parapet will be constructed by the Phase 1 framer.

Coordinate the work by the HVAC, plumbing and parapet installers with the new roofing work.
