FIELD OBSERVATION REPORT #05

2024-11 - New Board Office

■ TO:	Kenton County Board of Education 1055 Eaton Drive Ft. Wright, KY 41017	■ DATE:	2024.11.13
ATTENTION:	Mr. Kevin Pfefferman		
■ FROM:	Mark Perry mperry@embosdesign.com 906 Monmouth Street Newport, KY 41071 V: 859.431.8612 • D: 859.578.6013	■ PROJECT:	New Board Office KCSD BG#24-084
COPIES TO:	Mr. Matt Rigg; Mrs. Carrie Hooten, Mr. Brian Vanover	PROJECT NO.:	22-106

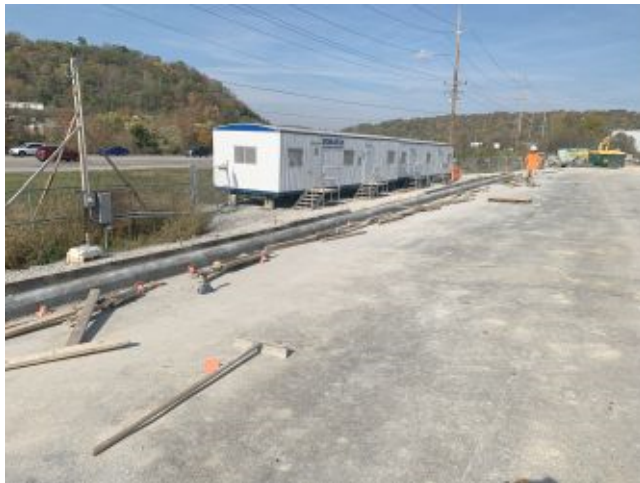
2024.10.29 – Header curb at west edge of parking

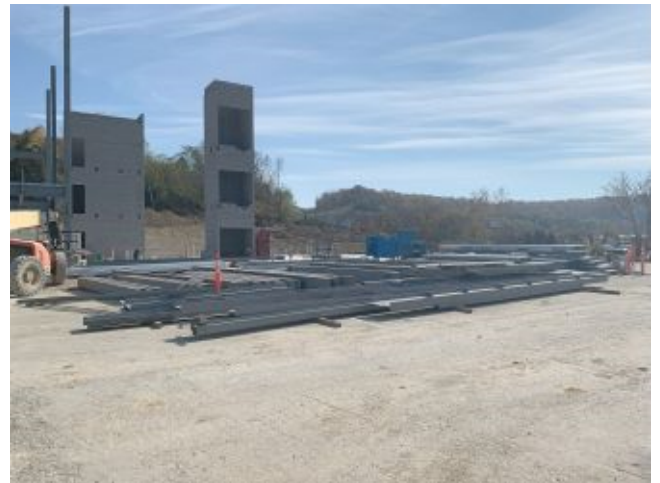
05.01: 2024.10.29 – High wind conditions were preventing steel erection at the time of my site visit. Detailing of some connections had occurred. At least some of the K-series roof joists had been delivered and staged. It was reported all but three Area B steel members had been delivered.

2024.10.29 – Steel staged for installation

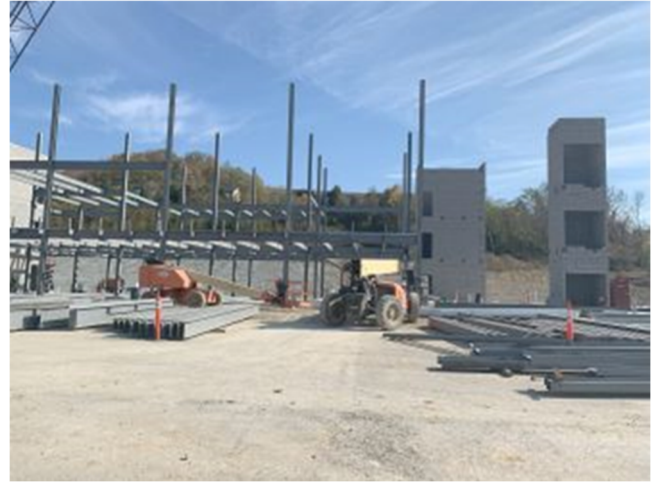
04.01: 2024.10.29 – Stair #2 shaft had been completed and scaffolding removed.

2024.10.29 – Area B including elevator shaft and Stair #2

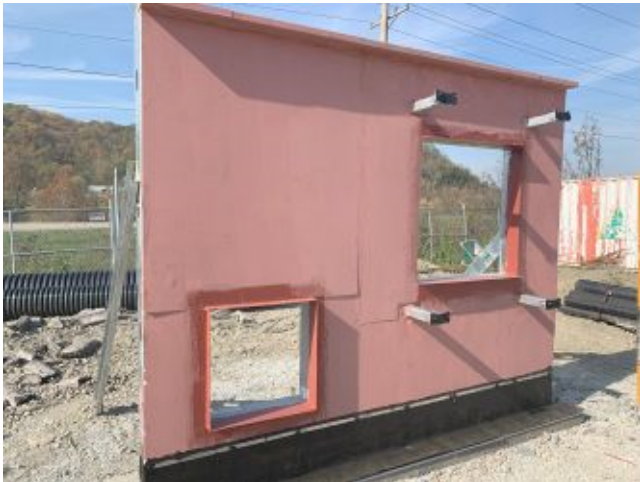
01.01: 2024.10.29 – The mock-up had been sheathed and air/weather barrier applied. The Valmont panels were staged, ready for installation.

2024.10.29 – Mock-up

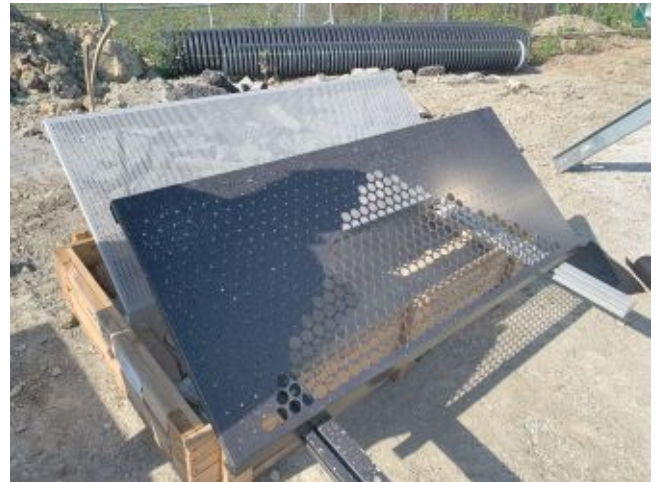
2024.10.29 – Valmont panels for mock-up

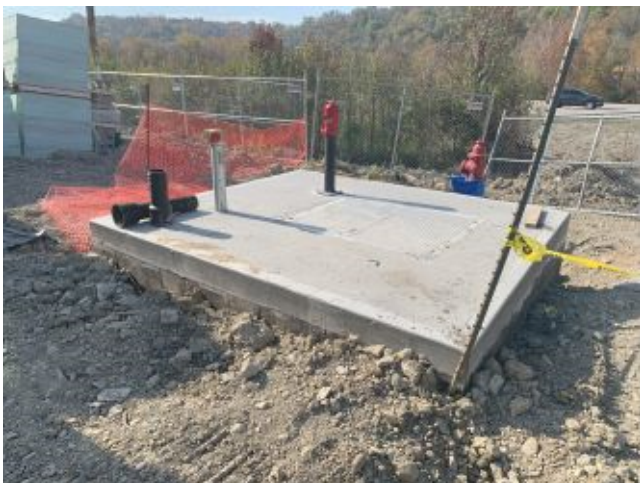
20-28.01: 2024.10.29 – The water meter pit lid had been poured.

2024.10.29 – Water meter pit

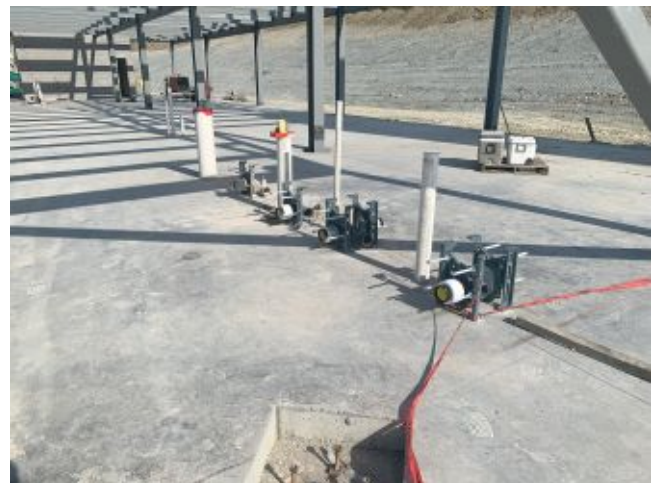
20-28.02: 2024.10.29 – Carriers had been installed at Women #163 and Men #164.

2024.10.29 – Carriers at Women #163 & Men #164

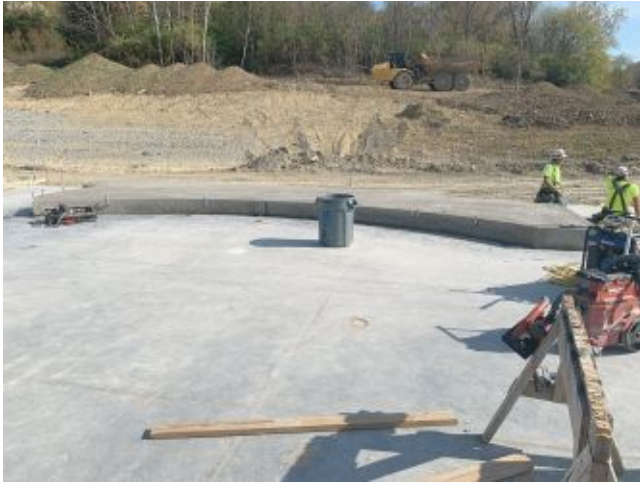
03.01: 2024.10.29 – The dais had been poured in the board room.

2024.10.29 – Dais in Board Room #102

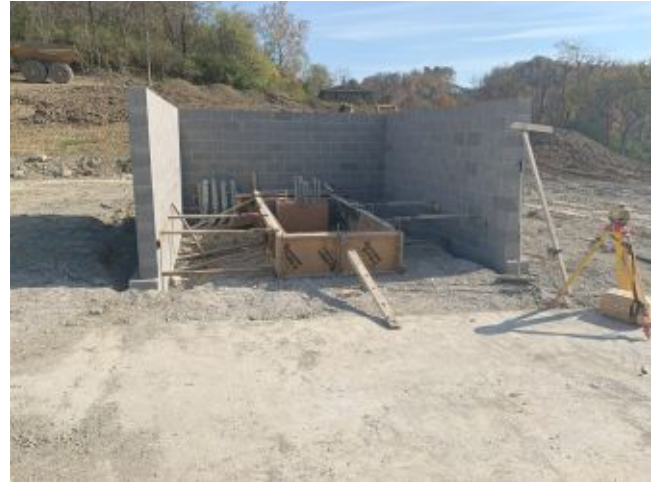
04.02: 2024.10.29 - Emboss questioned the generator screen wall height. Monarch confirmed a discrepancy in base elevation used by the mason. It was agreed the wall height was low. Two additional courses of CMU will be added when brick veneer is installed.

2024.10.29 – Generator screen wall

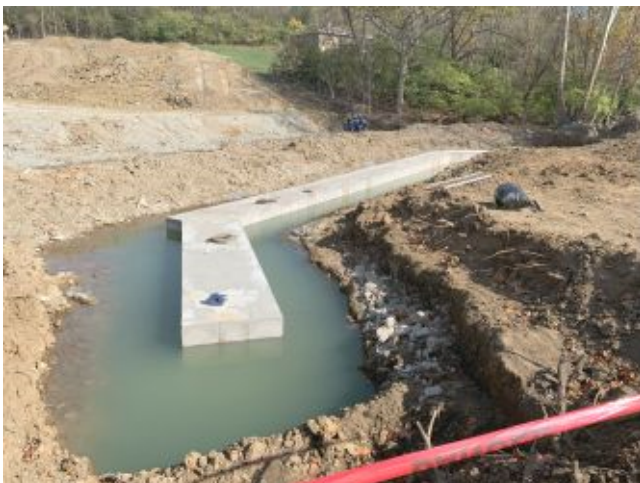
32.01: 2024.10.29 – The south bridge footing had been poured. Arch bridge sections are scheduled to be delivered and placed 11/5 and 11/6.

2024.10.29 – South footing for arch bridge

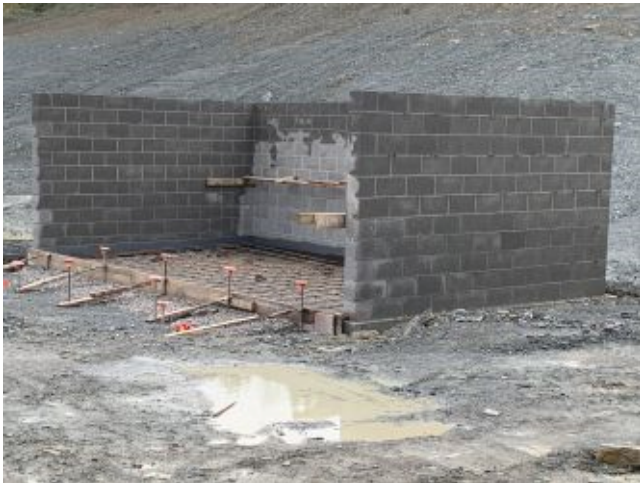
32.05: 2024.11.06 – The dumpster pad had been formed and reinforcing was installed, ready for a pour.

2024.11.06 – Dumpster enclosure

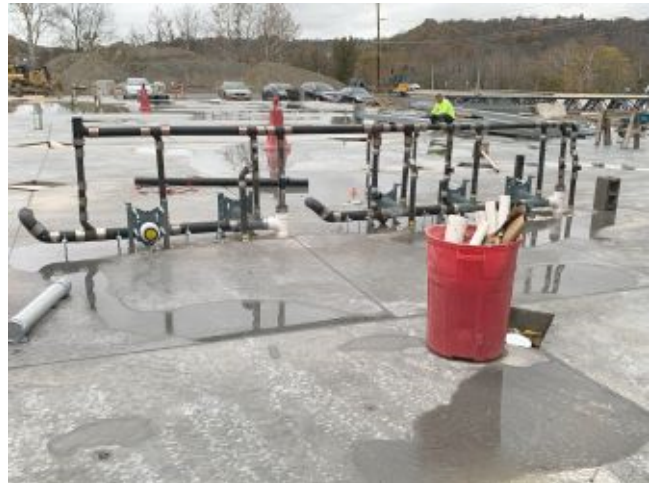
20-28.03: 2024.11.06 – Carriers had been installed at Men #111 and Women #112

2024.11.06 – Men #111 and Women #112

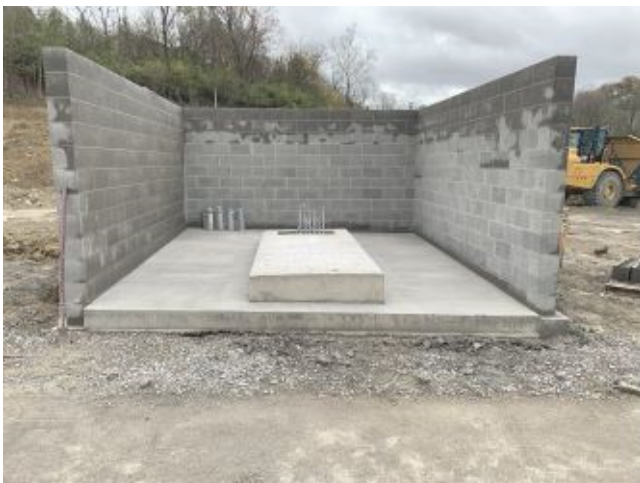
2024.11.06 – Generator screen wall

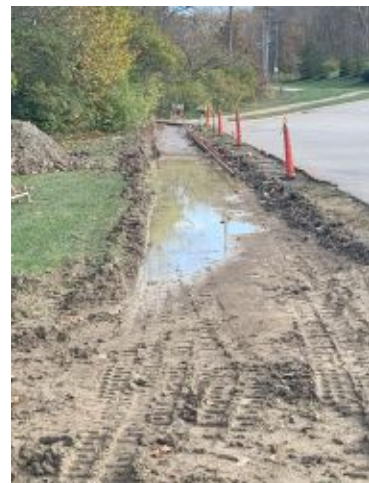
32.06: 2024.11.12 – A portion of sidewalk along Tuscanview had been formed, though work had been stopped due to concerns voiced by the City of Covington.

2024.11.12 – View along Tuscanyview

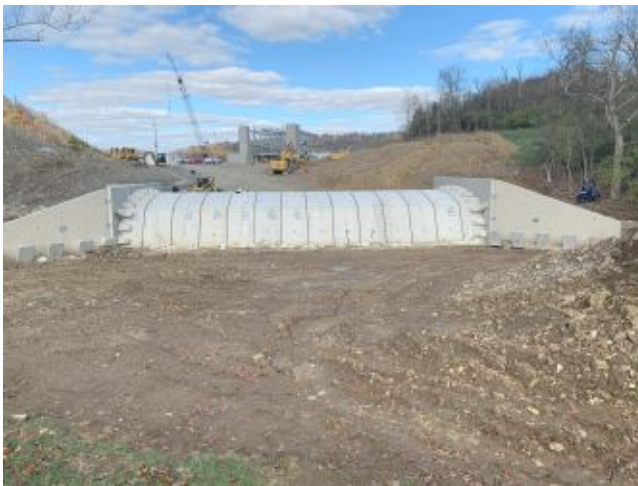
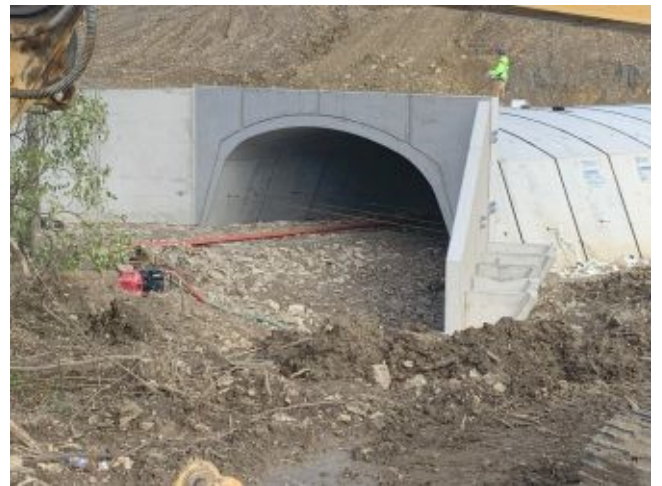
32.07: 2024.11.12 – Bridge section and wing wall installation was complete. Joint detailing was active.

2024.11.12 – Arch bridge

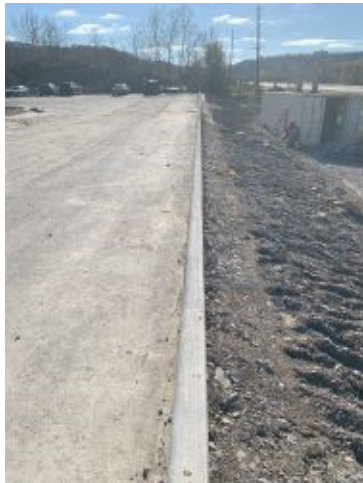
32.03: 2024.10.29 – Curbs had been poured along a stretch of the west edge of asphalt base.

2024.11.12 – Curb along west edge of parking

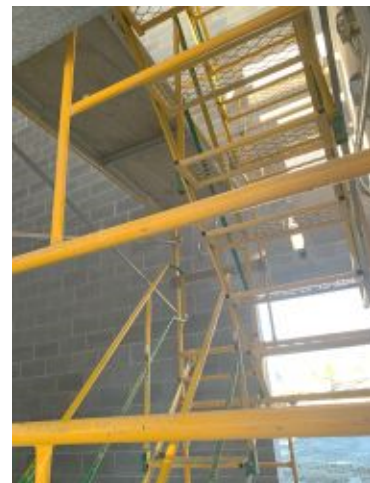
01.02: 2024.11.12 – A temporary scaffold stair had been installed in Stair-1, reaching the 2nd floor. Safety rail cable was observed at the exterior edge of the 2nd floor.

2024.11.12 – Temporary access to 2nd floor

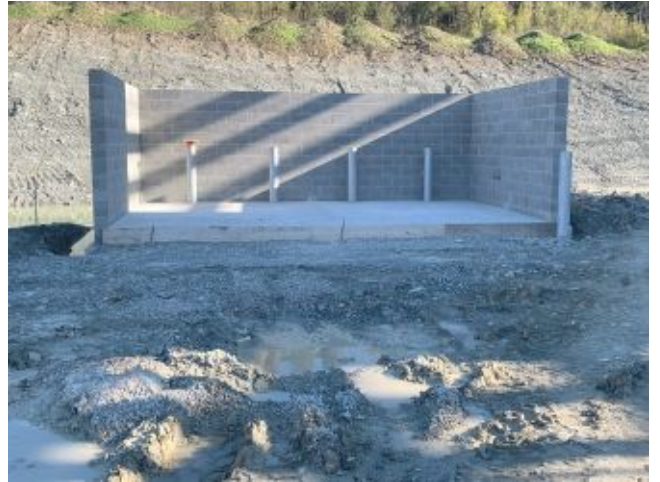
05.04: 2024.11.12 – Bollards had been installed at the dumpster enclosure.

32.08: 2024.11.12 – The dumpster pad and grade level pad around the transformer had been poured.

2024.11.12 – Dumpster enclosure
