FIELD OBSERVATION REPORT

New West Middle School – Cecilia, KY

2019111 – CA8

Report No: 1

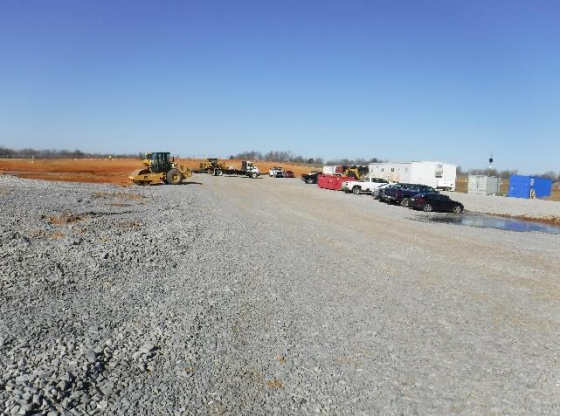
Item No.	Location	Description/Correction	Image	Action
1	Site – Looking West toward Wehr's Office Trailer	The trailer sits on the north side of the site closest to the rear (north side) of the building.

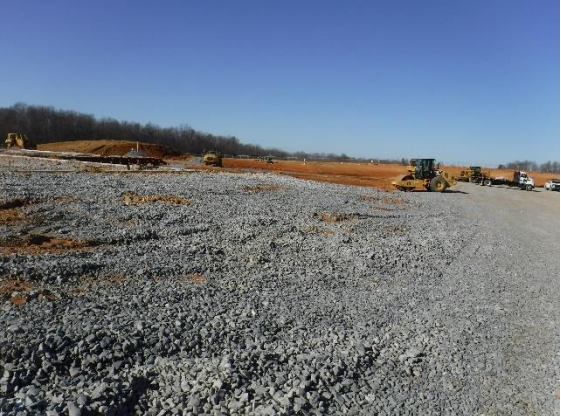
2	Site – Looking West	Earthwork continues outside the building pad.

Refer to field reports from EDG for sitework.
3	Site – Looking South	The building pad area is covered with crushed stone to allow for work to continue in the winter months.

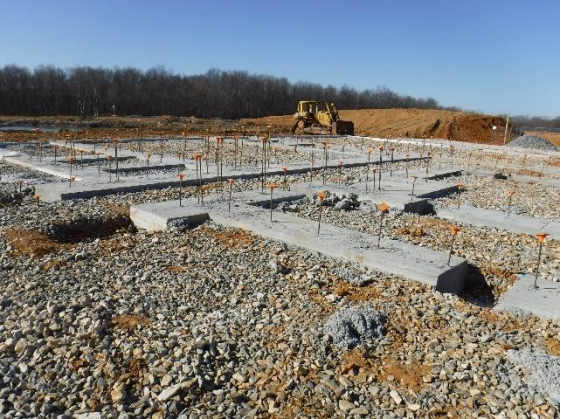
Item No.	Location	Description/ Correction	Image	Action
4	Interior Footings at the Southwest Corner of the Building	These footings support CMU walls.

Refer to revised control joint locations on revised drawings issued by Icon Engineering.
5	Footings at the Southwest Corner of the Building	Some areas of the footings were dropped for plumbing to pass over.

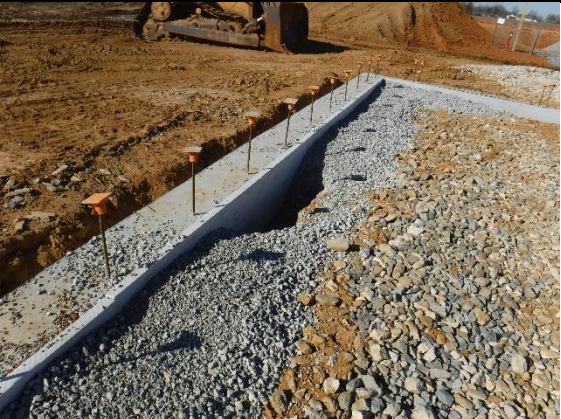
Coordinate sanitary sewer lines for required fall.
6	Exterior Stem Wall	Rigid insulation was placed against the stem walls.

Place rigid insulation without gaps, snug to the concrete stem walls.

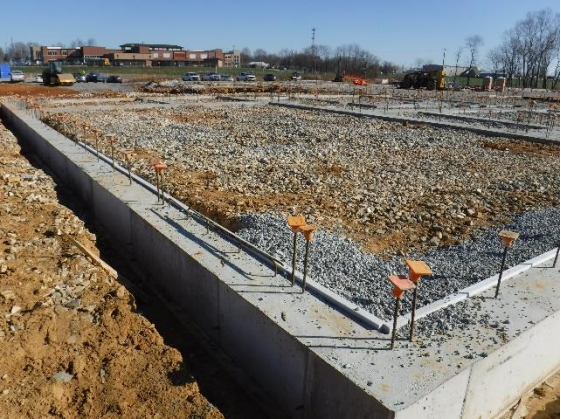
Item No.	Location	Description/Correction	Image	Action
7	Exterior Stem Wall	Rigid insulation was placed against the stem walls.

Monitor rigid insulation during backfill to prevent damage.
8	Footing and Stem Wall	Footings and stem walls were terminated with dowels extended for future pours.

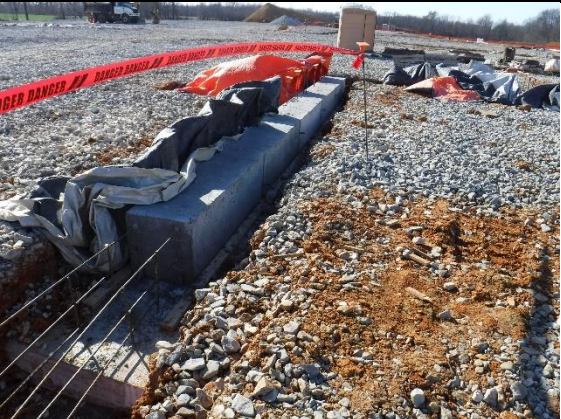
Refer to SPIN reports for proper installation of dowels and footing bottom conditions.
9	Footing and Stem Wall	Concrete poured during colder conditions was blanketed for protection.

Continue to use cold weather measures during cold periods.

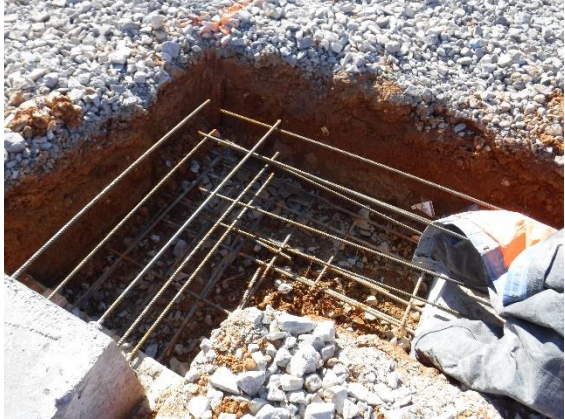
Item No.	Location	Description/ Correction	Image	Action
10	Footing Corner	Dowels were extended for future pours.

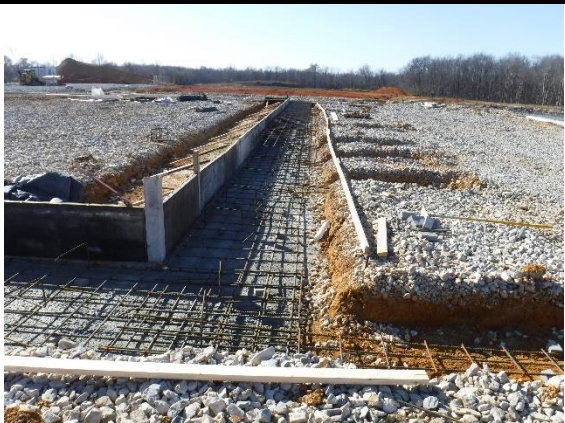
11	Footing Reinforcement	Footings were placed on crushed stone for plan bottoms. Reinforcing steel was supported on chairs.

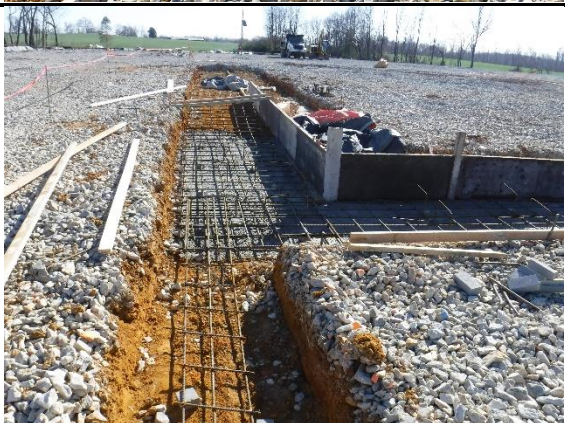
12	Footing Reinforcement	Footings were being poured over earth where dry and at the proper elevation.

Refer to SPIN reports concerning footing bearing at the time of pours.

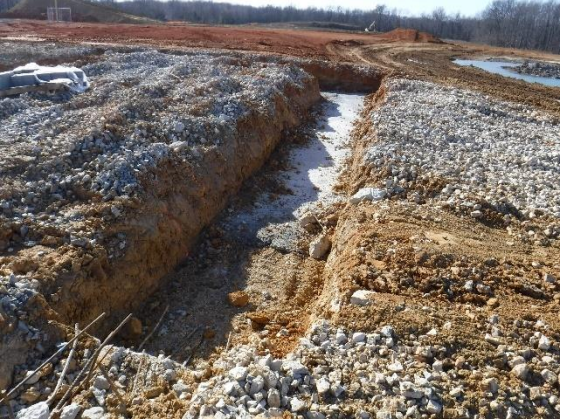
Item No.	Location	Description/ Correction	Image	Action
13	Footing Bottom	Footings were excavated. Crushed stone was placed to correct the footing bottom elevation.

Keep footing bearing material dry and firm.
14	Footing Reinforcement	Reinforcing steel was in place for a future pour.

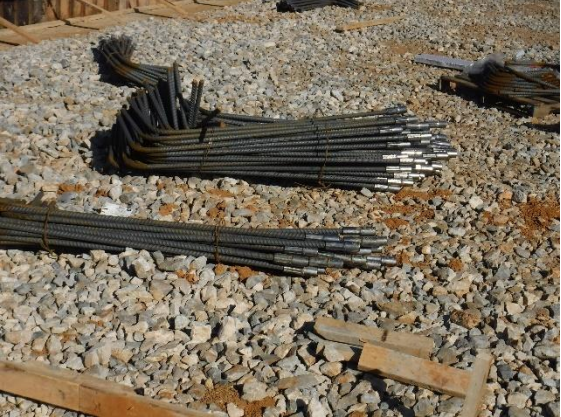
Refer to SPIN reports if footing bottoms are flooded before footings can be poured.
15	Dowels for Storm Shelter Wall Reinforcement	Couplers were installed on the upper ends of the dowels for the storm shelter walls.

Locate dowels of the size and type specified.
