## FIELD OBSERVATION REPORT

Central Hardin High School – Phase 2, Cecilia, KY

2019111 - CA8

Report No: 12

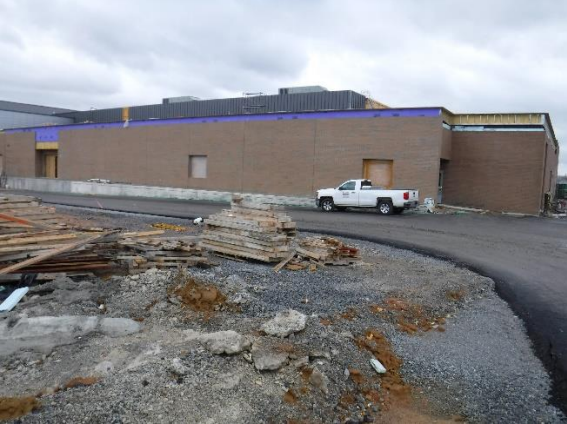
Item No.	Location	Description/Correction	Image	Action
1	East Side of Exterior of Area D	The added parapet was in place for the new roof.

Follow details for the completion of the parapet.
2	Area D North Elevation	The area is enclosed with permanent and temporary doors. The added parapet was in place for the new roof.

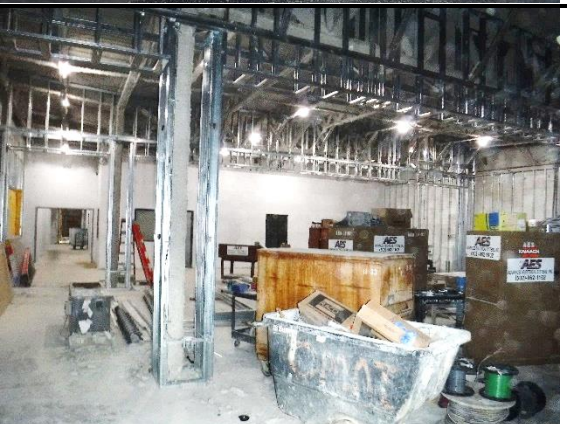
The parapet will be covered with metal panels. Phase 1 sheet metal work is nearing completion, workers will be available to begin on Phase 2.
3	Band Room	Metal framing was in place for wallboard soffits and at the columns.

Hang wallboard when all utilities are installed in the framing.

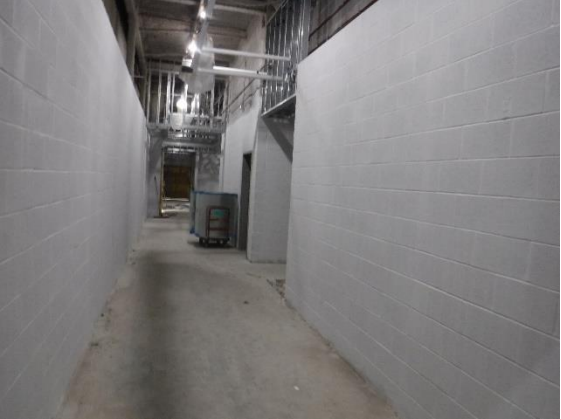
Item No.	Location	Description/ Correction	Image	Action
4	Area D East Corridor	Block fill was applied to the walls.

Inspect block walls for defects and correct before applying paint.
5	Area D Group Toilets	Ductwork was being installed. It appeared that fire dampers were installed where required.

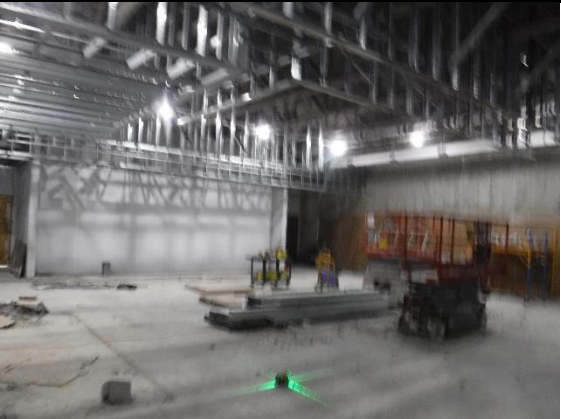
Install fire dampers in fire rated walls where required.
6	Area D Gym Lobby	The metal framing was in place for the wallboard soffits.

Complete utilities above framing and hang wallboard.

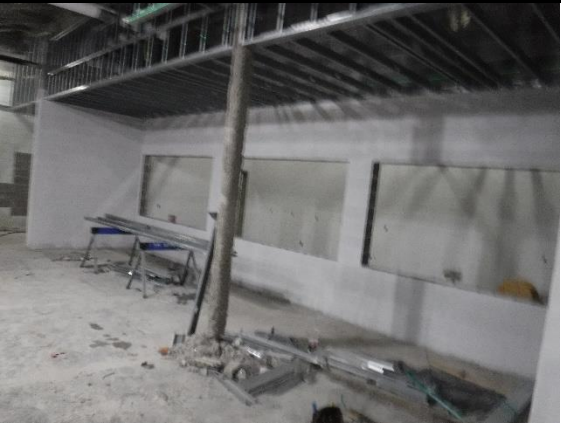
Item No.	Location	Description/ Correction	Image	Action
7	Area D Gym Lobby	The block wall was covered with block fill.

Follow jamb and sill details for the counter doors.
8	Area D Gym Lobby	Metal Framing was in place for the wallboard soffits.

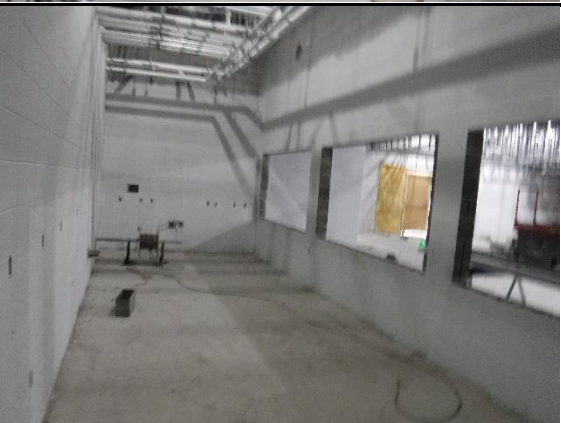
Coordinate soffits with acoustical ceilings.
9	Area D Concessions	The walls were covered with block fill.

Install finishes, counters, cabinets and counter doors.

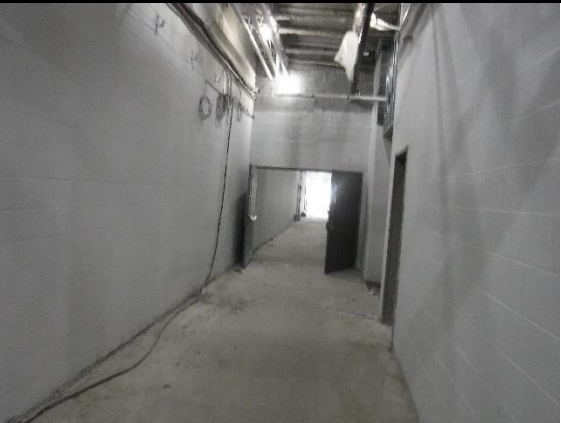
Item No.	Location	Description/ Correction	Image	Action
10	Area D West Corridor	The new and existing block walls were covered with block fill.

Correct defects in the block before painting.
11	Area D Gym Lobby	The opening for the roof top unit was moved. The new steel joist for the roof top unit was installed.

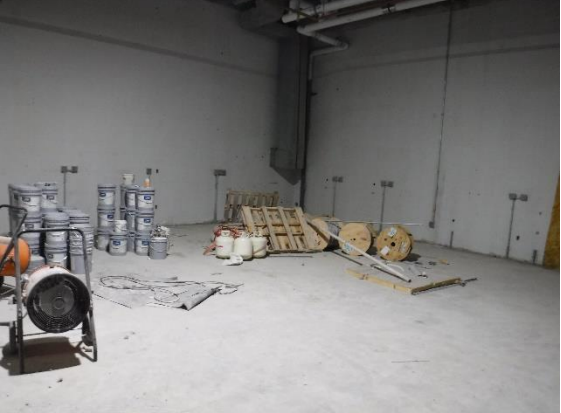
Apply spray fire proofing to the new steel joist.
12	Area D Ag Shop	The walls were covered with block fill. Paint was stored in the area.

Correct defects in the block before painting.

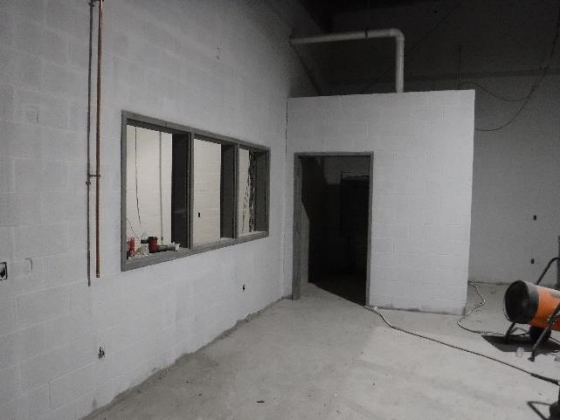
Item No.	Location	Description/ Correction	Image	Action
13	Area D Ag Shop	The block walls were covered with block fill.

Correct defects in the block before painting.
14	Area E Kitchen Door	The FRP door was installed.

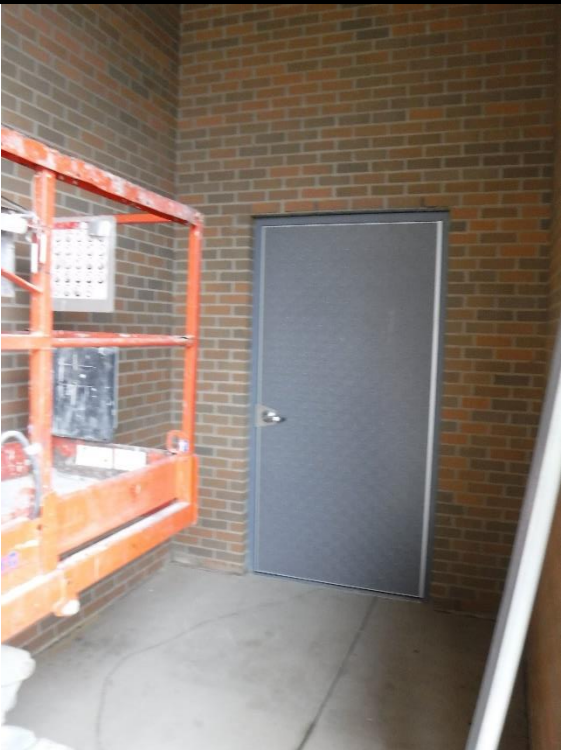
Item No.	Location	Description/ Correction	Image	Action
15	Area E Custodial Receiving Door	The FRP door was installed.

Paint the frame.
16	Area J Courtyard	The corridor connector foundations were in place between Area J and area H.

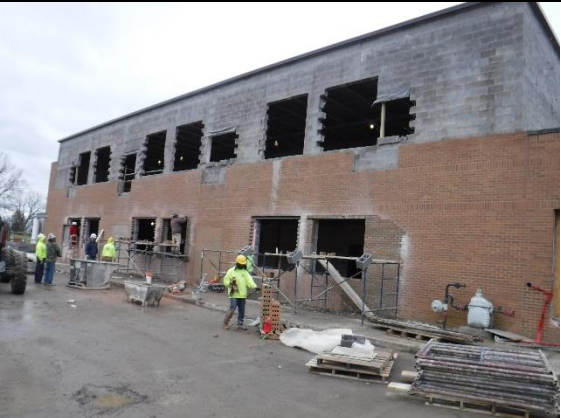
Prepare Area H and J exterior walls to receive the connector walls.
17	Area J East Elevation	Masonry work was being installed for the new window openings.

Complete block and brick replacements to create new window openings.

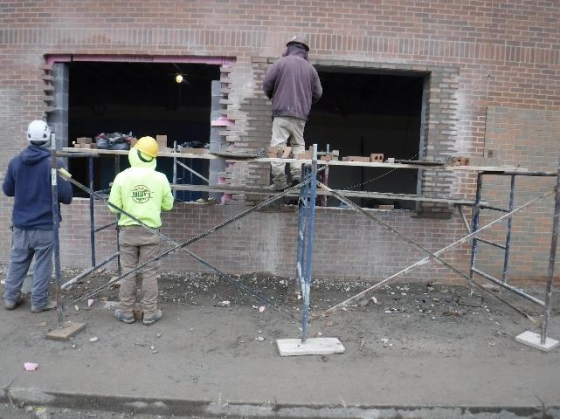
Item No.	Location	Description/Correction	Image	Action
18	Area J East Elevation	The new window openings were being created with new brick at the exterior and new block at the interior.

Install brick to match existing coursing. Clean brick. (Note – Mortar will be dark until it cures, and brick will be the final color when it is cleaned.)
19	Area J East Corridor	Openings were created for new classroom doors.

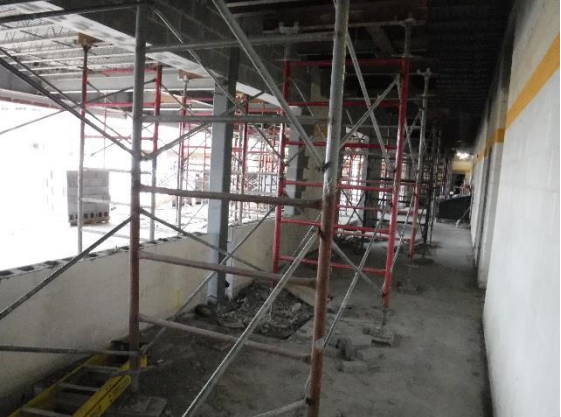
Detail new block to blend with existing block walls.
20	Area J West Corridor	Shoring was in place to add additional steel floor joists to support new block walls on the second floor.

Complete joist installation so shoring can be removed.

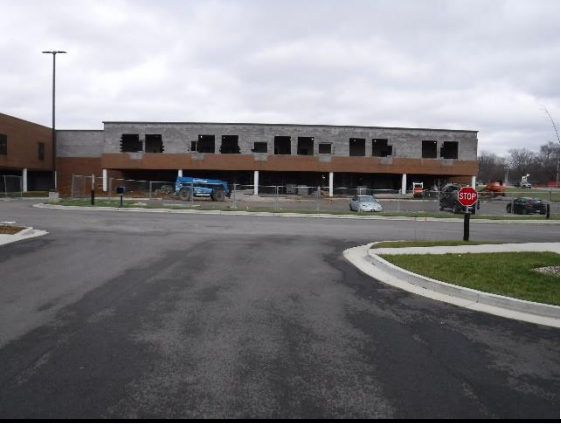
Item No.	Location	Description/Correction	Image	Action
21	Area J West Elevation	Windows will be placed in the enlarged openings.

Replace block at new window openings. Upper portion of second floor walls will be covered with metal panels.
22	Area J Southwest Corridor	Openings were enlarged and created for the new windows.

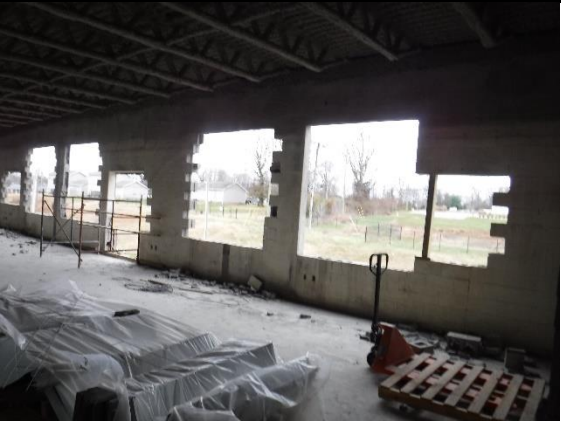
Prepare upper portion of block walls for metal panels.
23	Area J First Floor Classrooms	Block was removed to accommodate the new windows.

Fill in block at the jambs of new window openings. Detail block to blend in with existing.

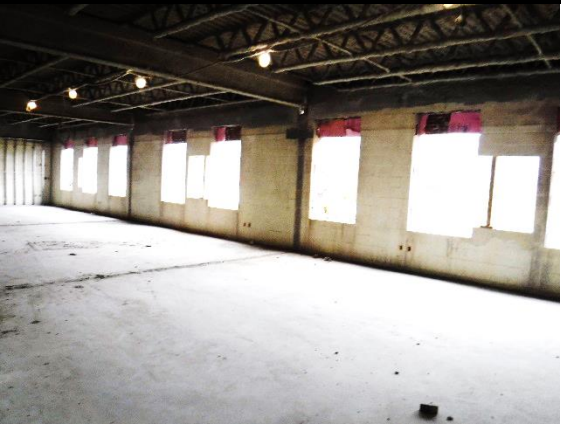
Item No.	Location	Description/Correction	Image	Action
24	Area J Second Floor Classrooms	Window openings were enlarged for the new windows.

Fill in block at new window openings.
25	Area J West Corridor Shoring Area	Floor joists will be added to support block walls on the second floor.
