Roof Asset Management Program

Powell Co Schools - Middle and Highschool - 2025 / 26 Reroof Documents

**Powell Co. Public Schools
Powell Co Middle and High School
Reroof Project 2025/26**

ROOF MEASUREMENT REPORT

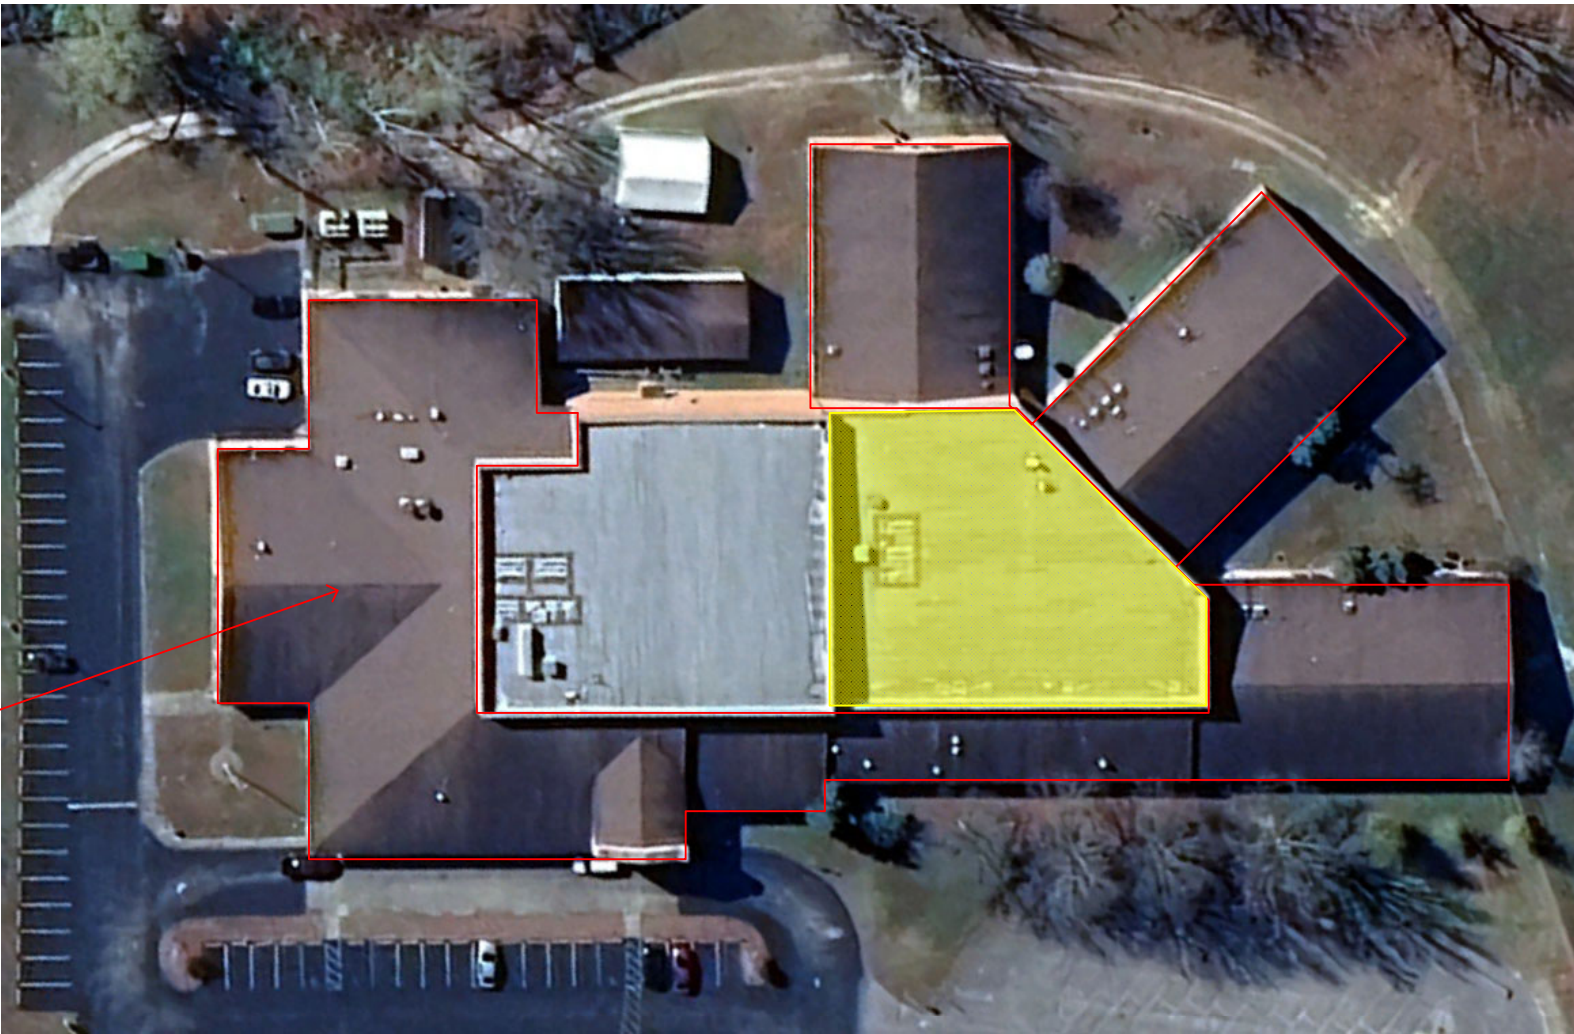
Low Slope Solution:
New Mod Bit Roofing

Steep Slope Solution:
New Standing Seam Metal Roofing

Summary of Roof Recommendations: Areas highlighted above. Not including the gym roof not shaded above that was completed in 2025.

- Low Sloped Solution:
- New Mod Bit Roof over existing roofing, removing existing wet insulation where identified by infrared scan
- Steep Sloped Solution:
- Remove existing shingles and install new standing seam metal roofing to match previous projects at other schools

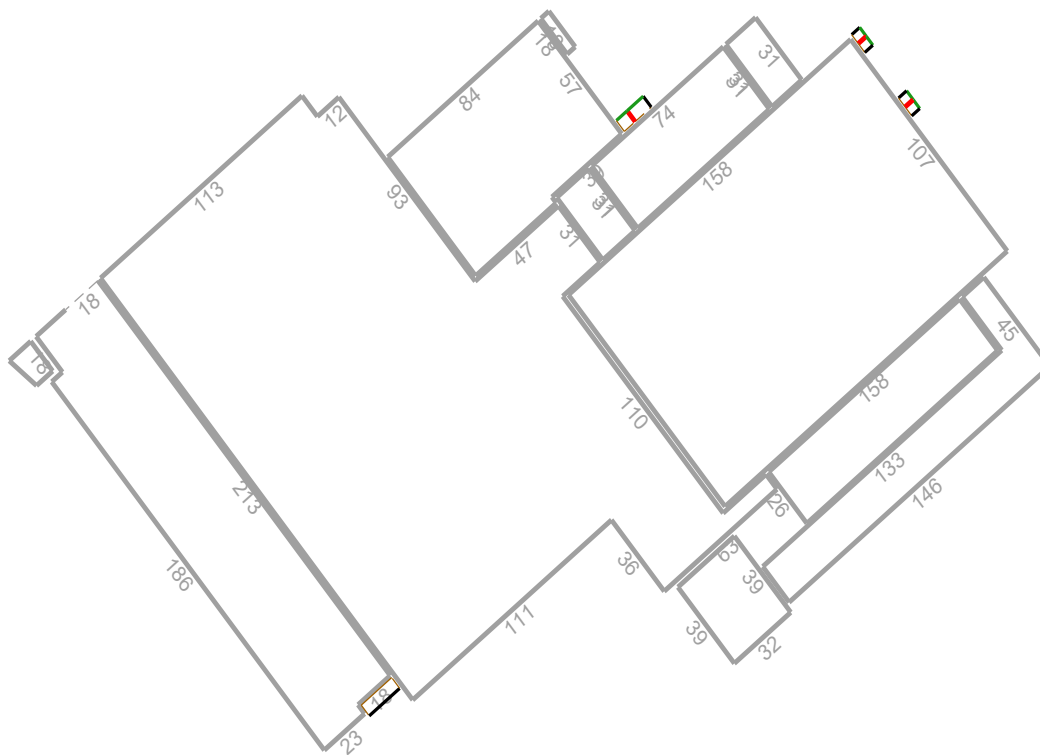
Total Line Lengths: **Ridges = 15 ft** **Valleys = 0 ft** **Flashing = 42 ft** **Eaves = 41 ft**
 Hips = 0 ft **Rakes = 36 ft** **Step flashing = 29 ft** **Parapets = 3,464 ft**

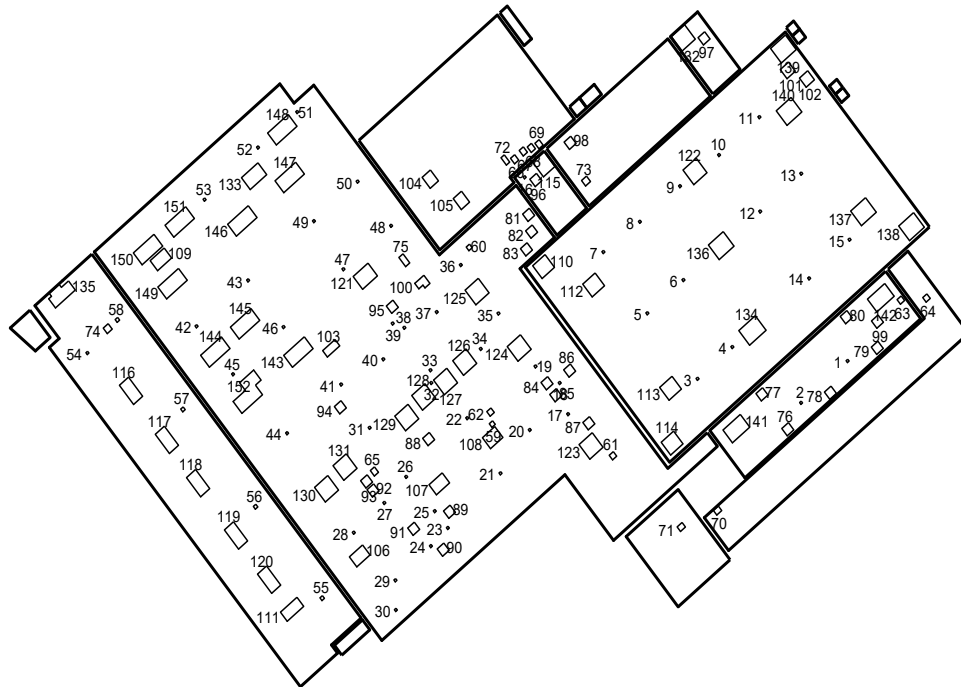
Total Penetrations Area: 3,856 sq ft

Total Roof Area Less Penetrations = 68,201 sq ft
