# Facility Update – May 2025

Prepared by: Heather Rivera, Interim Maintenance Director

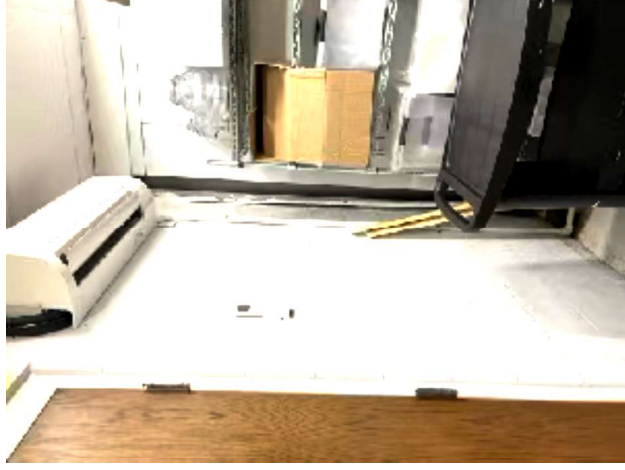
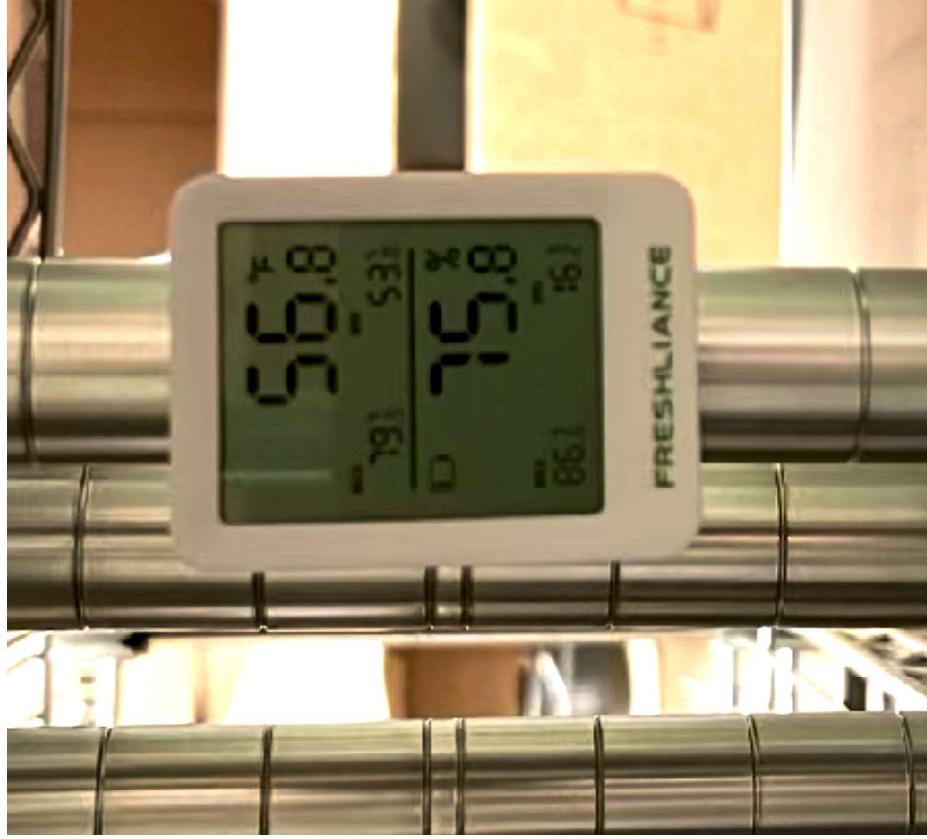
Dry Storage Room post Multi-Zone Ductless Split System

Walker Mechanical completed installation of the new multi-zone ductless split system serving the dry storage and science storage rooms. Both indoor fan coil units are operational and maintaining stable temperatures in the mid to upper 50s. However, we are continuing to experience elevated humidity levels — consistently measuring above 75% relative humidity — in both locations.

Further investigation is underway to identify contributing factors. A large vertical gap was discovered along the wall adjacent to the walk-in refrigerator in dry storage. This opening extends from floor to ceiling and may be allowing humid air to enter or conditioned air to escape. Aaron and Steve from Walker Mechanical flagged this as a possible source of the issue. DC Contractors inspected the space and recommended sealing the gap, insulating the area above the ceiling, and addressing wall surfaces that are transferring heat from the kitchen side. An estimate for this work is pending.

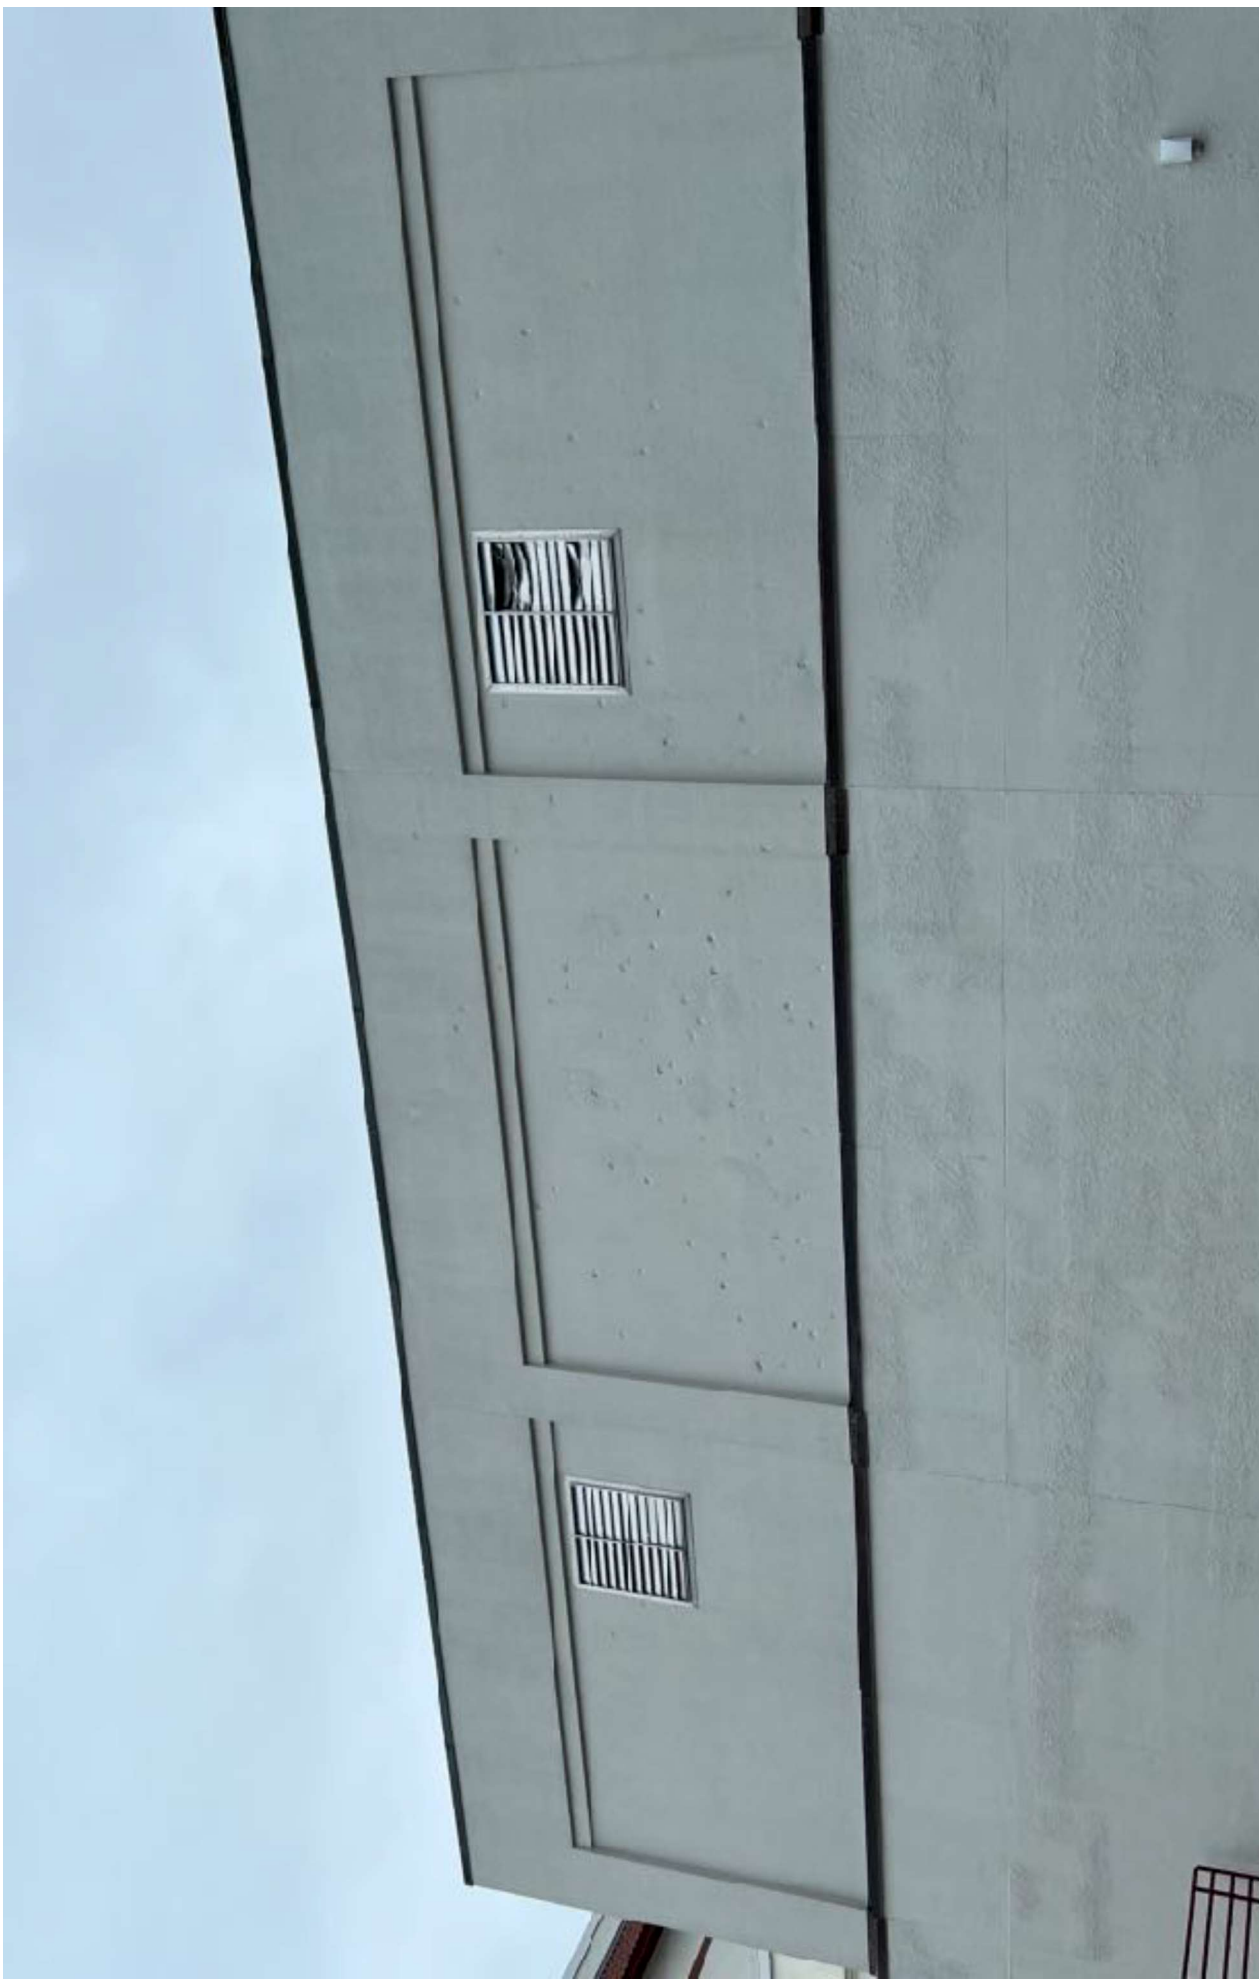
Large Gym Outside Wall Damage

Surrounding EIFS wall surfaces show visible damage and wear, raising concerns about potential water intrusion. Julius Schnurr & Sons previously submitted a proposal for \$14,360 to repair and refinish the area, including patching eleven holes in the EIFS system.

Replacement louvers for the large gym have arrived and are currently in the possession of Walker Mechanical. Installation is scheduled to begin on June 10, weather permitting, once the parking area behind the gym is cleared.

Walker Mechanical modified the protective cages by adding additional brackets to ensure secure attachment to the exterior wall. The cages were delivered to Snap Painting Plus, who coordinated with Kevin at Dages Paint to match the school's trim color ("Anchorage Red"). Walker will retrieve and install the cages along with the louvers.

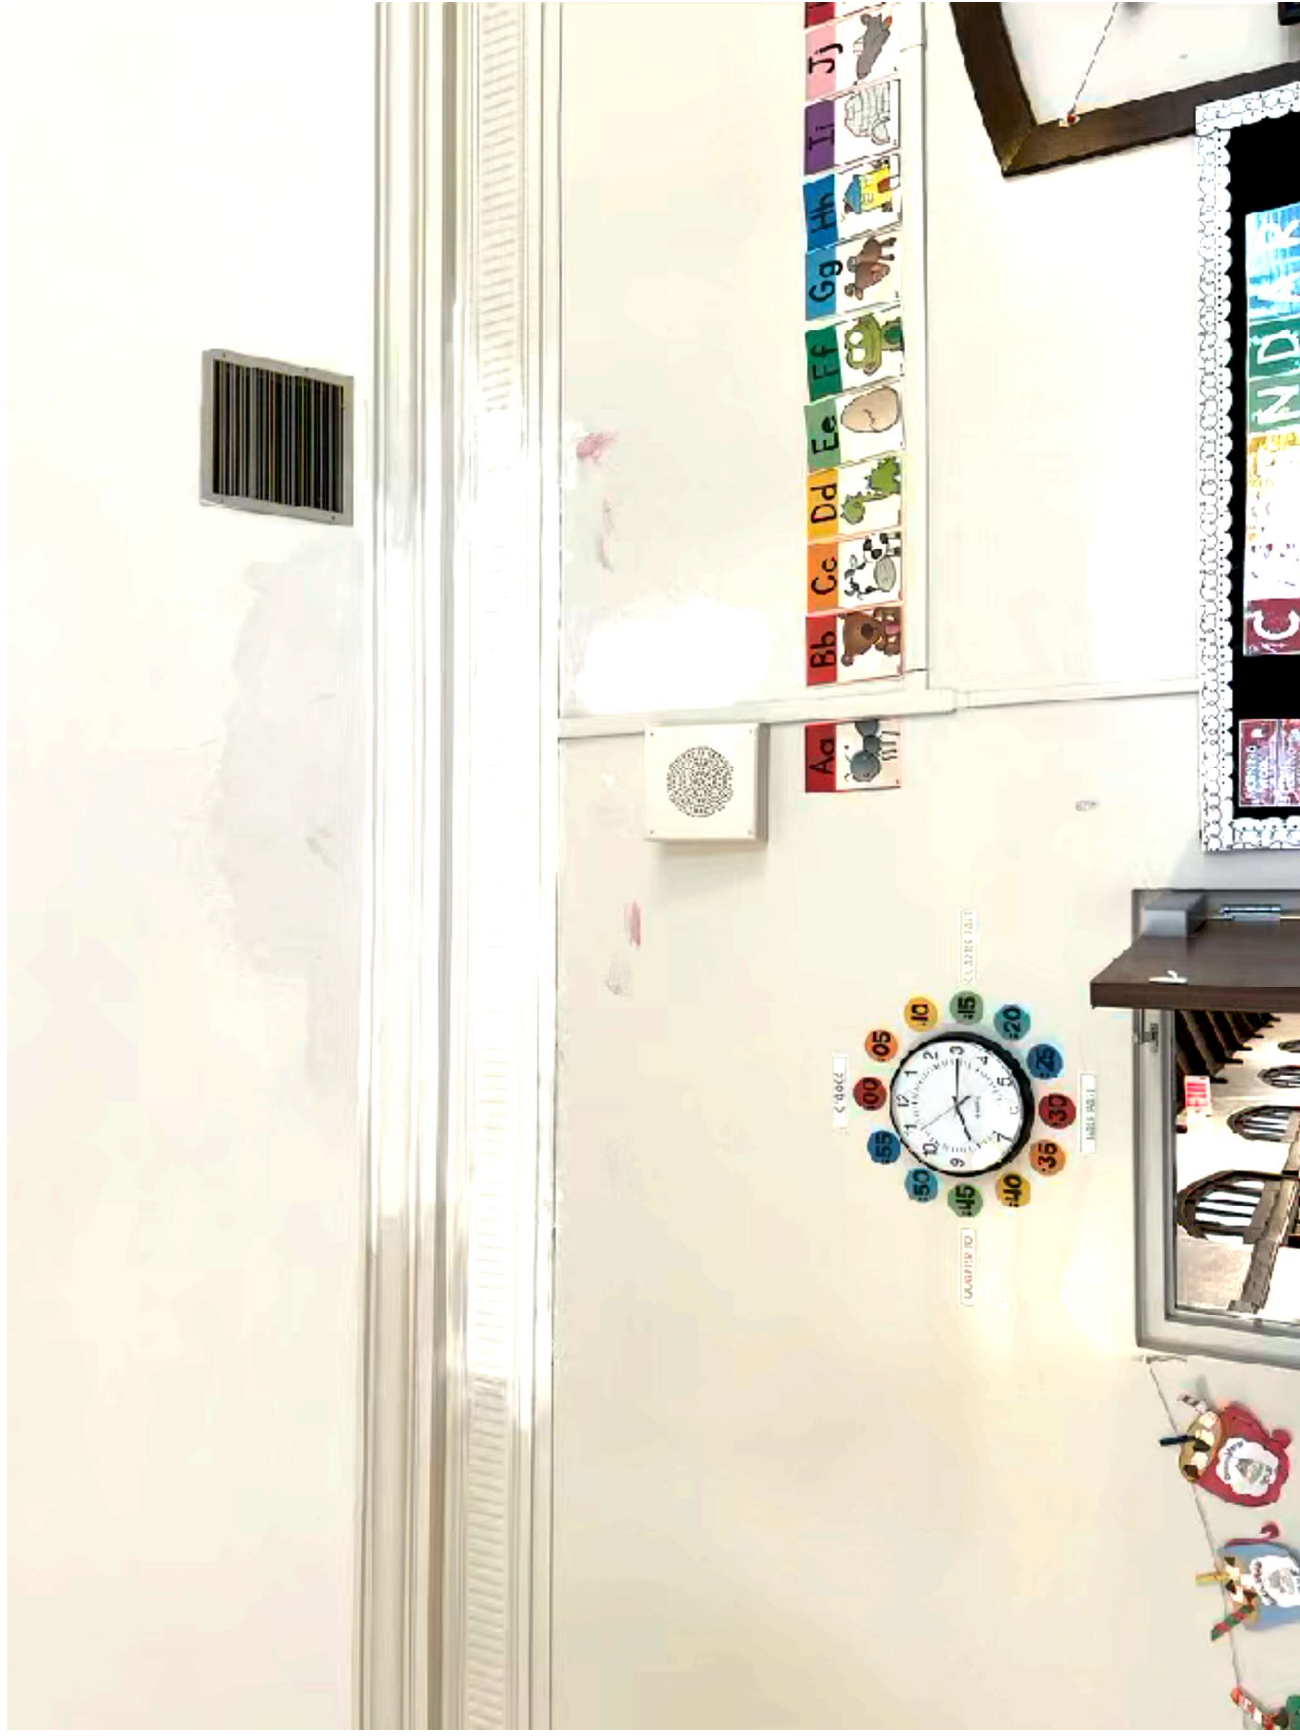
## Room 206 Painting

Ceiling repairs in Room 206 are complete. Painting is scheduled as part of summer maintenance. Snap Painting Plus provided a quote of \$1,800 to repaint the affected wall and ceiling section. Work will begin sometime after July 1.

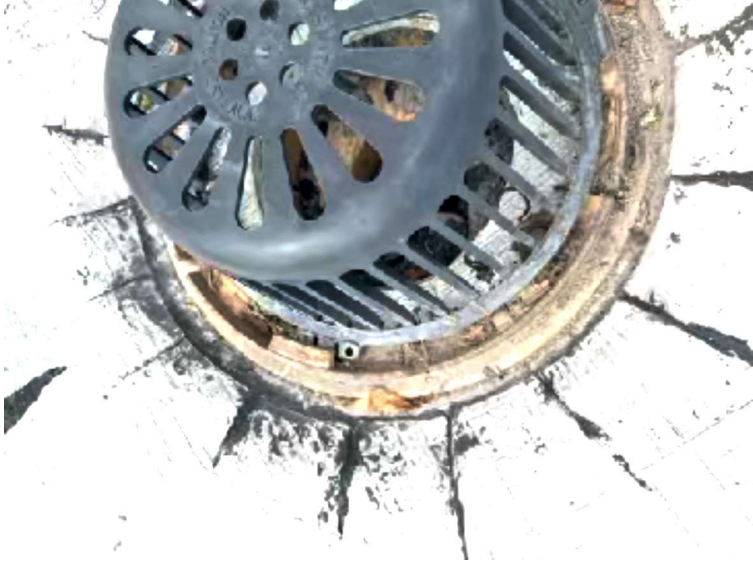
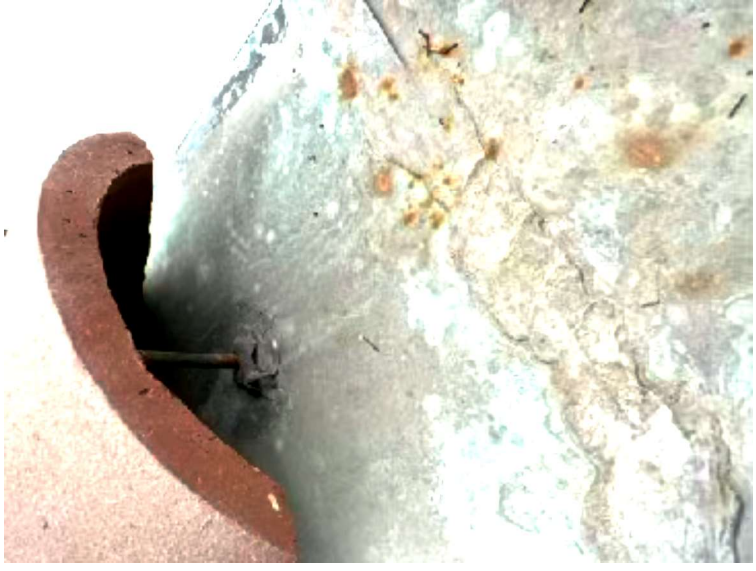
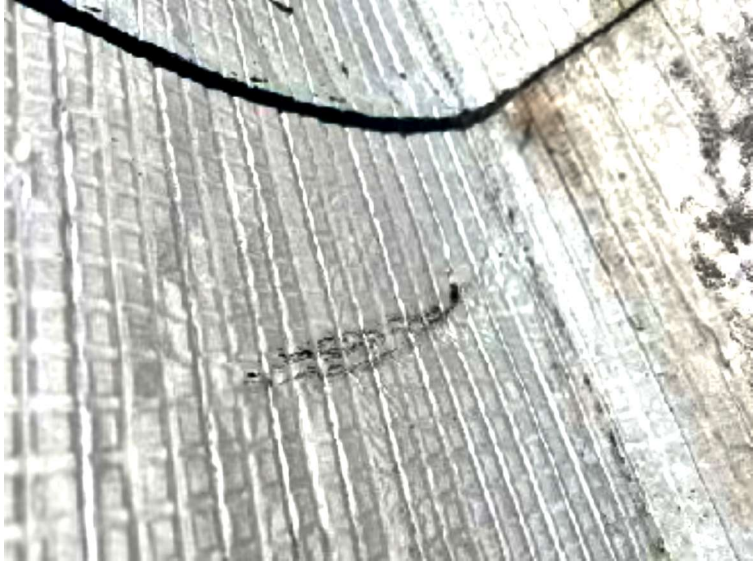
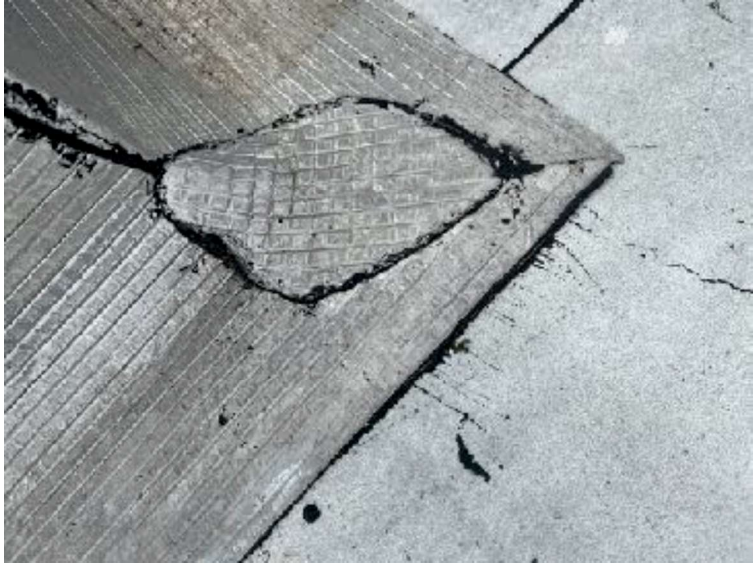
## Roof Repairs over Library Stairwell

Robert Cook from Highland Roofing inspected the rooftop and identified several potential entry points near the roof drain and wall seams. His team is scheduled to complete repairs on May 22, weather permitting. Since that inspection, new water streaks have appeared near Room 205, which will also be evaluated.

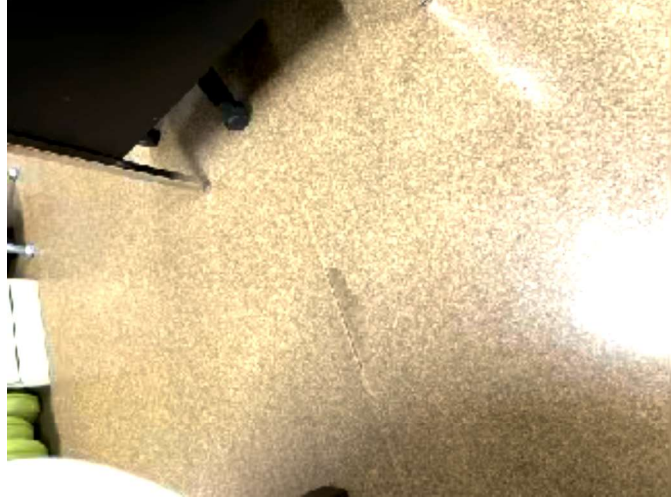
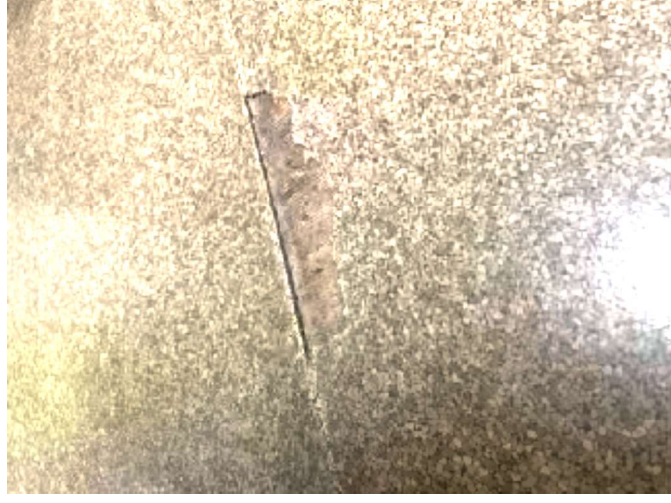
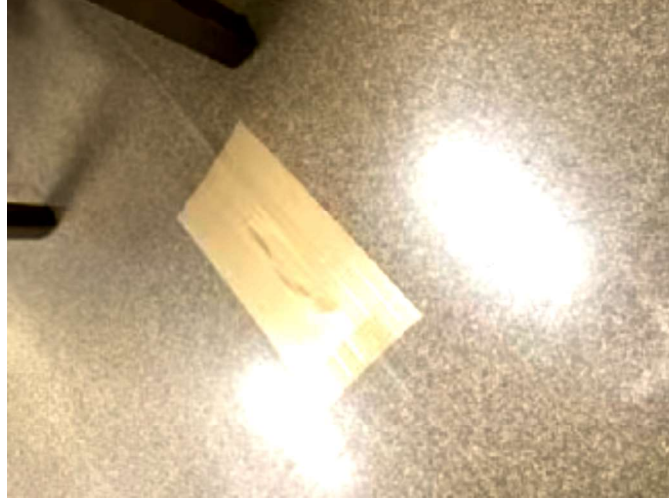
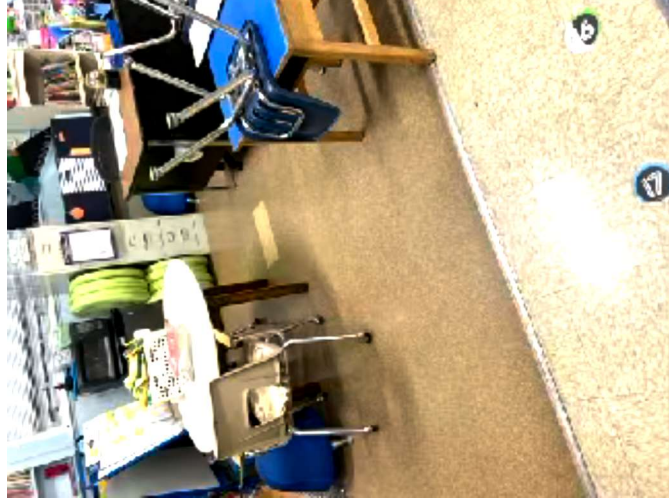
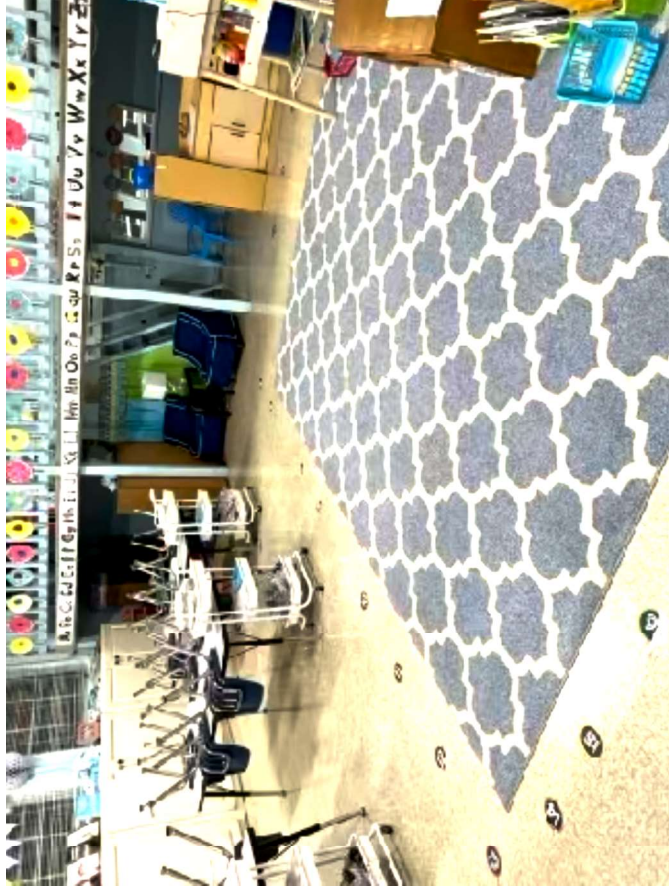
## Room 211 Floor Damage

Because this area is covered with non-VCT flooring, a patch repair is not possible. Addressing the issue will require either replacing the entire dark brown section (including the adjoining bathroom) or fully replacing the room's floor with seamless material. A final decision will be made by the incoming maintenance team.

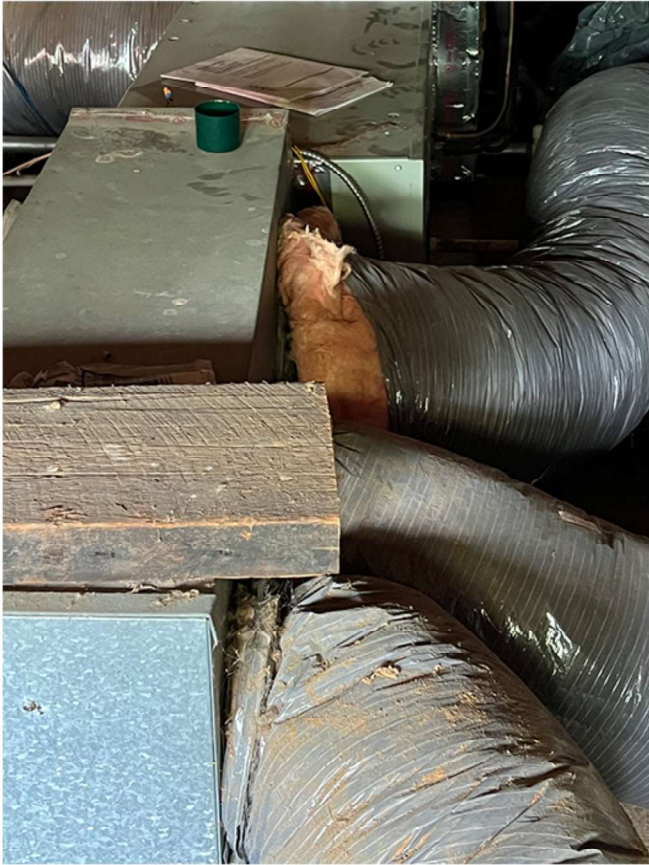
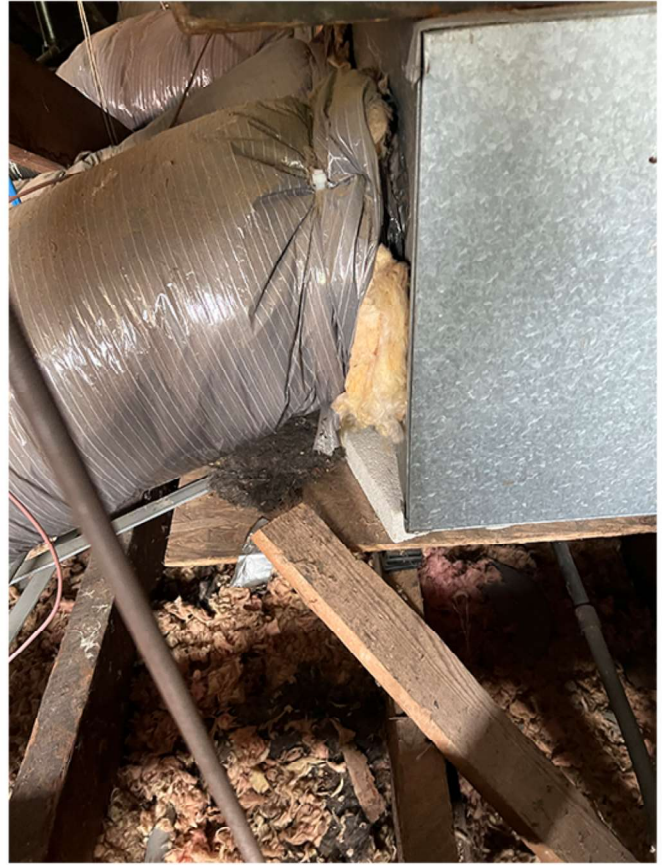
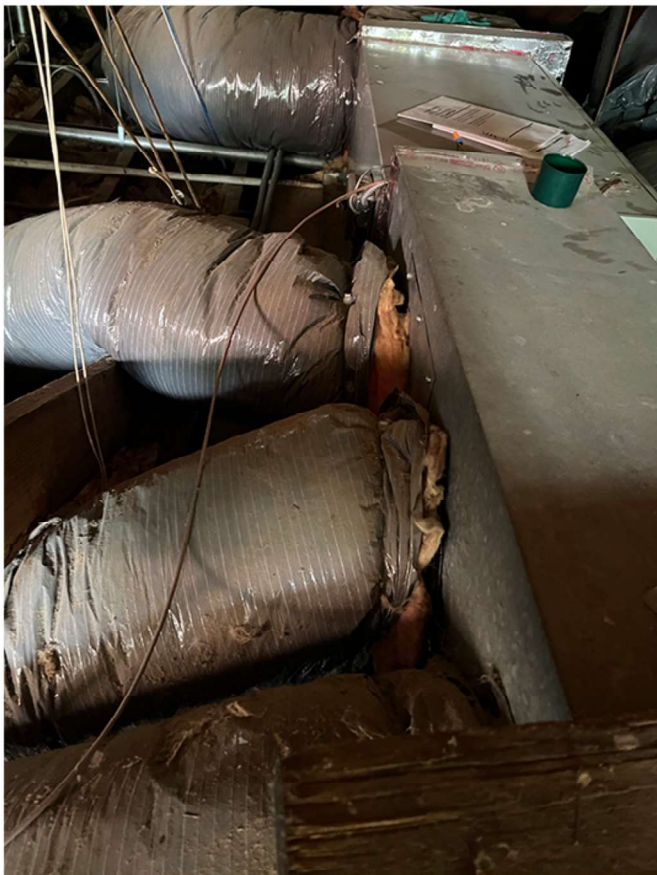
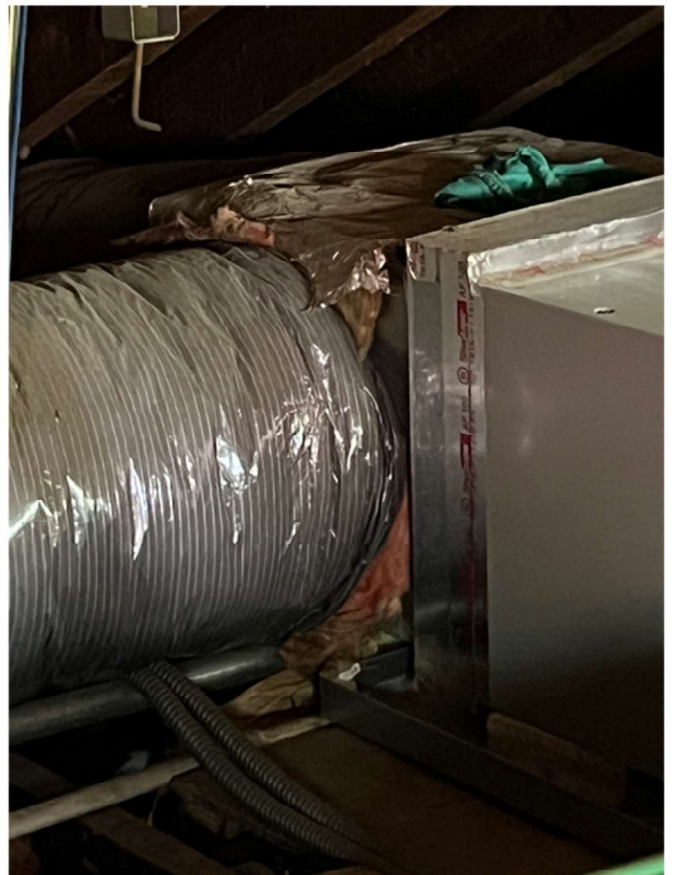
## Attic Unit 1

- Multiple duct takeoffs are unsealed or damaged with pink fiberglass insulation visibly exposed.
- Insulation is pulled back or torn at collar connections.
- Flex ducts appear unsecured or deteriorating, some may be leaking.

A repair estimate of \$5,750 was approved with Walker Mechanical, and work began on May 21. These attic units serve upper-level front classrooms such as Rooms 201 and 202, where humidity issues have been reported. Correcting structural duct issues is a critical step in ensuring system performance and may reduce moisture problems by restoring proper airflow and insulation.

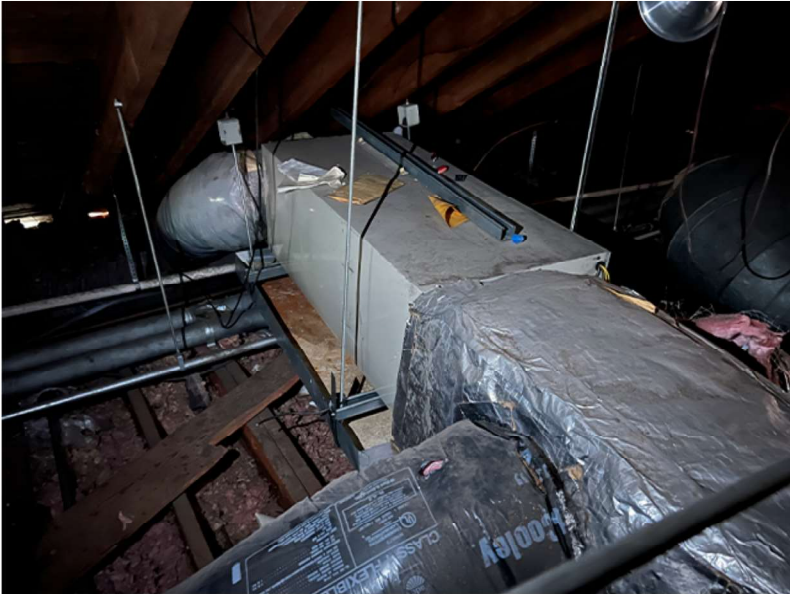
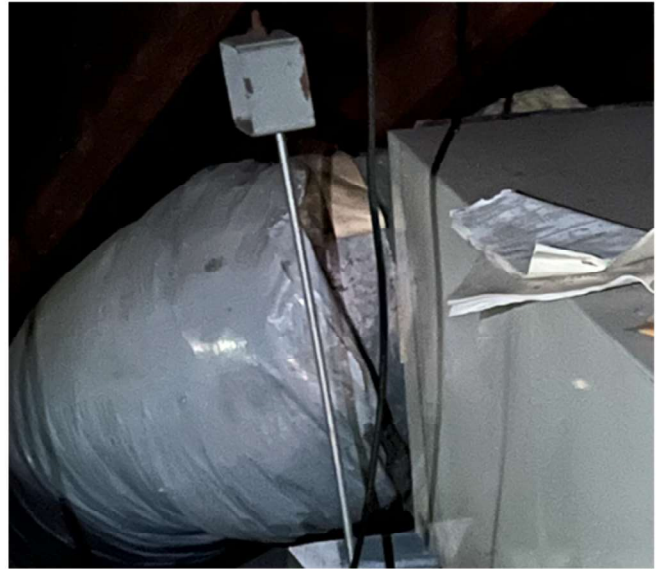
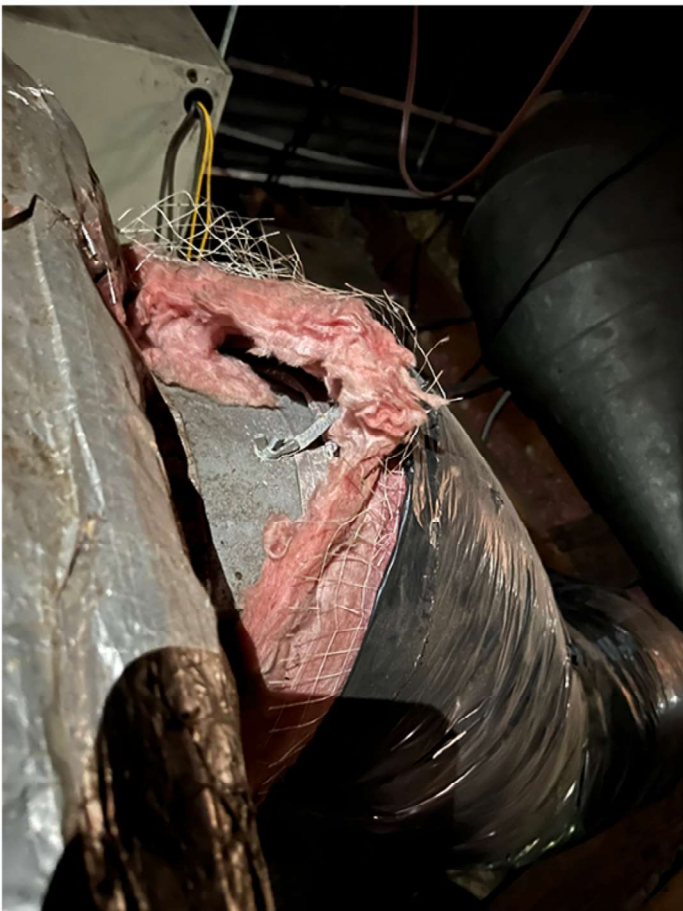
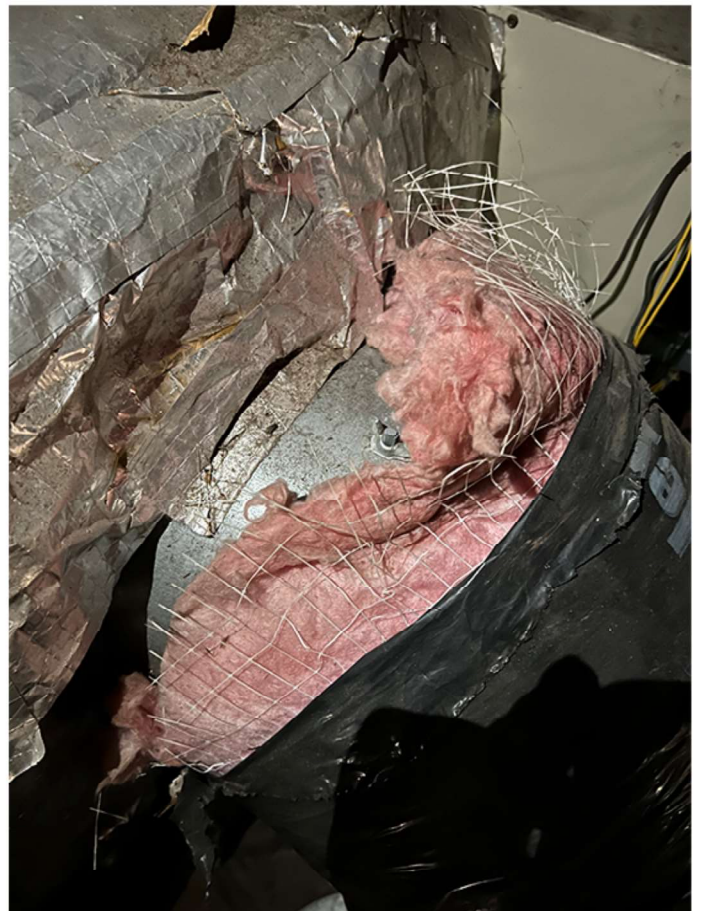
## Attic Unit 2

- One duct shows heavy insulation damage and separation at the collar.
- Torn insulation and visible fiberglass.
- Return duct may be partially disconnected based on visual gap at the wall-side connection.

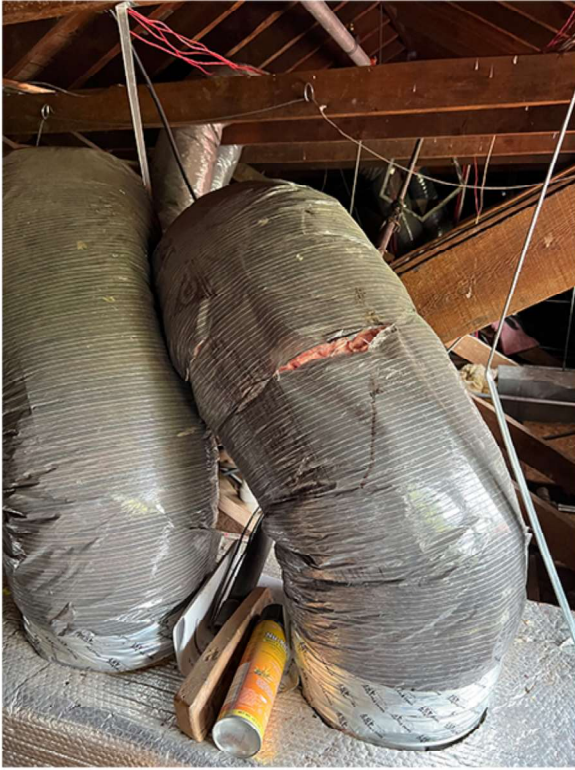
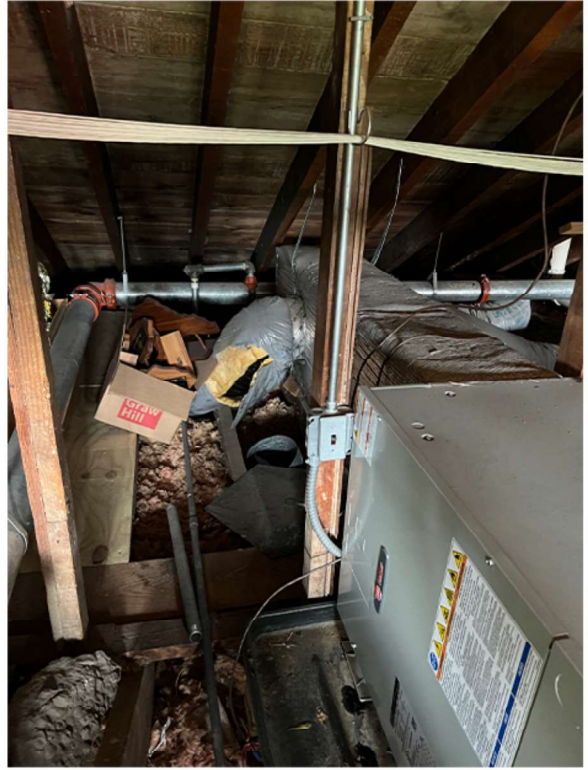
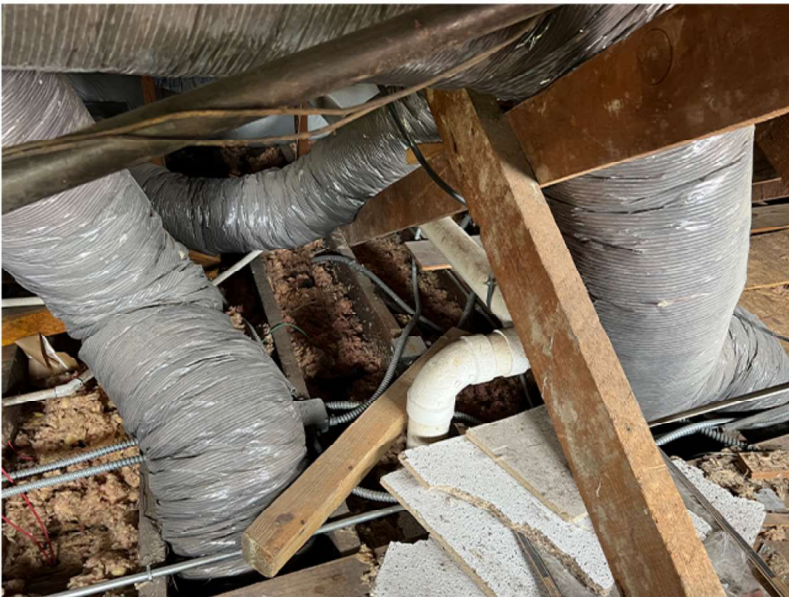
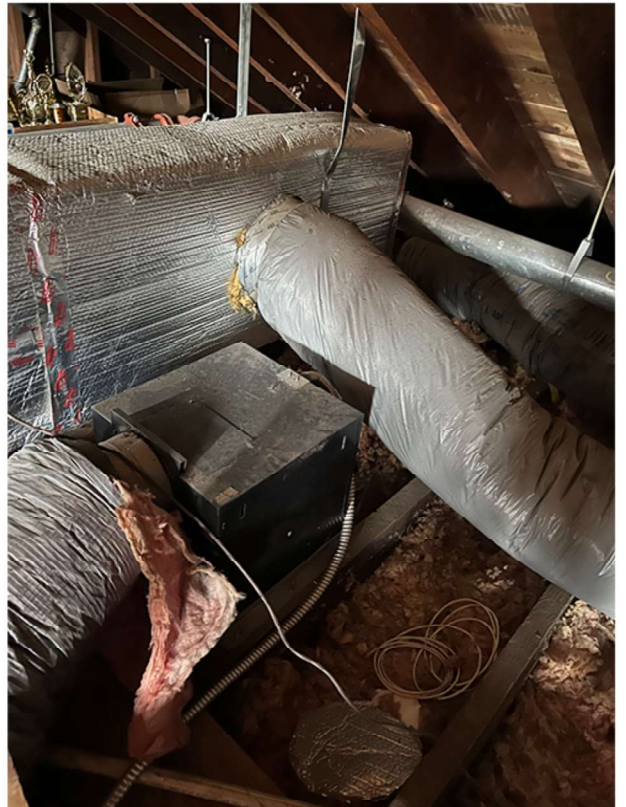
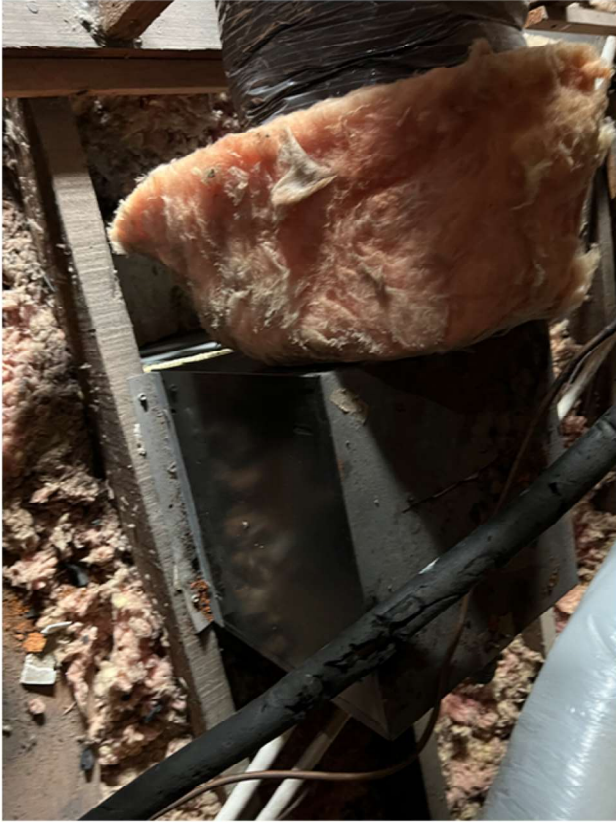
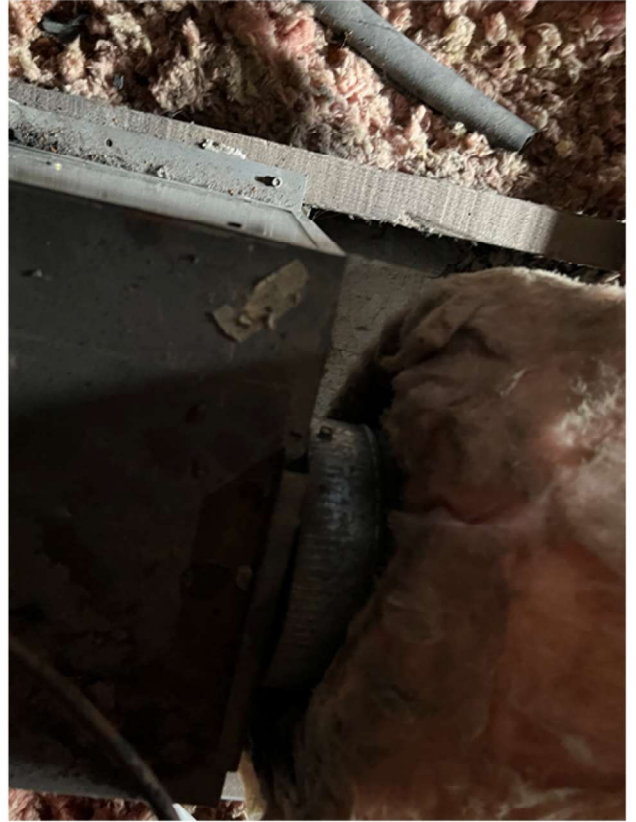
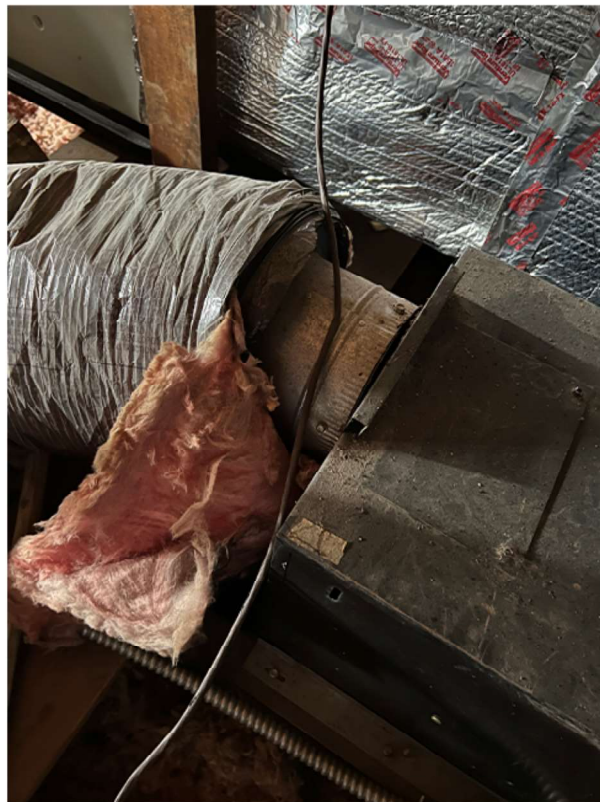
## Attic Unit 5

- This is the unit already approved for repair due to widespread damage to flex duct insulation and unsealed plenum connections.

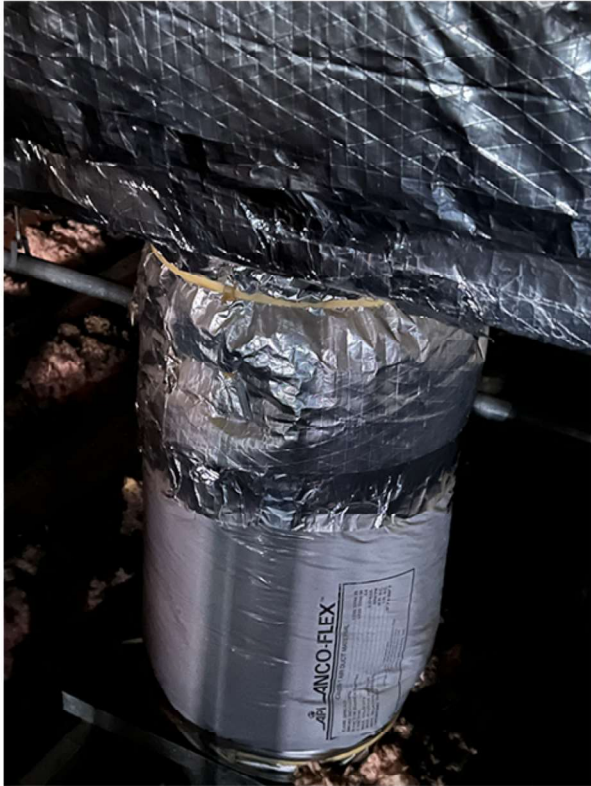
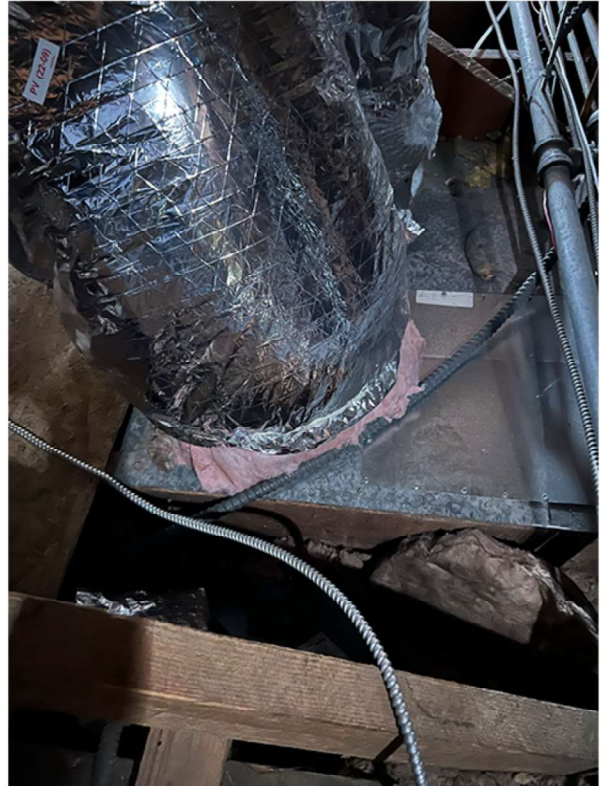
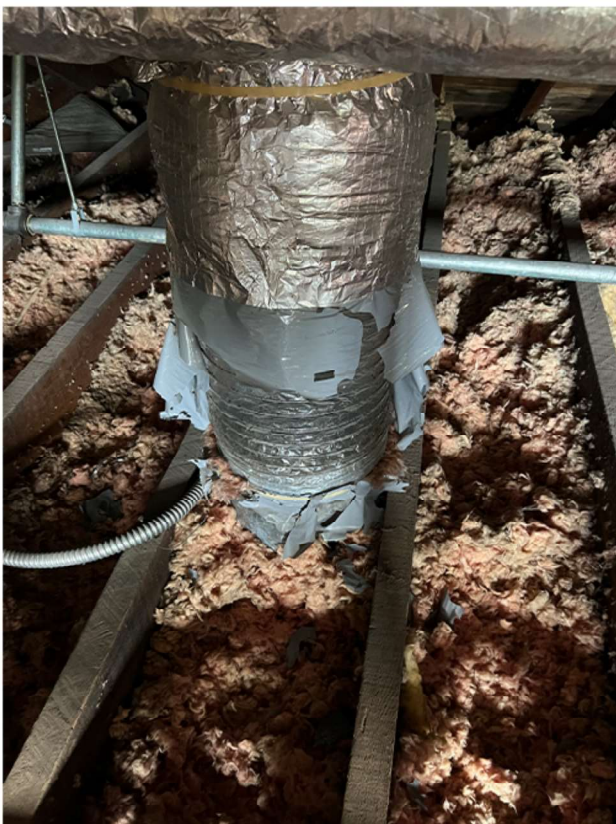
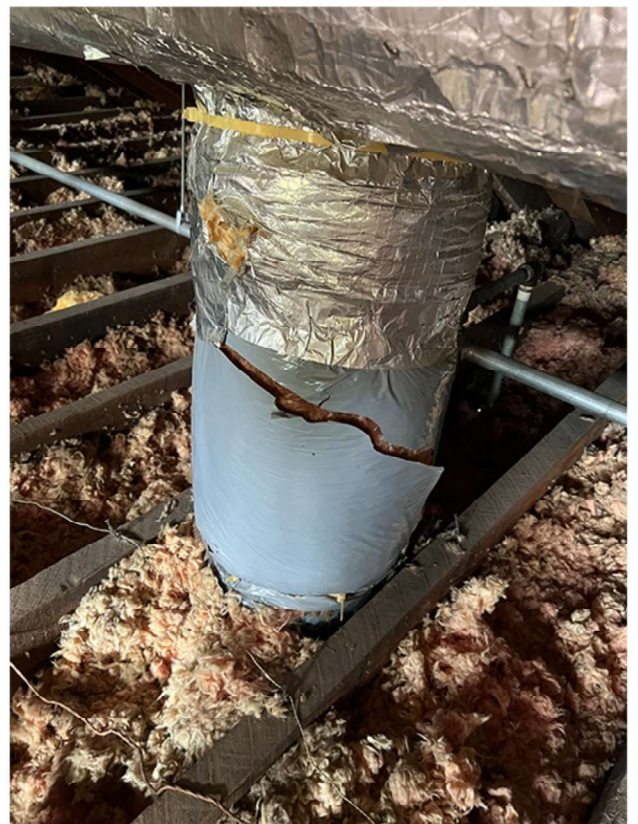
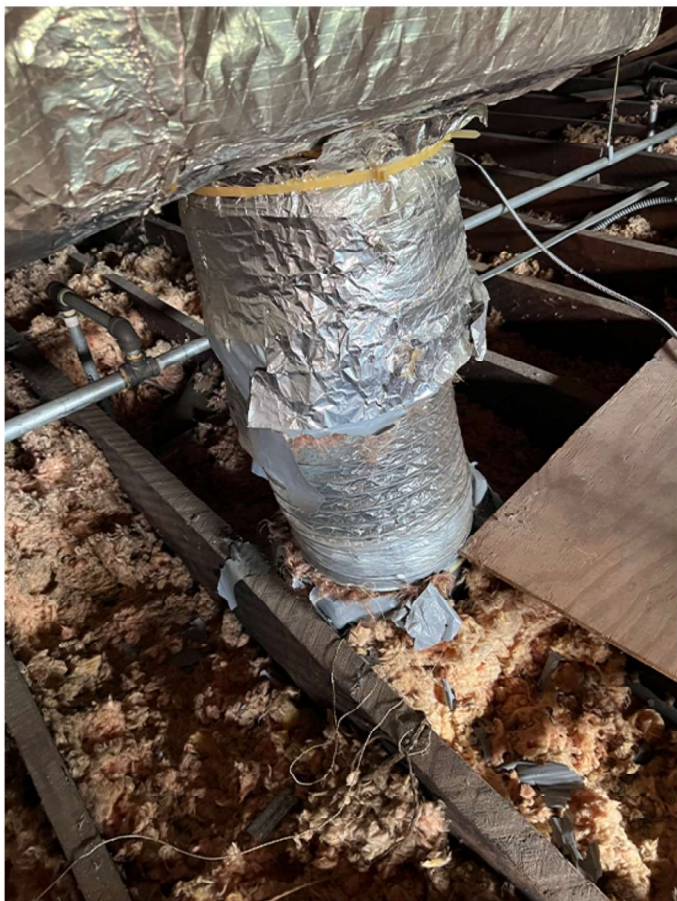
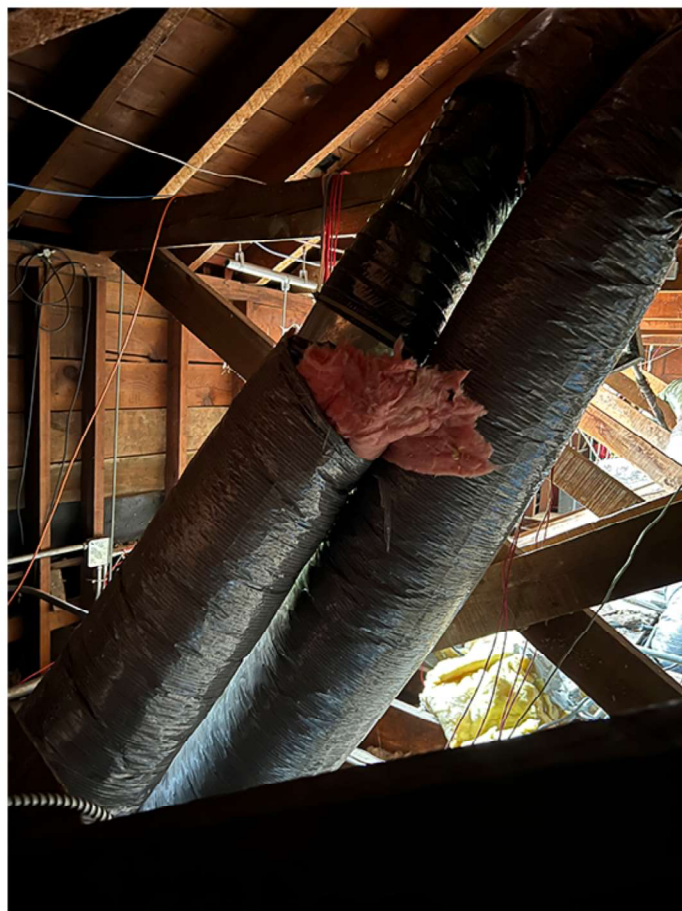
## Attic Unit 6

A review of all seven attic HVAC units revealed widespread deterioration in flex ducts, insulation, and collar connections. Attic Units 1, 2, 4, 5, and 6 were noted for torn

insulation, unsealed joints, and potential air leaks. Units 3 and 7 are in good condition and require no action.
