# Facility Update – May 2025

Prepared by: Heather Rivera, Interim Maintenance Director

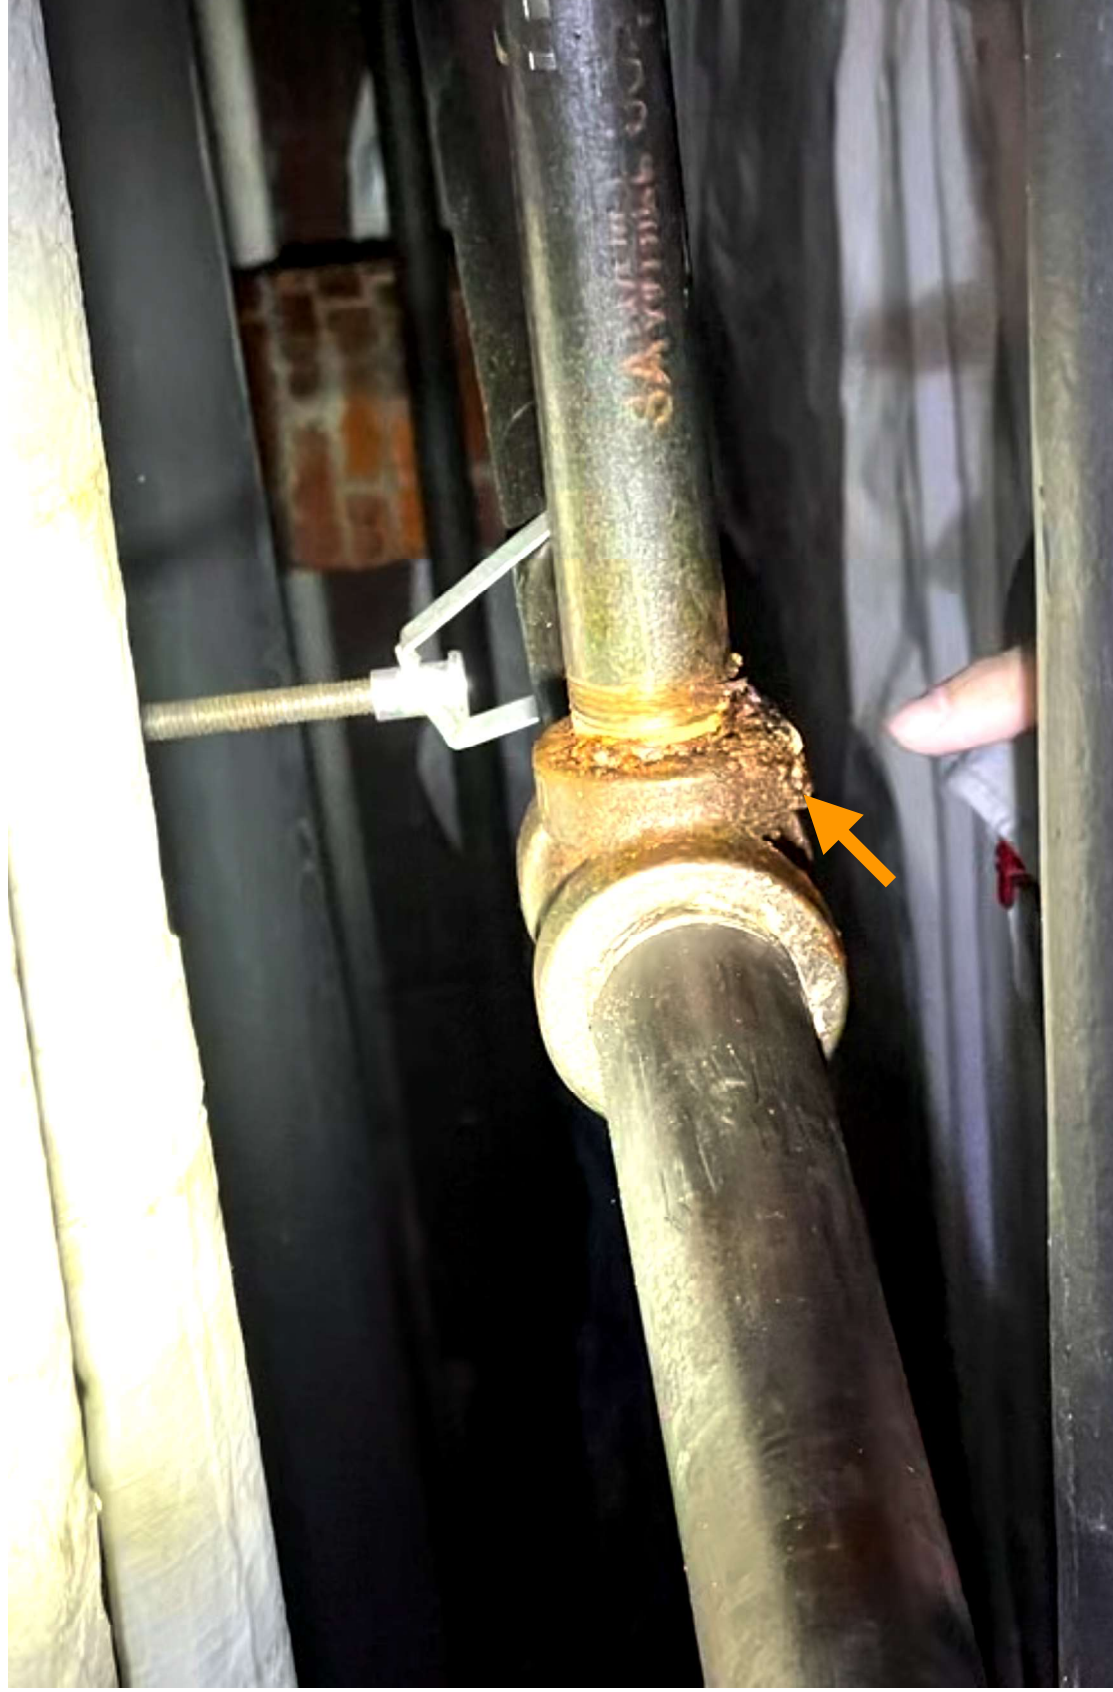
Fire Sprinkler System - Crawl Space Leak Repair

During this upcoming inspection, we have also scheduled a repair to address a leak in one of the sprinkler heads located in the crawl space off Room 105. The pipe is corroded at a threaded joint and shows visible signs of deterioration. This concern was initially identified during a crawl space inspection, and PuroFirst advised proactively addressing the issue to prevent any potential water damage should the pipe fail. The quote received from Alpha Mechanical to perform this repair is \$936.50. The repair includes cutting out the affected section of 1-inch sprinkler pipe and replacing it.

- Cut out 1" sprinkler pipe that is leaking in a thread and replace.

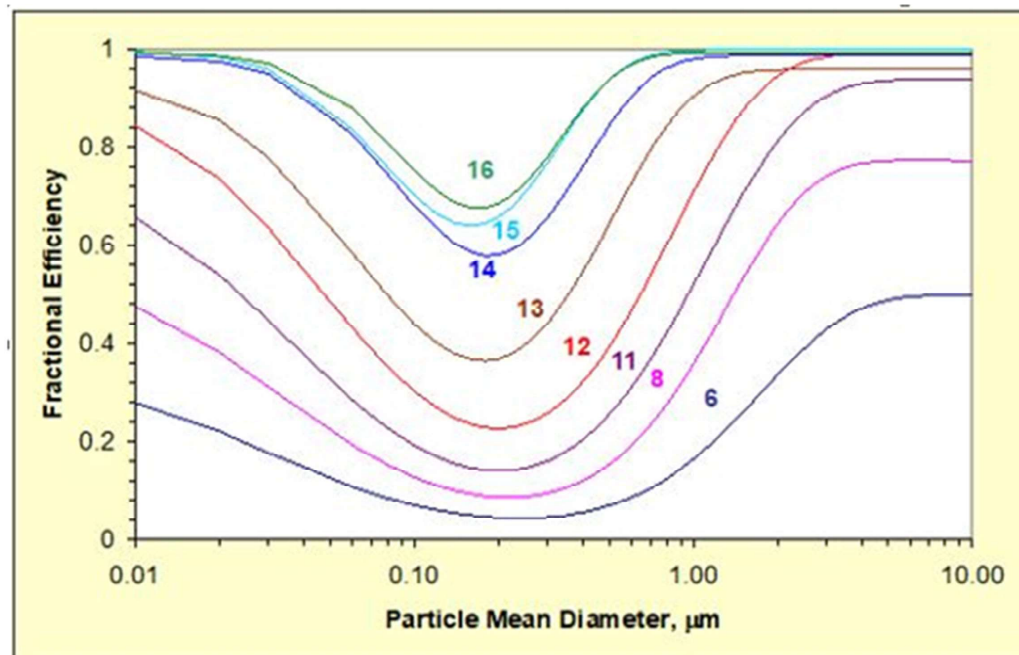
**Figure 2** MERV filter models.

While higher filtration is more effective, it may not be practical, because there are diminishing returns in improvement of particulate removal and increases in static pressure and cost. Additionally, existing equipment may have several limitations such as fan static capacity. Higher levels of filtration are better; however, research has determined that diminishing returns in the effectiveness of particle removal begin at MERV 13 to MERV 14 filter ratings.

An increase from MERV 8 or MERV 11 represents a substantial increase in the efficacy of filtration of small infectious particles. Filter frame size should be evaluated by your HVAC professional to handle the filter upgrade. If the filter frame cannot be increased, proceed with the highest level MERV filter that will
