PROJECT:	Gallatin County High School Field House	JOB NUMBER:	2228
CLIENT:	Gallatin County Board of Education	WEATHER:	Sunny, 40s
CSI PROFESSIONAL:	Daniel Huffaker, S.I., C.E.T.	DATE:	Monday 26 February 2013

KBC Special Inspections - Summary of Observations

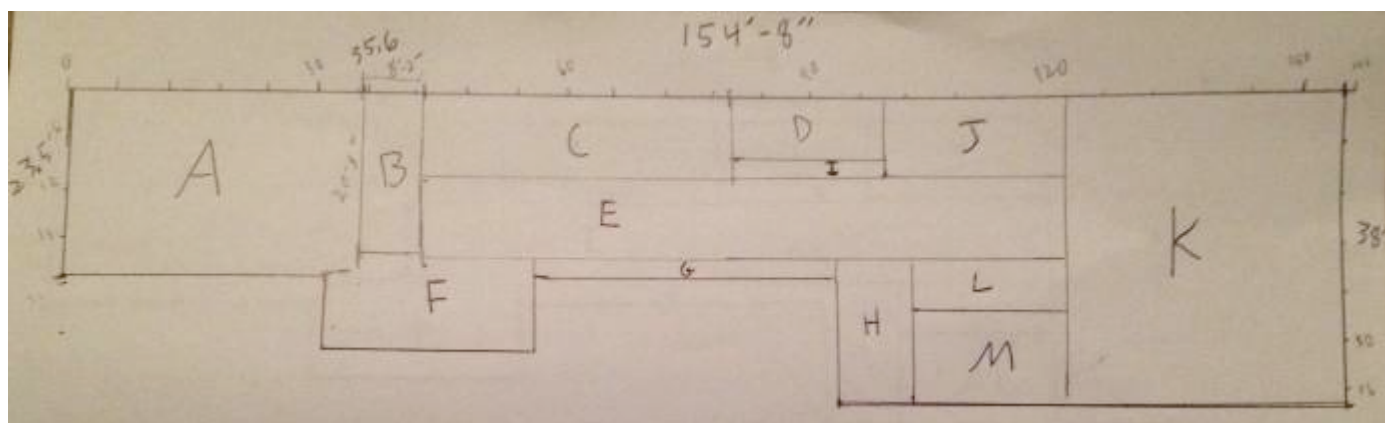
Figure 1: Approximate Drawing of Undercut Areas

The CSI representative observed the undercutting of the rear section of the building pad where soft material had previously been encountered during proofrolling on February 15, 2013. The section was undercut to a more bearable material at approximately 2 feet below existing grade. Mr. Lanigan cut the remainder of the section to this depth. A proofroll was conducted for the bottom of the undercut by the contractor utilizing a loaded dump truck weighing approximately 27,000 pounds. Some areas exhibited rutting and pumping. Mr. Jones, Mr. Lanigan, Mr. Whalen, and the CSI representative contacted Ross Tarant Architects and described the soil conditions. Ross Tarant directed that the rutted areas be skimmed down to suitable material and backfilled with soil fill from the on-site borrow area. The rutted sections were skimmed down. Mr. Jones and the CSI representative measured and recorded the undercut as noted on figure 1 and table 1. Total undercut was observed to be 415.81 cubic yards.
