Roof Analysis Report
Woodford County Schools
330 Pisgah Pike
Versailles, KY 40383

Inspection Date: 01/12/21
Building Name: Woodford County High School
Roof Name: Ag Extension Roof
Square Footage: 2,811 sq. ft.
Site Address: 180 Frankfort St. Versailles KY

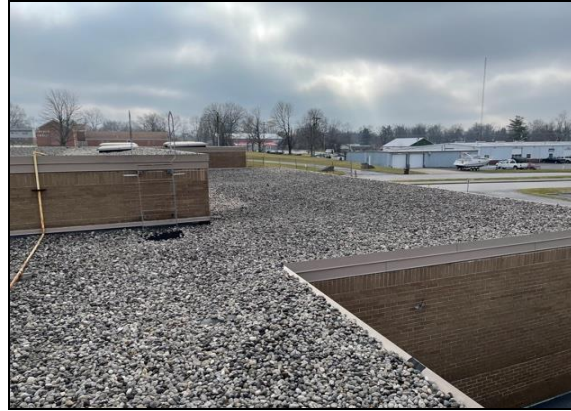
- Counterflashing caulking deteriorating in spots.

Overall the roof is in fair condition. The roof has good slope allowing for good drainage. The flashing at the walls will need to be monitored in years to come to watch for shrinking. Some areas of counterflashing could be re-caulked as a preventative maintenance measure.

- Re-caulk counterflashing in areas where the caulking has deteriorated.

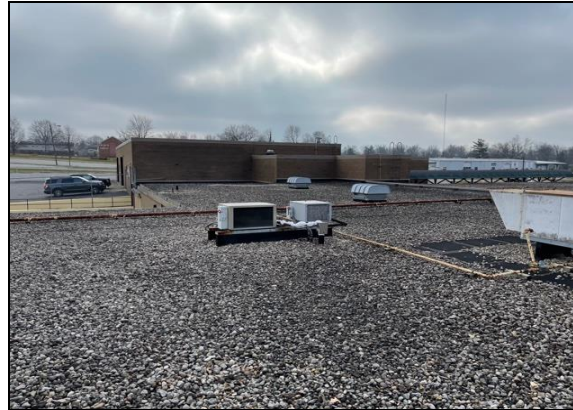
- Major “tenting” in the flashing seen.
- Hood motor is missing a cover.
- HVAC unit on the roof is freezing.

Overall the roof is in fair to poor condition. There is major tenting along the flashing due to shrinkage of the membrane. A moderate amount of repairs have been done on this roof previously due to aging of the roof.

Notes: Replace the roof as budget allows.

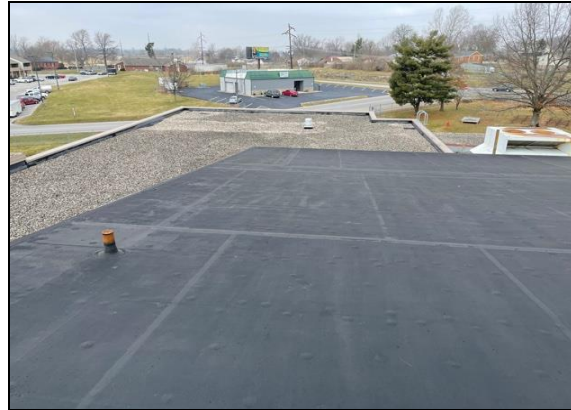
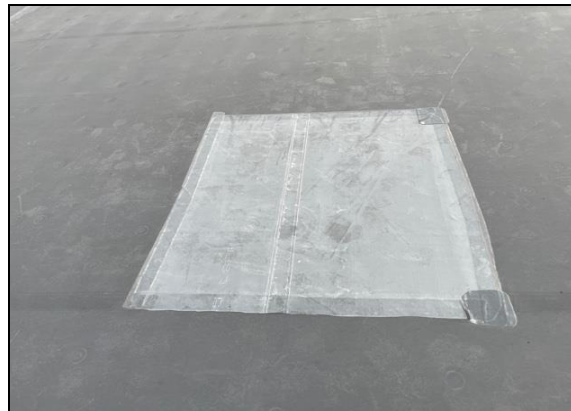
- Previous patches showing signs of minor deterioration.

Overall the roof is in fair condition. The roof good slope. Previous repairs that were done after storm damage need touched up.

- Touch up previous repairs that are deteriorating.

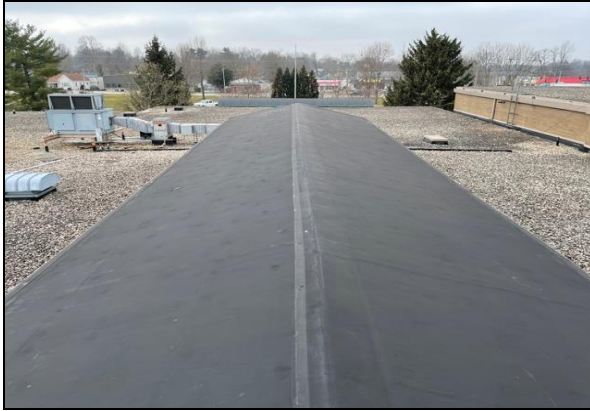
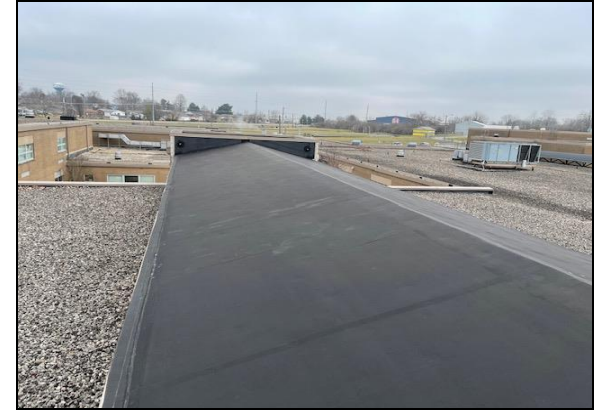
Overall the roof is in fair condition. The roof has good slope and the membrane doesn't have any current deficiencies. There have been previous repairs made to stop some leaks.

- Periodically inspect the roof to monitor for deficiencies.

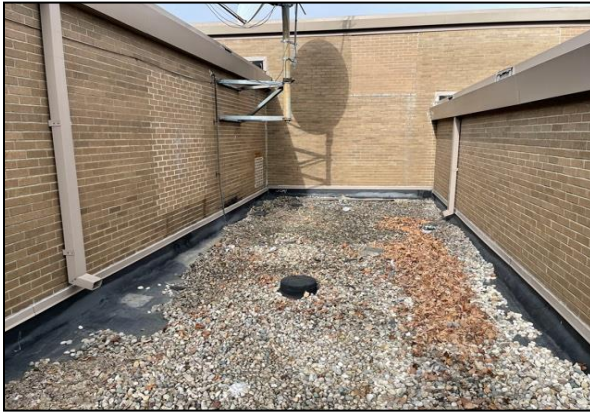
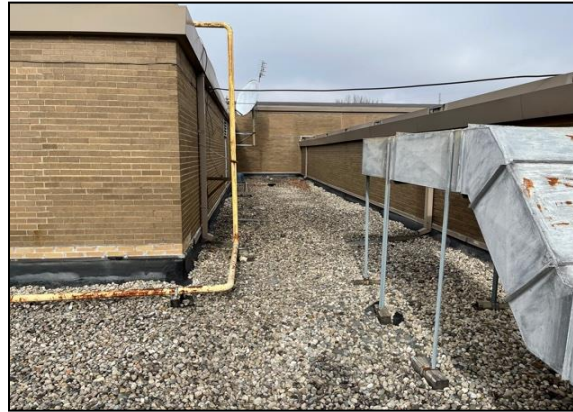
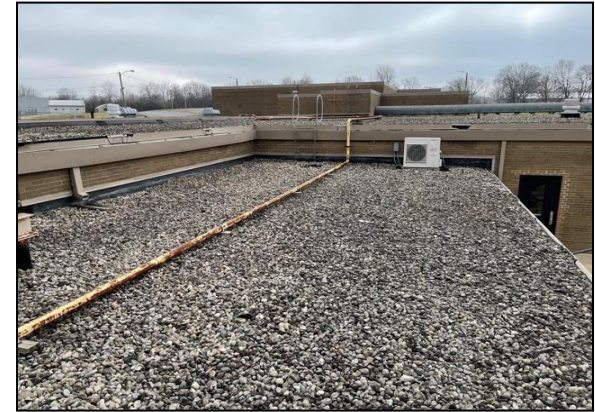
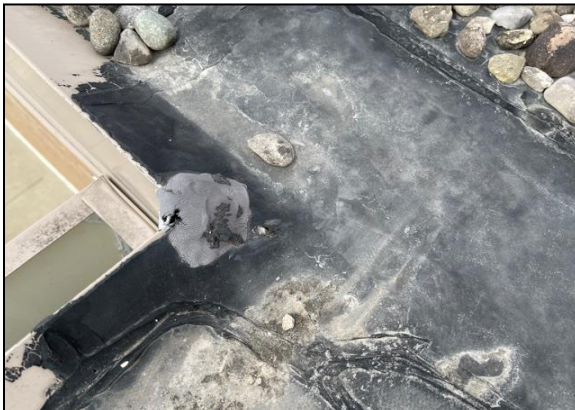
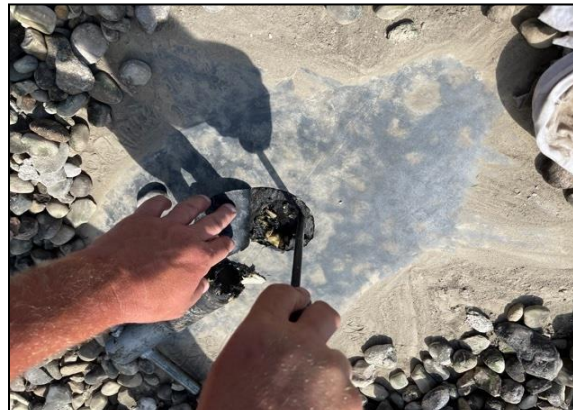
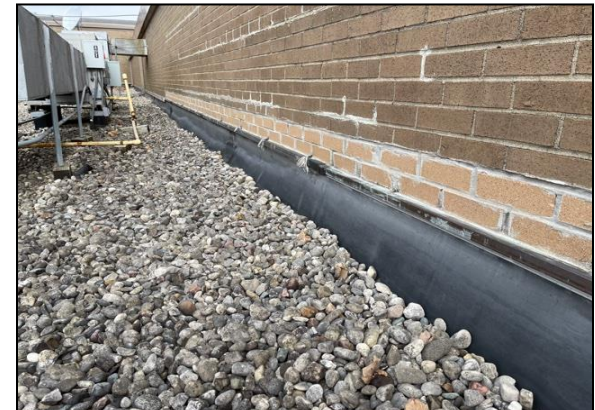
Leakage Notes: Leaks occurring in Room 139

Interior Damage Notes: Diverter tarps have been hung to keep moisture from saturated roof to damage interior.

Overall the roof is in poor condition. This roof system has been saturated with moisture due to the surrounding walls taking on moisture. A through wall flashing needs to be installed prior to or during roof replacement. This roof is in replacement mode.

- Add a copper through wall flashing to approx. 165 lineal feet to keep additional moisture out of the roof system.
- Replace roof as soon as possible to prevent damage from water in the roof system.

Notes: Replace roof as soon as possible.

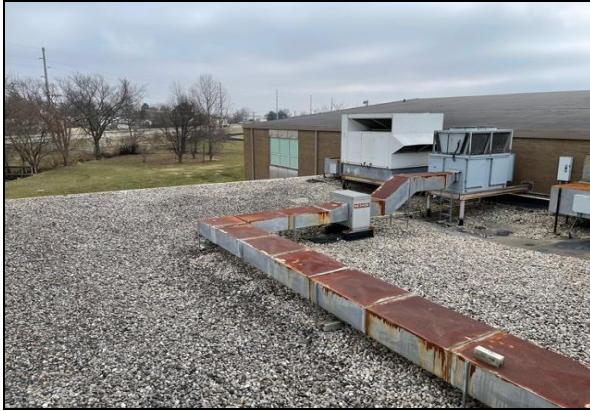
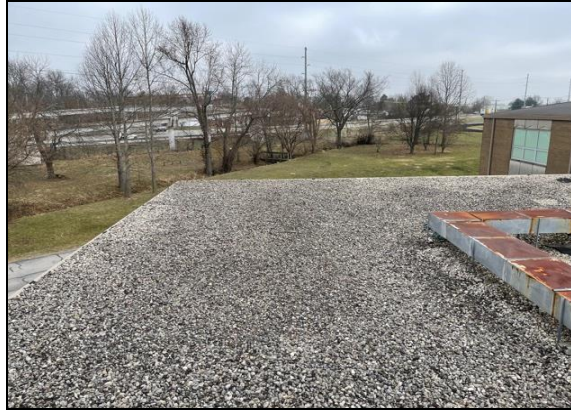
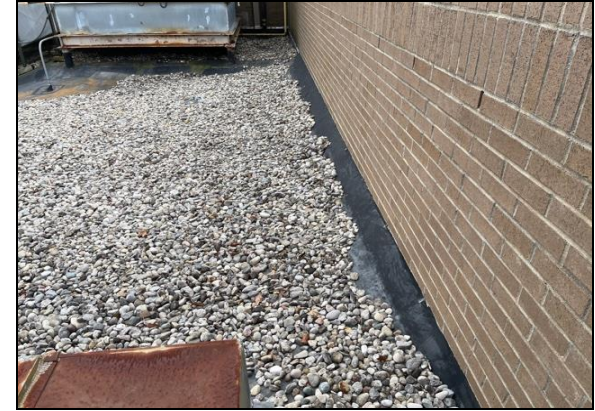
Overall the roof is in fair/poor condition. There is tenting along the wall flashing and the roof is showing signs of aging. The roof is at the end of its service life.
