## FIELD OBSERVATION REPORT

### 2023-05 (Scott Phase V)

■ TO:	Kenton County Board of Education 1055 Eaton Drive Ft. Wright, KY 41017	■ DATE:	2023.05.25
ATTENTION:	Mr. Rob Haney / Mr. Matt Rigg		
■ FROM:	Mark Perry mperry@pca-arch.com 906 Monmouth Street Newport, KY 41071 V: 859.431.8612 • D: 859.578.6013	■ PROJECT:	Kenton County School District Scott Phase V
COPIES TO:	Mr. Kevin Pfefferman; Ms. Carrie Hooten	PROJECT NO.:	20-032

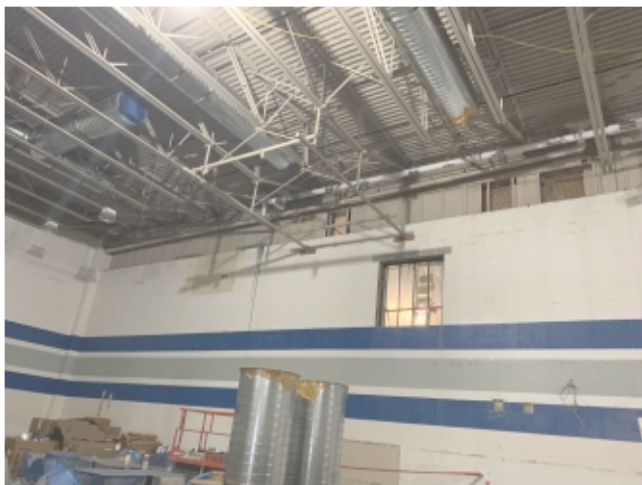
2023.04.19 – Main gym

02.01: 2023.04.19 – The temporary partition at the main gym spectator seating area had been removed, as had existing lights and wiring. The louver opening in the West masonry wall appeared complete. First floor demolition appeared to be largely complete outside of the Auditorium. Crews were actively removing materials in the Auditorium. Brick veneer had been removed at the East exterior wall of the Auditorium. The condition of the CMU was noted as very poor all along the East elevation. Corrections will have to be made or the wall replaced.

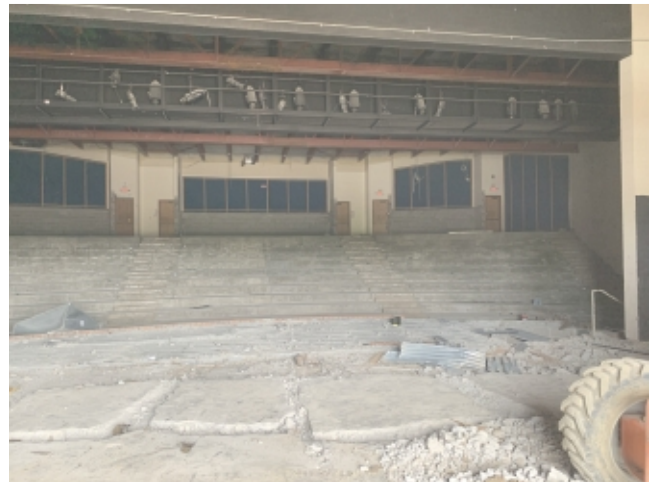
02.02: 2023.05.03 – Demolition crews were actively removing concrete at the stage area. 2<sup>nd</sup> floor seating riser demolition was complete as was ceiling demolition over the seating area. Concrete removal at the thrust stage was largely complete with deck removal 50% complete.

2023.05.03 – Stage demolition

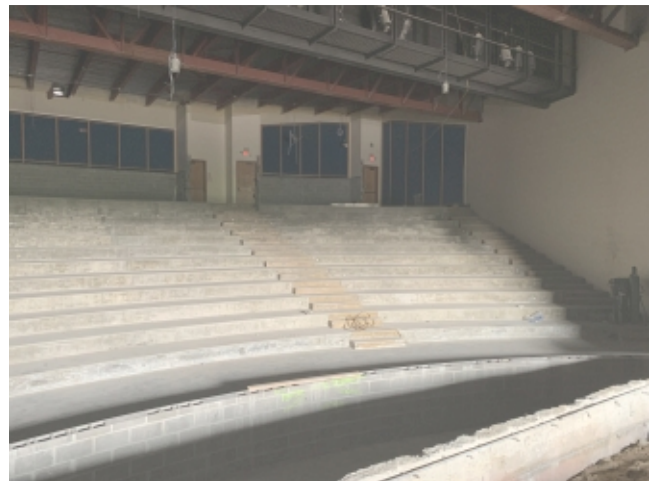
2023.05.17 – Daylight coming through North wall of Stage
