August 7, 2023

Re: Structural Observation at Estill County Middle School

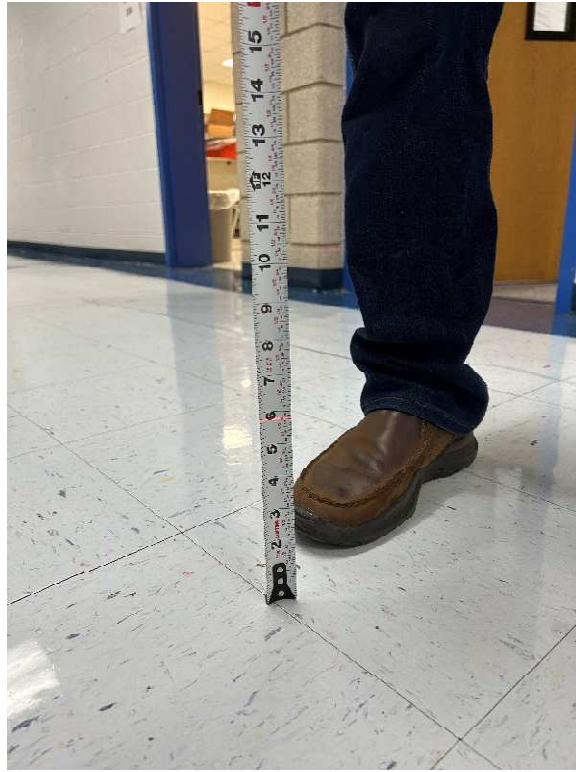
Some floor slabs within a single classroom have heaved as much as four inches. Many doors “stick” and will not fully open or close. Many interior door frames are warped and notably out of square. With this much slab heave observed, we also question the condition of under-slab plumbing pipes and electrical lines.

Laser level indicating a rise in concrete slab of approx. 2" from exterior door to mid-point in classroom hallway.

Although the functionality of the building is compromised, in our opinion the building is not in danger of collapse or a structural life safety issue to its occupants. The building needs to be placed on a monitoring program, and we recommend a reputable structural engineer perform a structural observation every school semester for the next 3 to 5 years. This would be to observe how much (if any) the building is still moving and to call attention to any life safety issues that may result with further heaving of the shale.

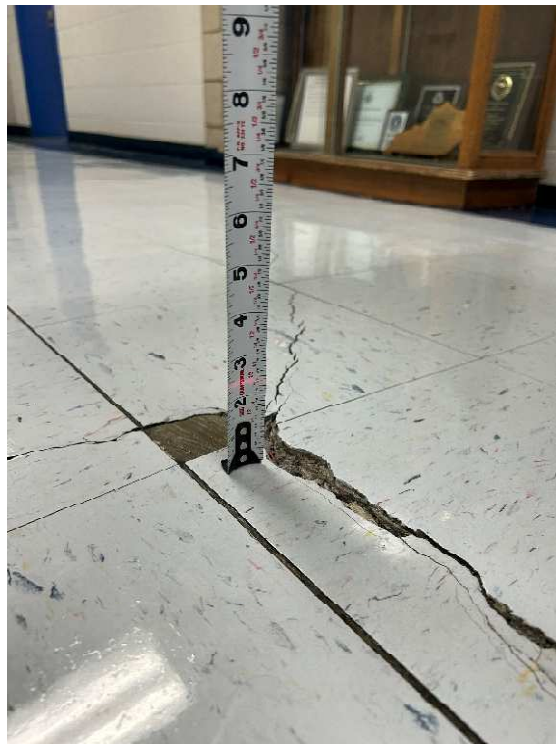
Laser level indicating a rise in concrete slab of approx. 5 1/4" from exterior door to most severe heave location in corridor.

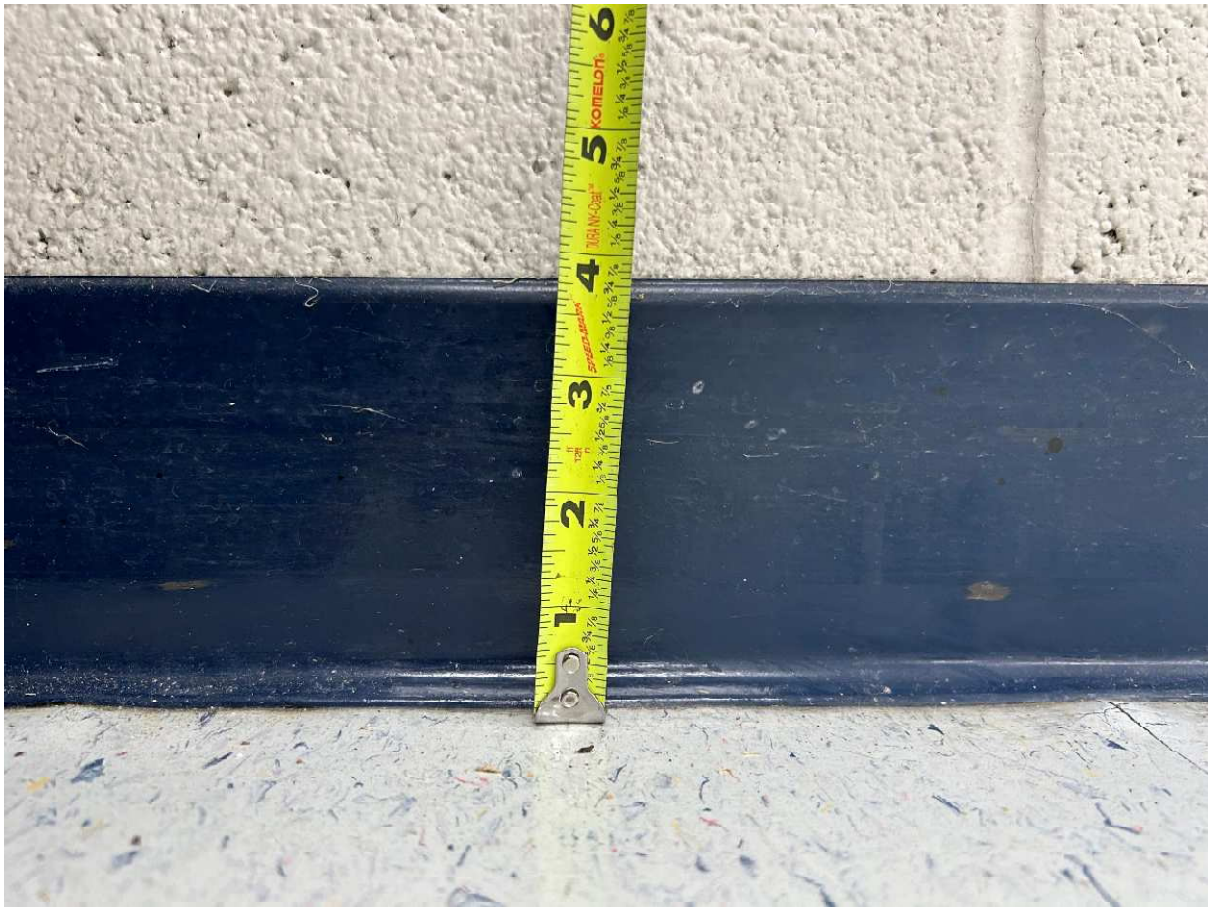
Room 121 at location where vinyl wall base fully visible (no visible heave in slab)

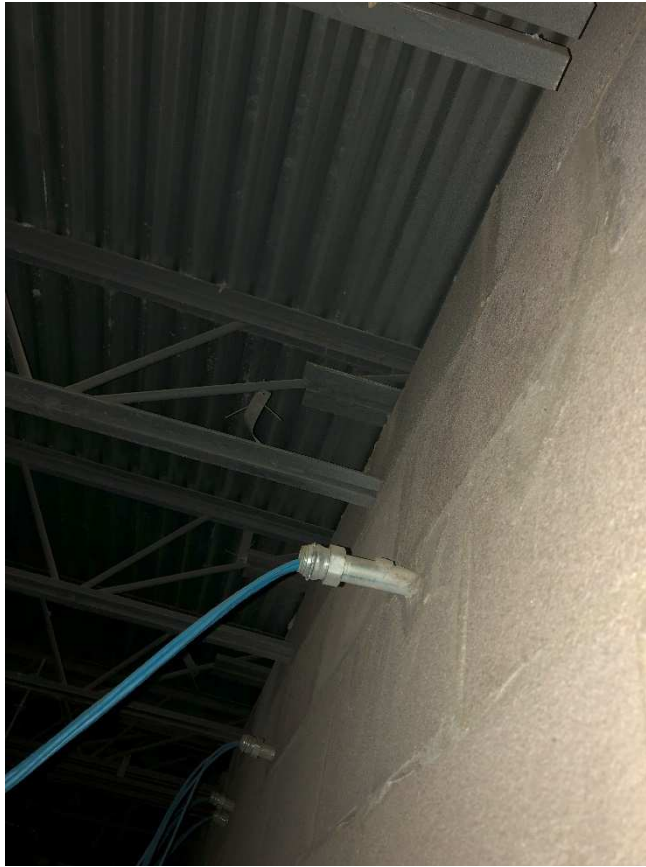
Joist bearing. No apparent issues at bearing locations observed.
