FIELD OBSERVATION REPORT

New West Middle School – Cecilia, KY

202280 – CA8

Report No: 3

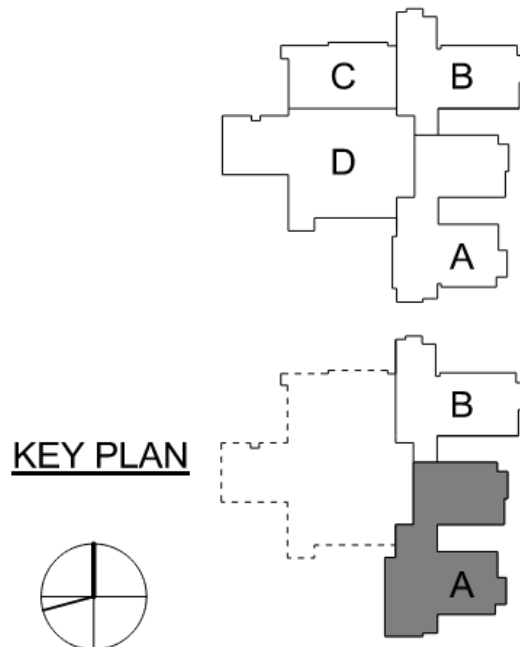
- a. East and Westbrook Construction was installing foundations and forming one of the concrete portals.
- b. The contractors continue to work in less than favorable weather conditions in an effort to make progress on the foundations and associated below slab utilities. Earthwork has been slowed due to wet soils.
