## FIELD OBSERVATION REPORT #08

### 2025-02 - New Board Office

■ TO:	Kenton County Board of Education 1055 Eaton Drive Ft. Wright, KY 41017	■ DATE:	2025.02.19
ATTENTION:	Mr. Kevin Pfefferman		
■ FROM:	Mark Perry mperry@embosdesign.com 906 Monmouth Street Newport, KY 41071 V: 859.431.8612 • D: 859.578.6013	■ PROJECT:	New Board Office KCSD BG#24-084
COPIES TO:	Mr. Matt Rigg; Mrs. Carrie Hooten, Mr. Brian Vanover	PROJECT NO.:	22-106

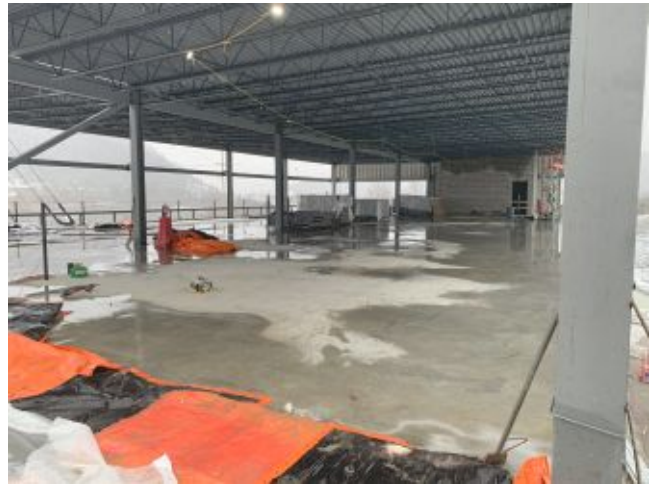
2025.02.12 – 3<sup>rd</sup> floor

03.03: 2025.02.12 – The 3<sup>rd</sup> floor pour had occurred, and the slab was curing under blankets and plastic.
