Facility Condition Report

NORTHERN KENTUCKY COOPERATIVE FOR EDUCATIONAL SERVICES

ROBERT EHMET HAYES & ASSOCIATES, PLLC

Condition Report

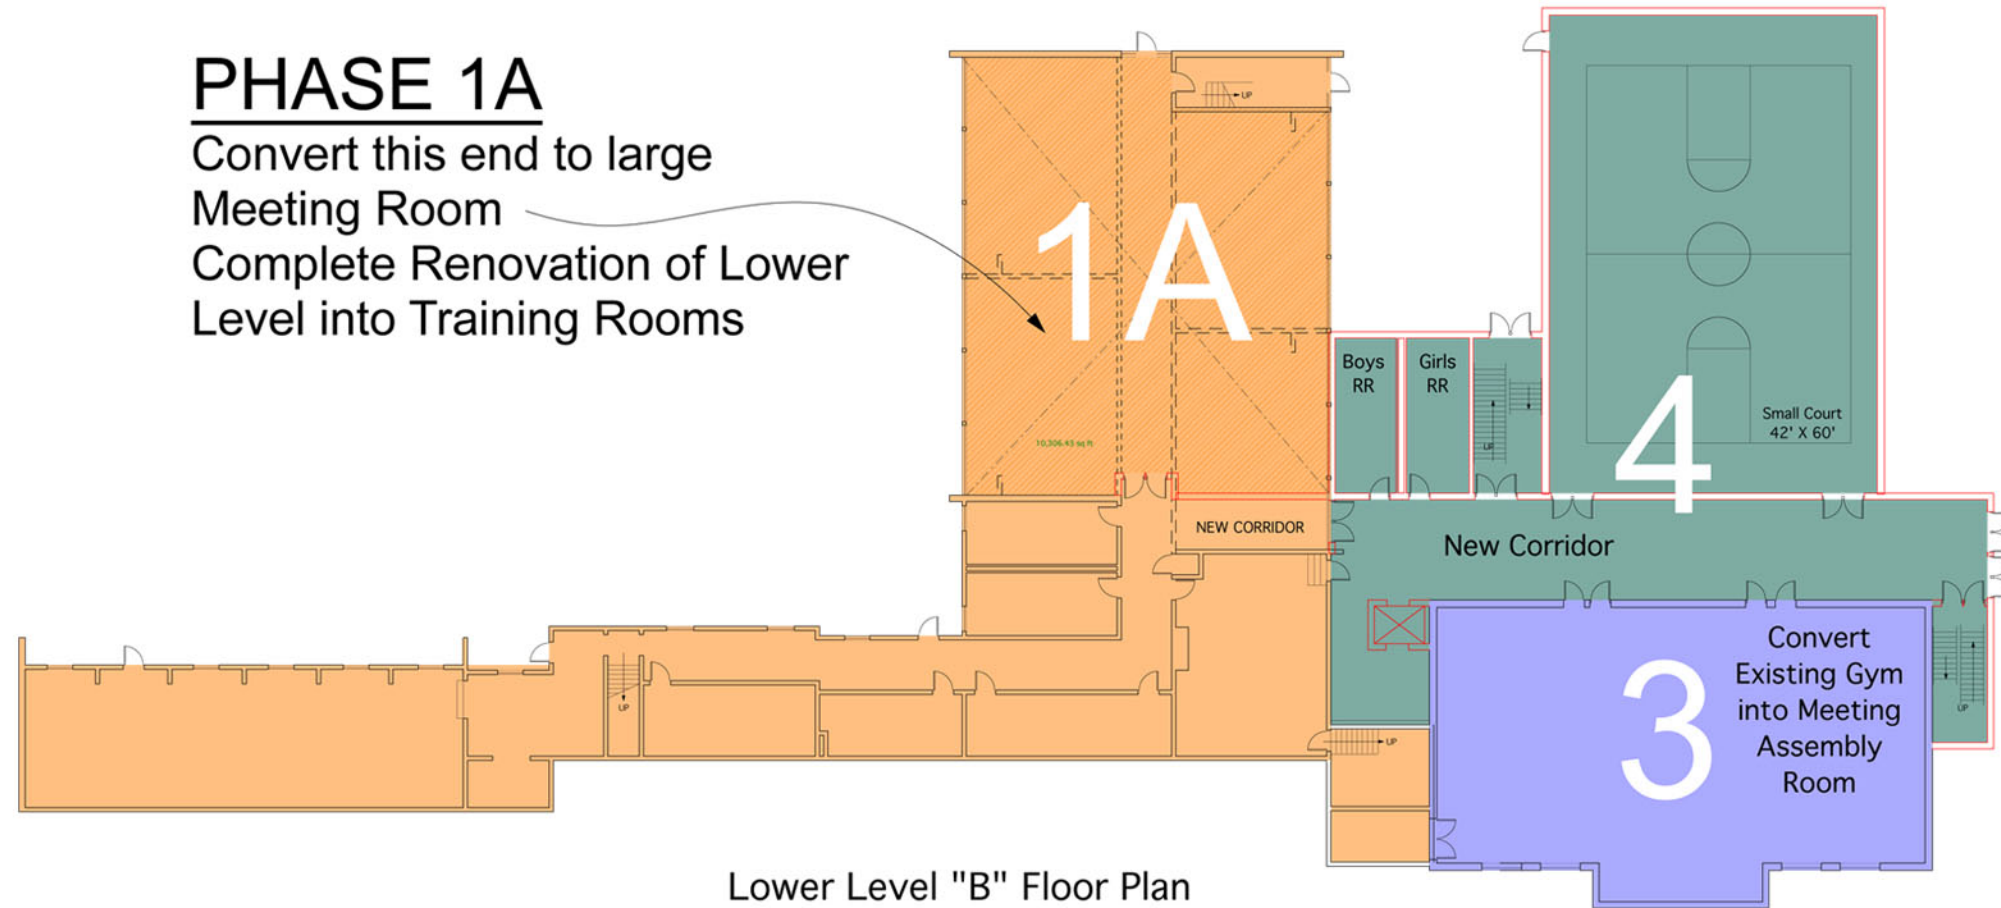
Lower Level "B" Floor Plan

PHASE 1A

Convert this end to large Meeting Room
Complete Renovation of Lower Level into Training Rooms

PHASE 4

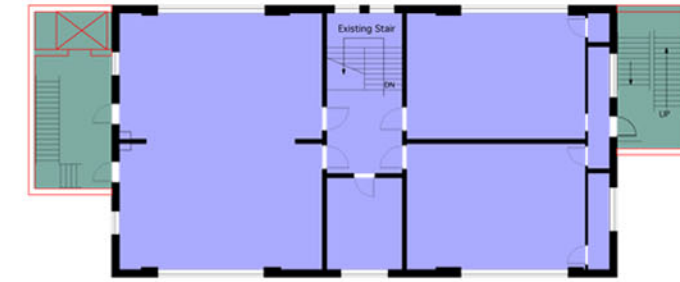
Upper Level "3" Floor Plan

PHASE 2

Renovation of 1922 Building;
convert Gym into Large Assembly
