Re: BG 22-104- Christian Co. - New Consolidated High School Schematic Design Review - Response

CCPS - NEW SCHOOL

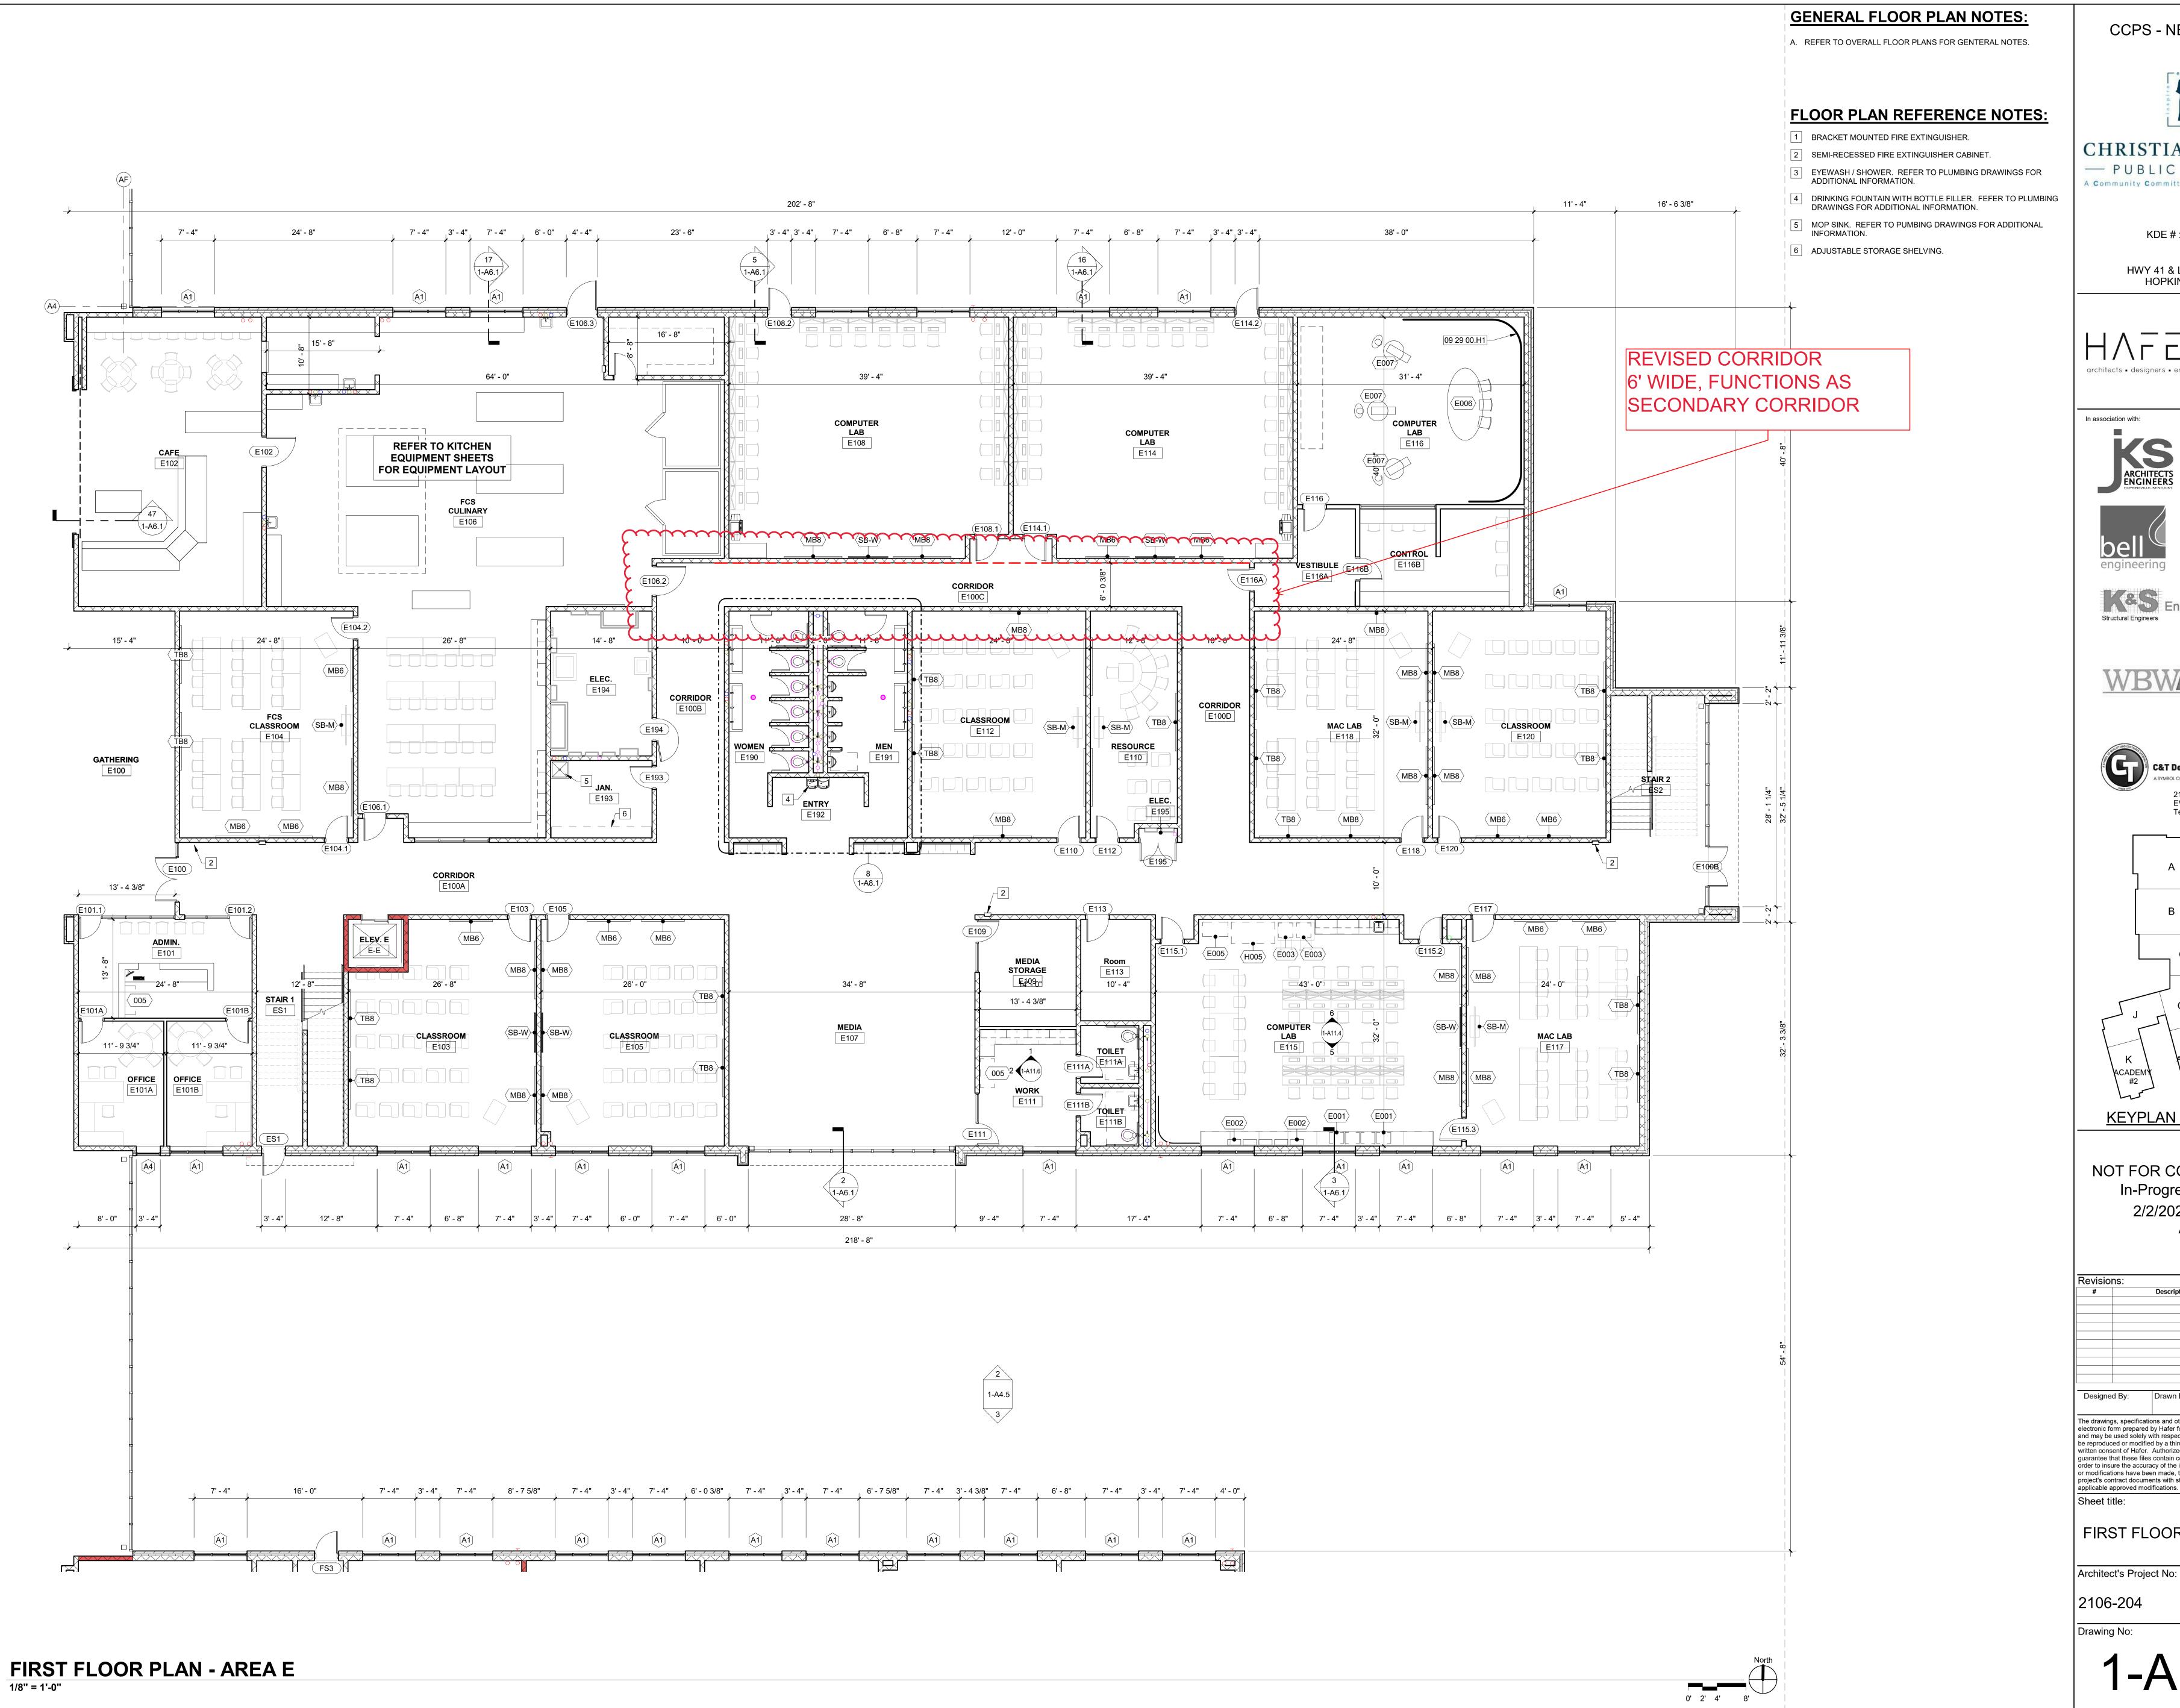
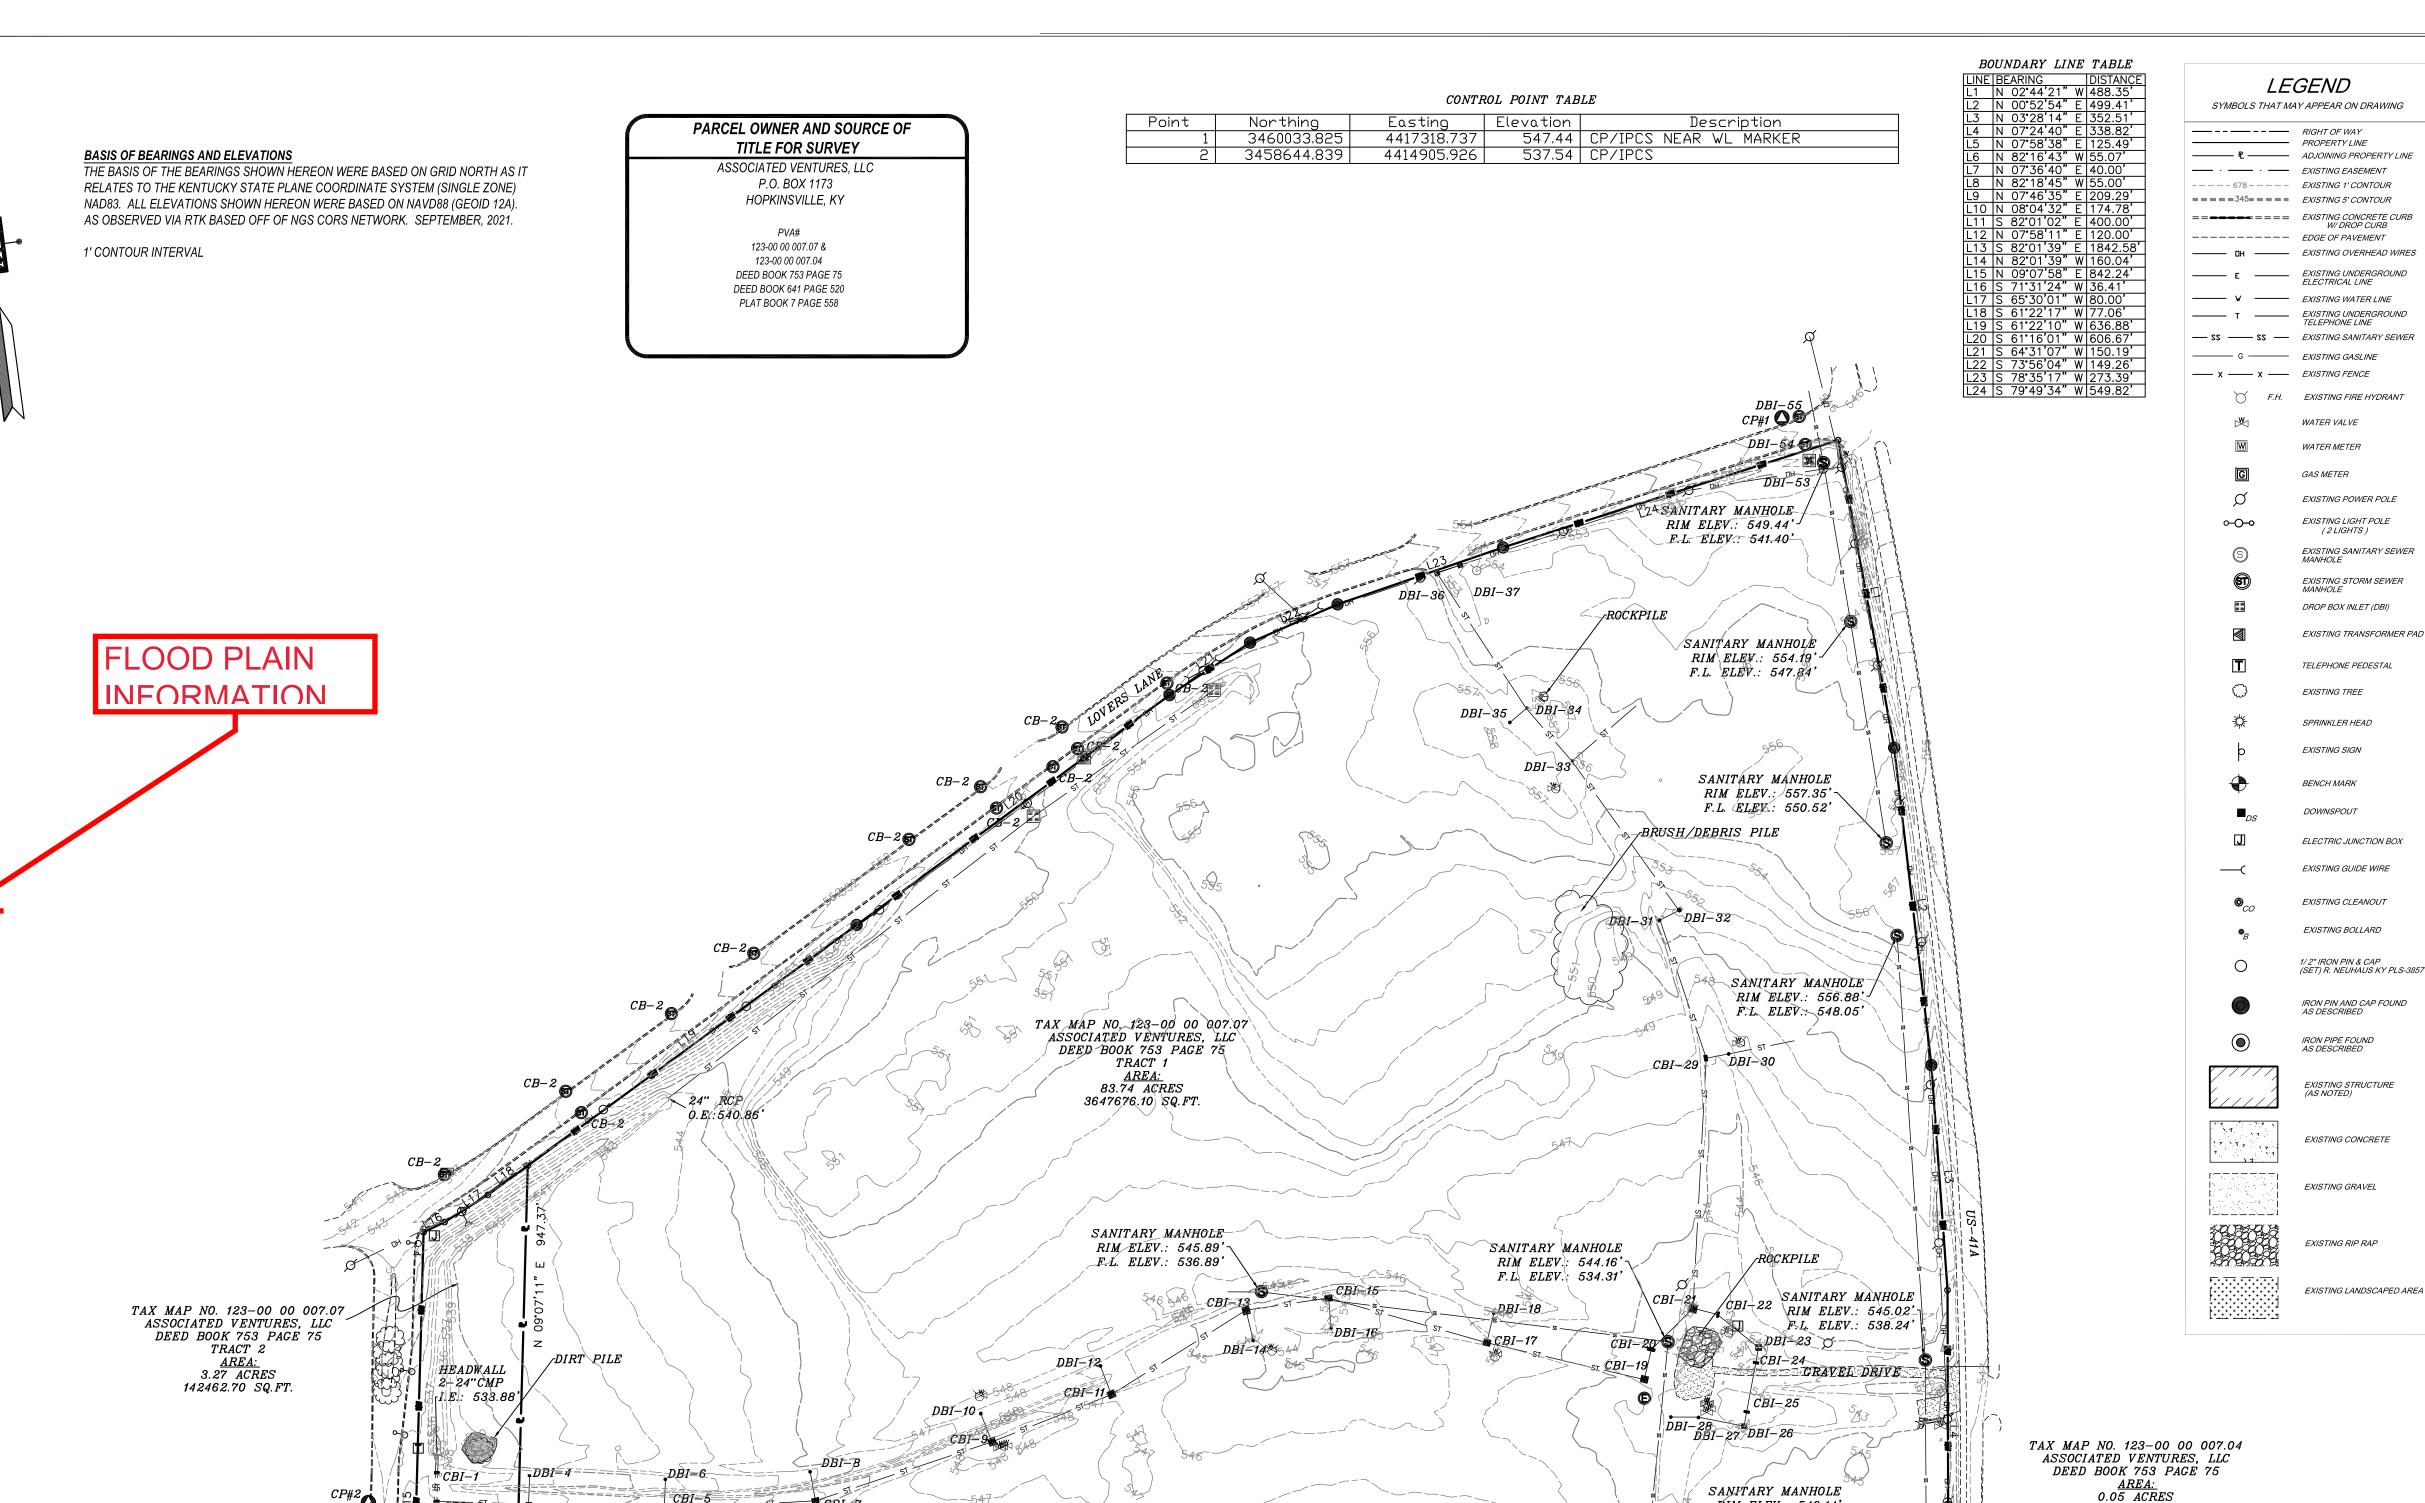
Attachment: Survey noting no flood plains are on property.

THIS PROPERTY IS NOT LOCATED IN A SPECIAL FLOOD ZONE AS INDICATED BY FLOOD INSURANCE RATE MAPS COMMUNITY PANEL NO. 21047C0361D, EFFECTIVE DATE OF APRIL 19, 2019.

RESPONSE: The Proposed High School School Building FFE = 553.0. The lowest elevation on the site is approximately 535.17. This property is not located in a 100-year flood hazard area as indicated by Flood Insurance Rate Map Nos. 21047C0361D, dated April 19, 2019 (attached).
