FIELD OBSERVATION REPORT

Central Hardin High School, Cecilia, KY 2019111 -CA8

Date: 2/10/2022 Time: 10:30 AM ET

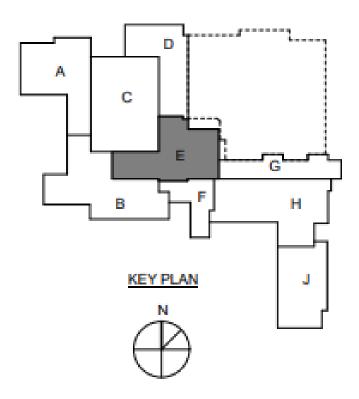
a. Excavators were preparing the building pad for Areas B, E and F.

b. Alliance was wrecking forms for the foundation wall to the south of Area C.

c. Plumbers were placing gravel around under slab piping in Area A.
