Consider/Approve Change Order No. 2 with Morel Construction for the Support Operations Center Project – BG 23-173.

## Change Order

## Daily Field Report

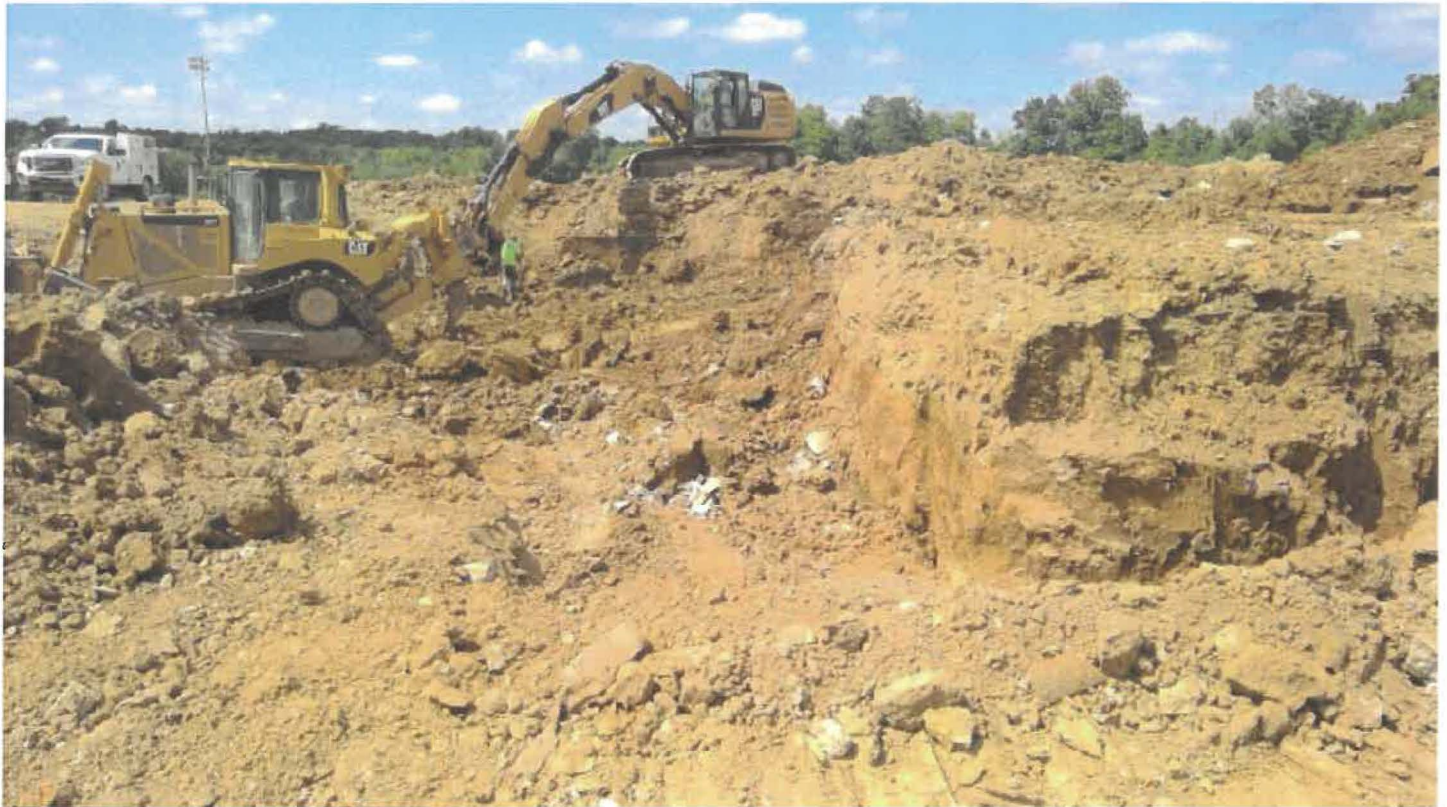
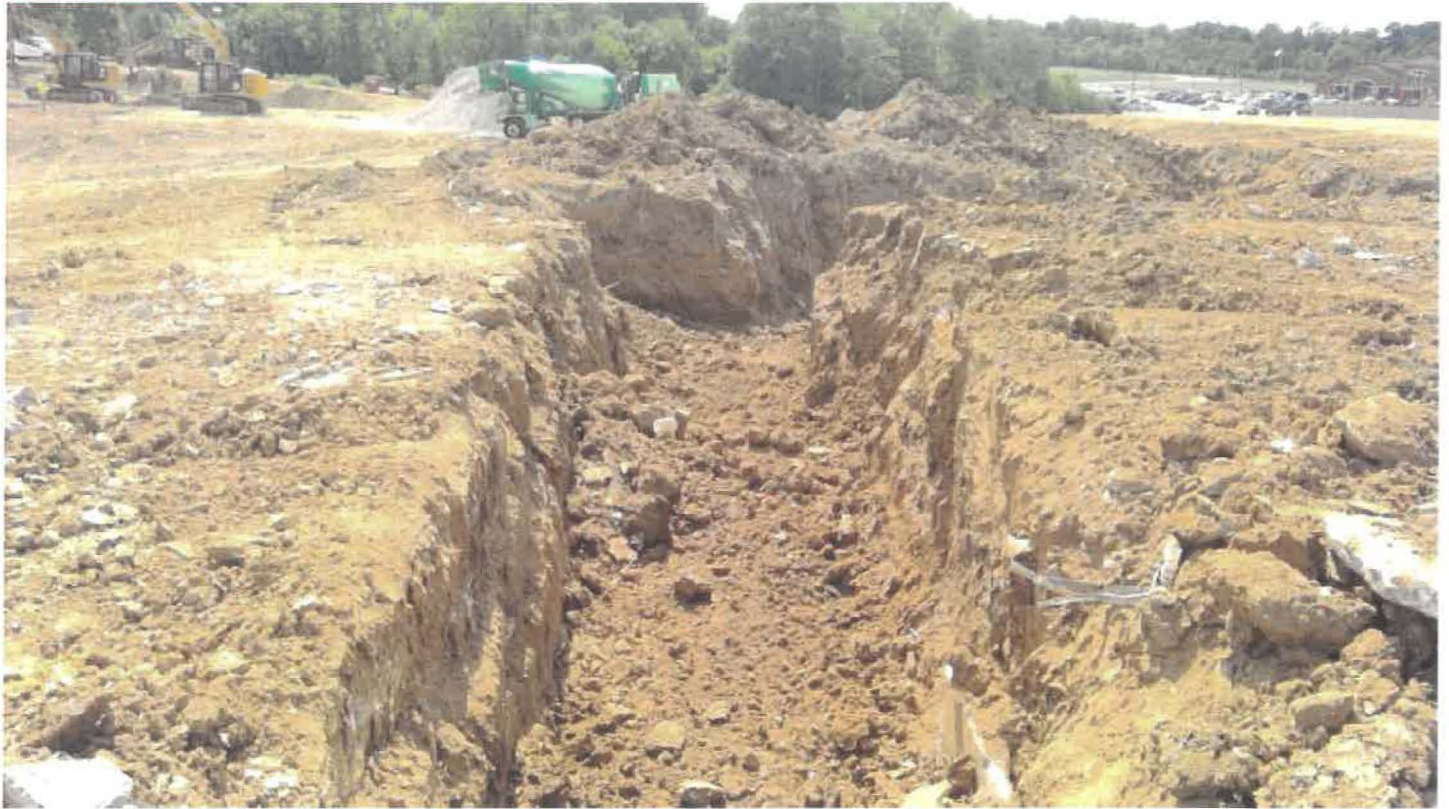
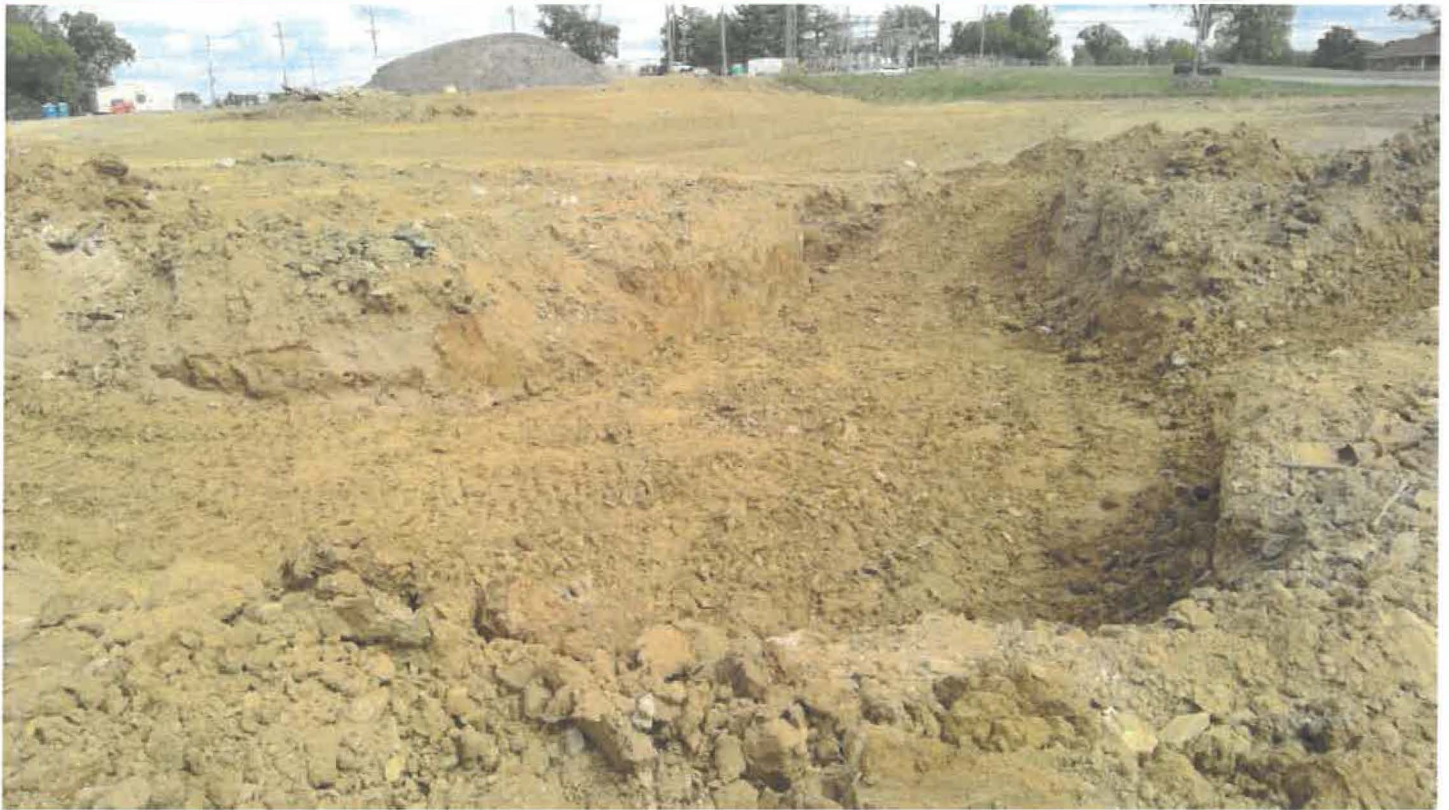
Undercut areas observed included old foundations around the loading dock. Observed undercuts for the purpose of removing old foundations. Approximately 8-9 feet of material was removed from below existing subgrade. Approximate dimensions of material removed today was 101'x27'x9'; 44'x10'x10'; 45'x18'x6' and 17'x10'x8' for an approximate total of 1242 cubic yards. Observations were reviewed with the contractor.

**Remarks:** The undercut depths were obtained by the contractors GPS as distances from the bottom to the SG.

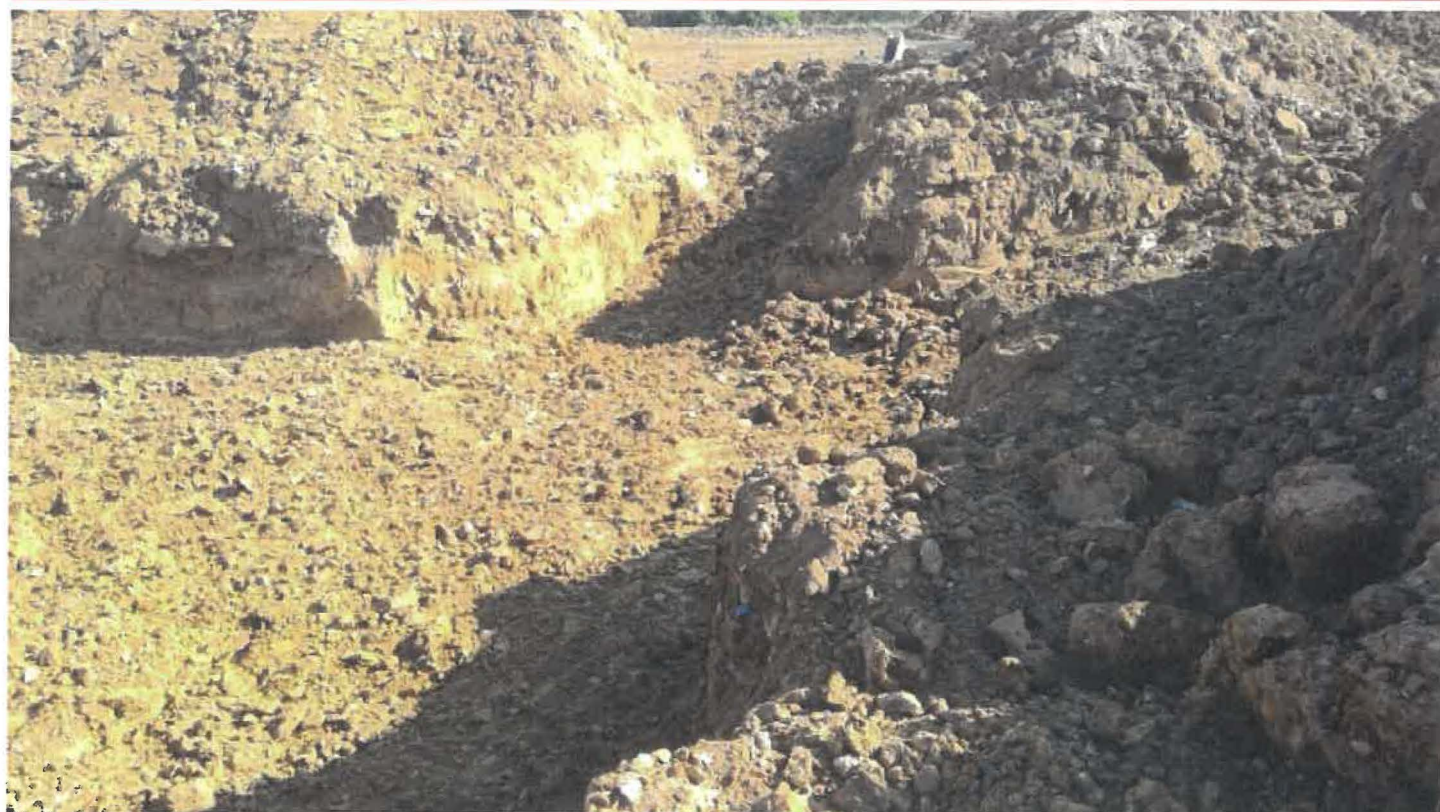
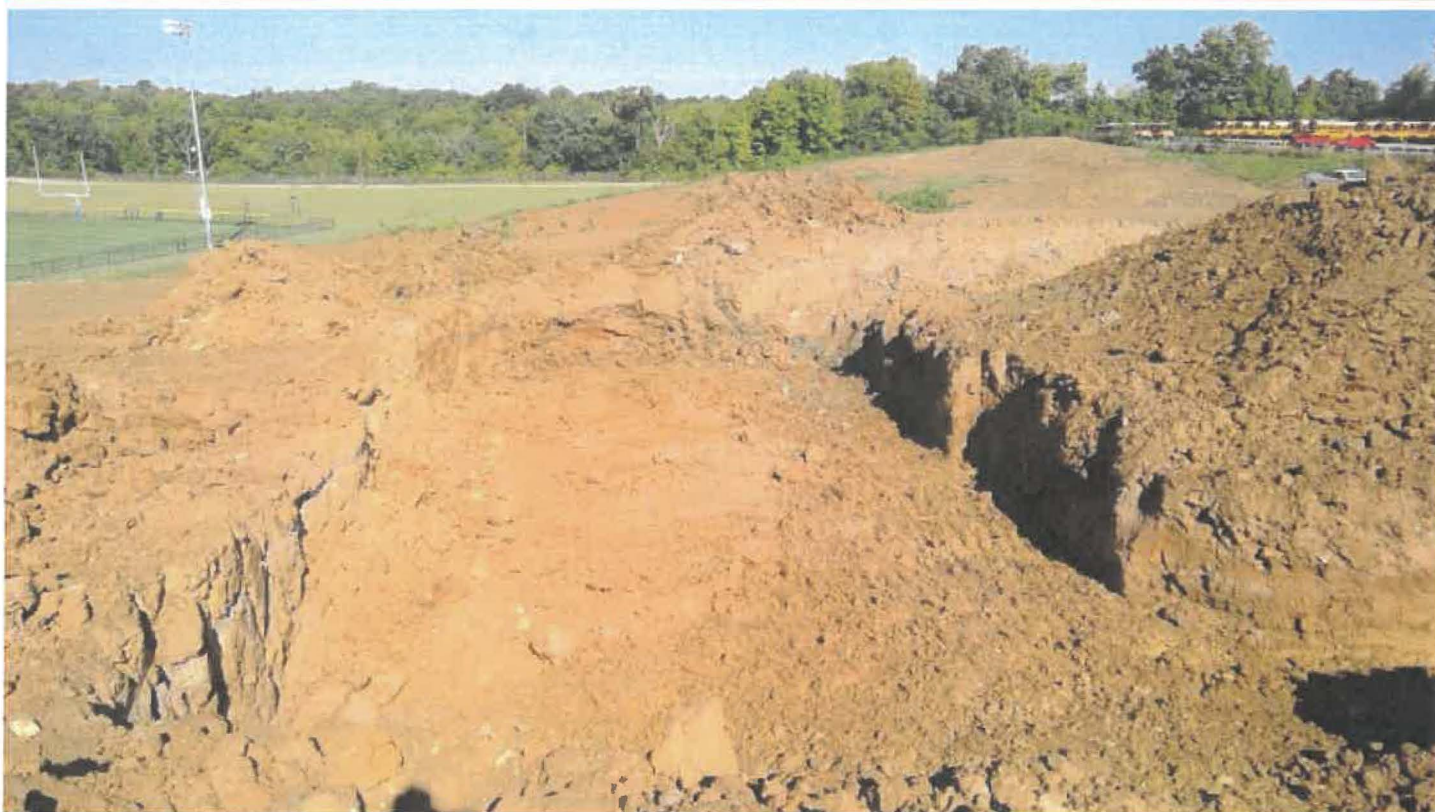
Undercut area observed included second foundation undercut west of the loading dock. Observed undercut for the purpose of removing old foundations. Approximately 5.5' feet of material was removed from below existing subgrade. Approximate dimensions of material removed today was 93'x38'x8.42'; 58'x20'x5.5'; 20'x15'x5.5' for an approximate total of 1429 cubic yards. Observations were reviewed with the contractor.

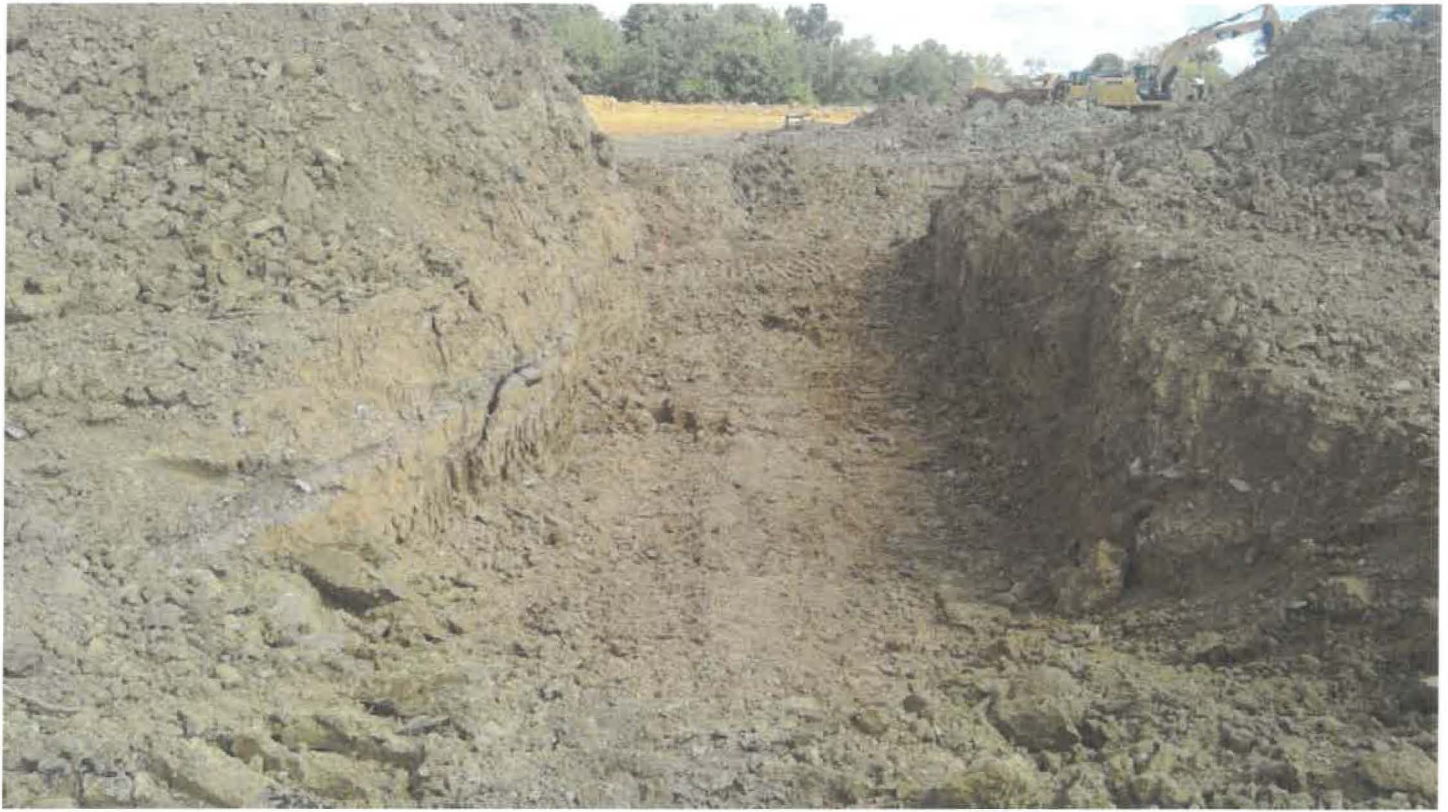
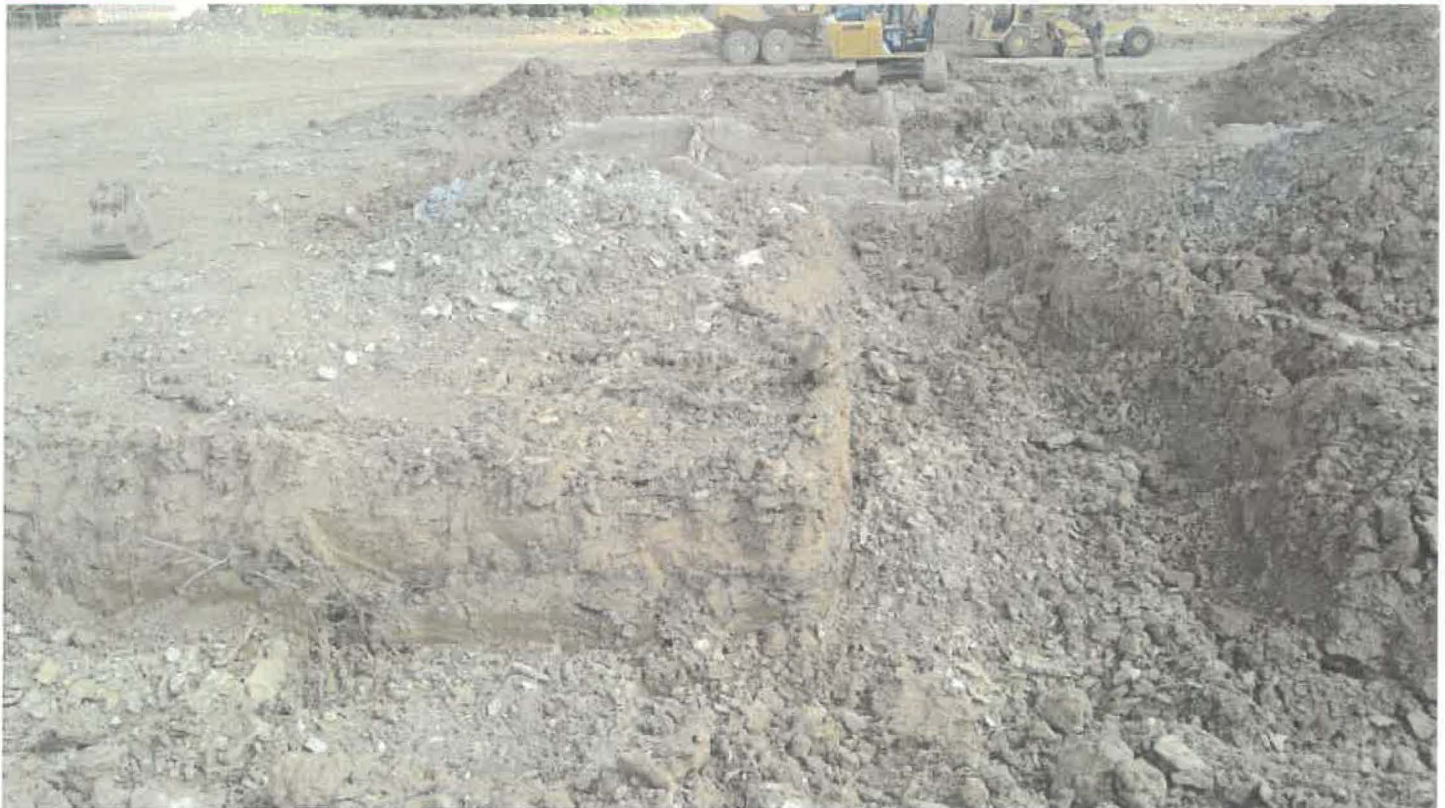
Undercut areas observed included the area adjacent to the North of the Second Foundation removal. Observed undercuts for the purpose of removing old foundations. Approximately 6 feet to 7.5 feet of material was removed from below existing subgrade. Approximate dimensions of material removed today was 69'x17'x7.5' and 50'x15.5'x 6' for an approximate total of 498 cubic yards. Observations were reviewed with the contractor.

**Remarks:** The contractor decided to fill on the North Building Pad area instead of the undercut, to prepare the area for foundations in the middle of the week. The writer mentioned the limit of limestone use to 2 feet bellow the building pad SG.

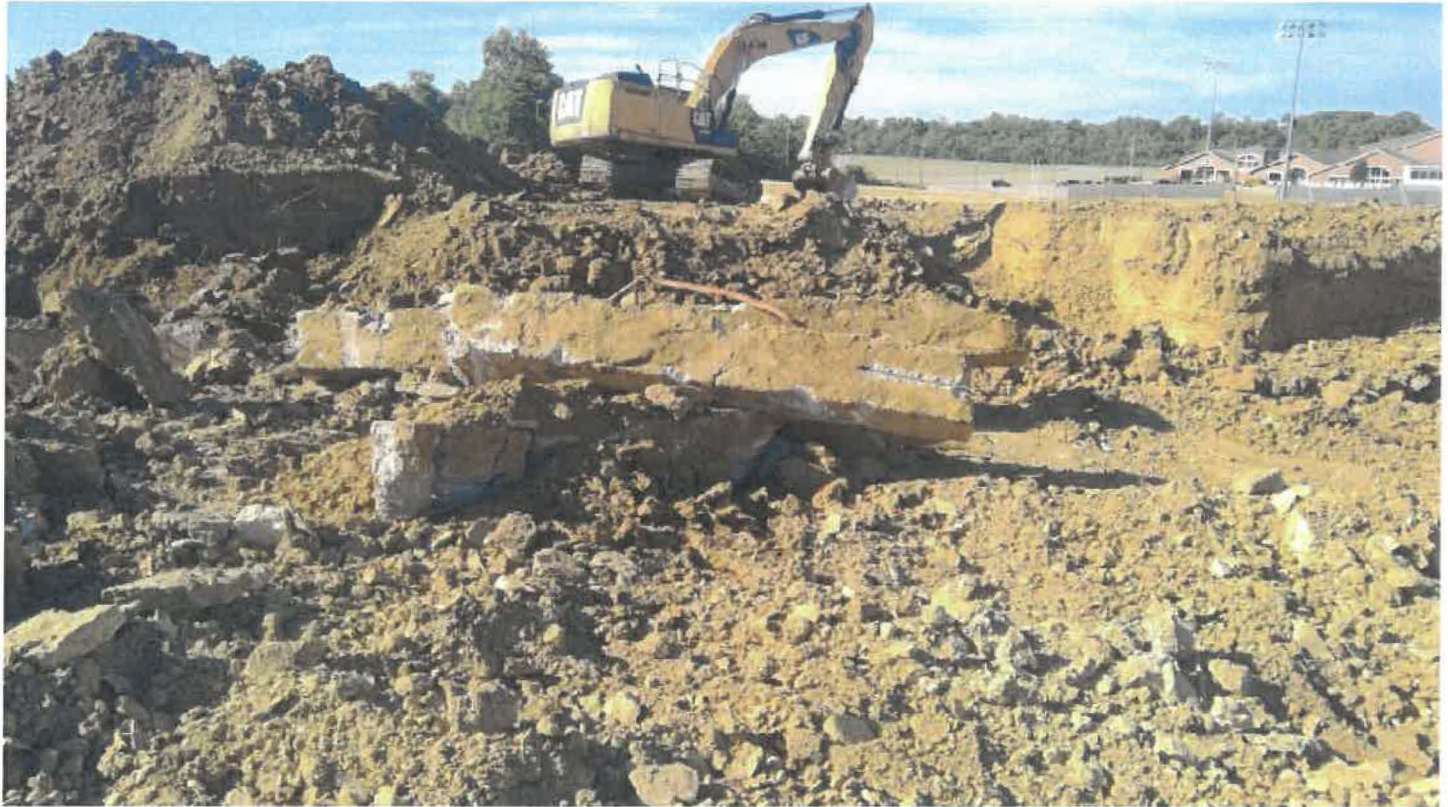
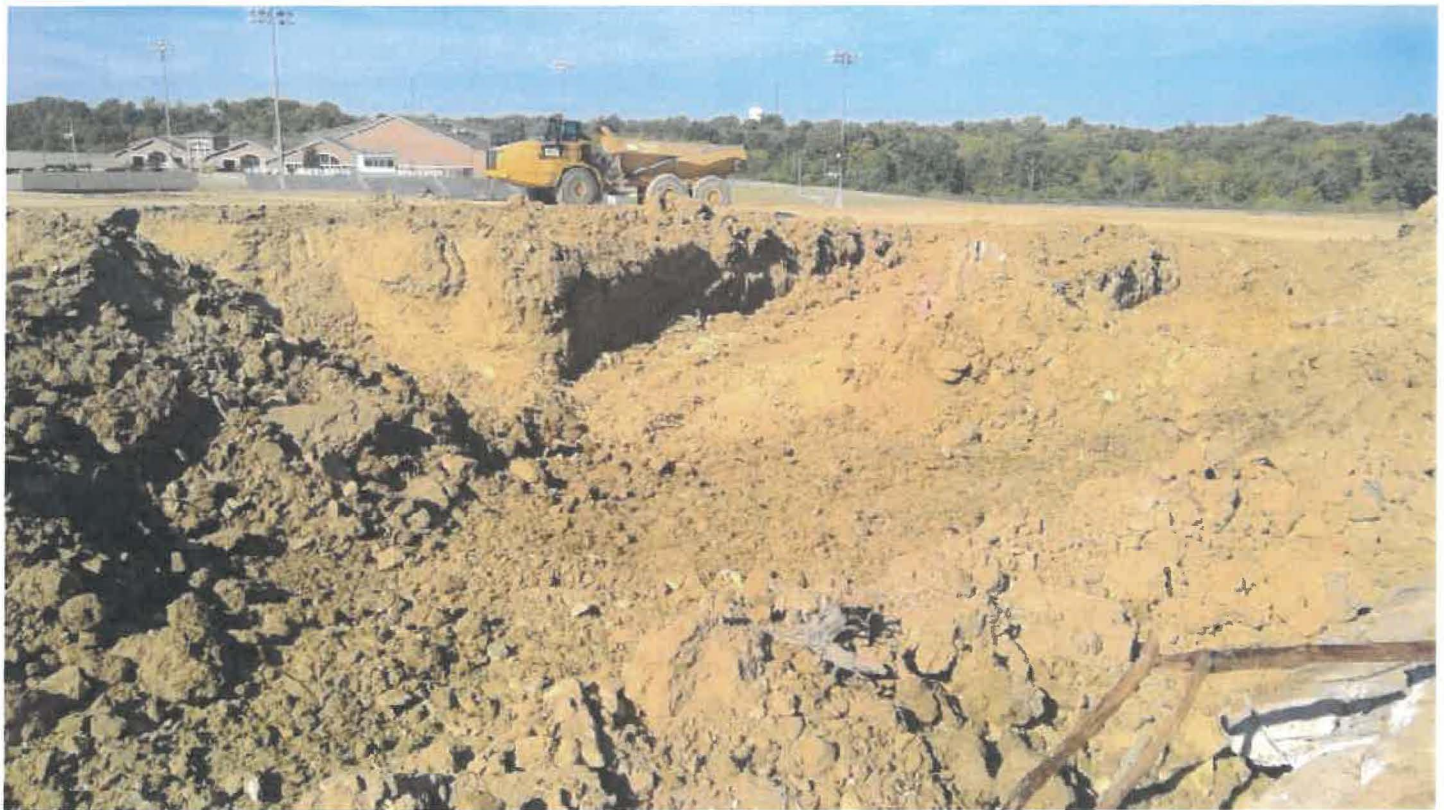
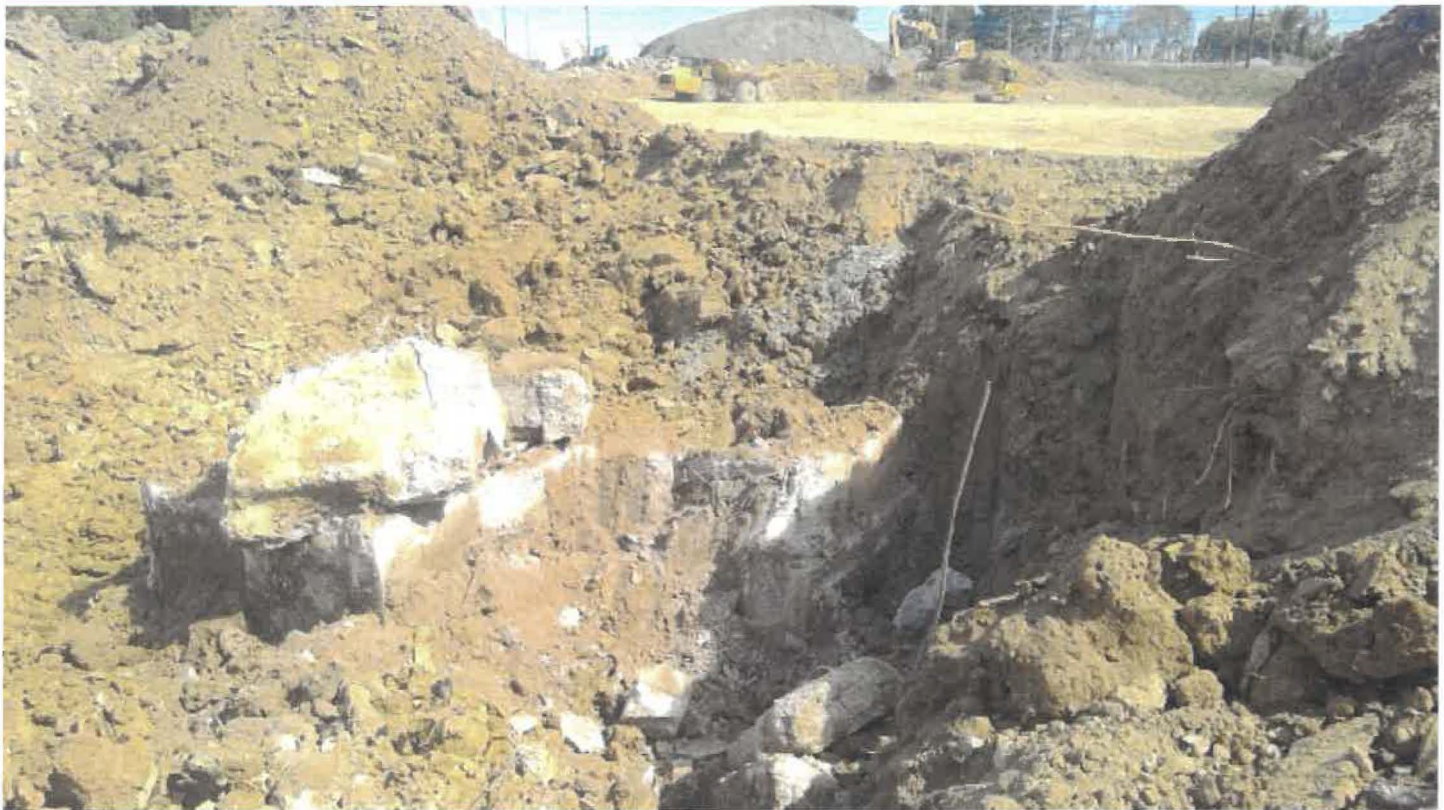
Undercut areas observed included old Foundation area-150'S, 240'W from the NW Building corner. Observed undercuts for the purpose of removing old foundations. Approximately 4 feet of material was removed from below existing subgrade. Approximate dimensions of material removed today was 50'x24.5' for an approximate total of 182 cubic yards. Observations were reviewed with the contractor.

**Remarks:** The contractor discovered another foundation adjacent to the previously undercut area.

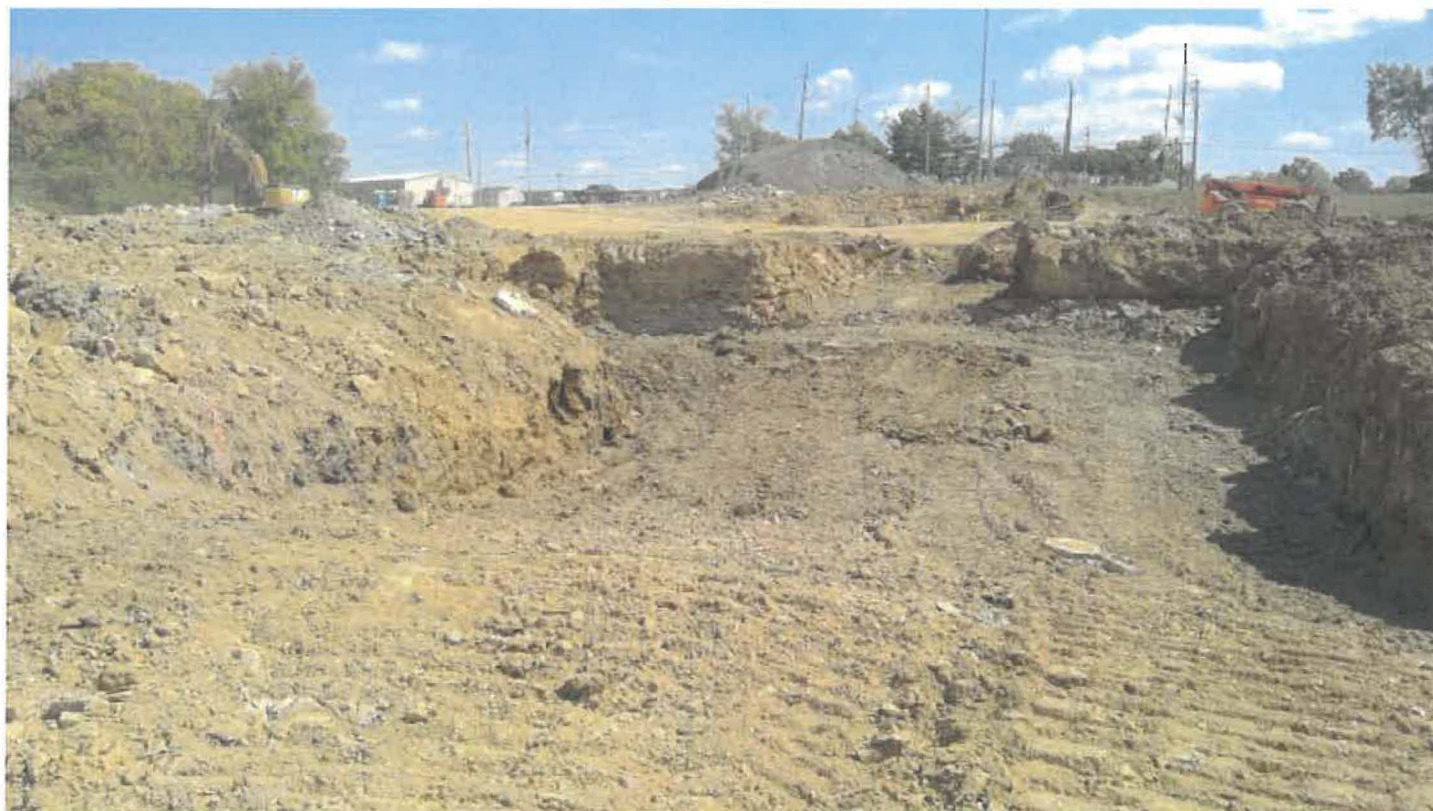
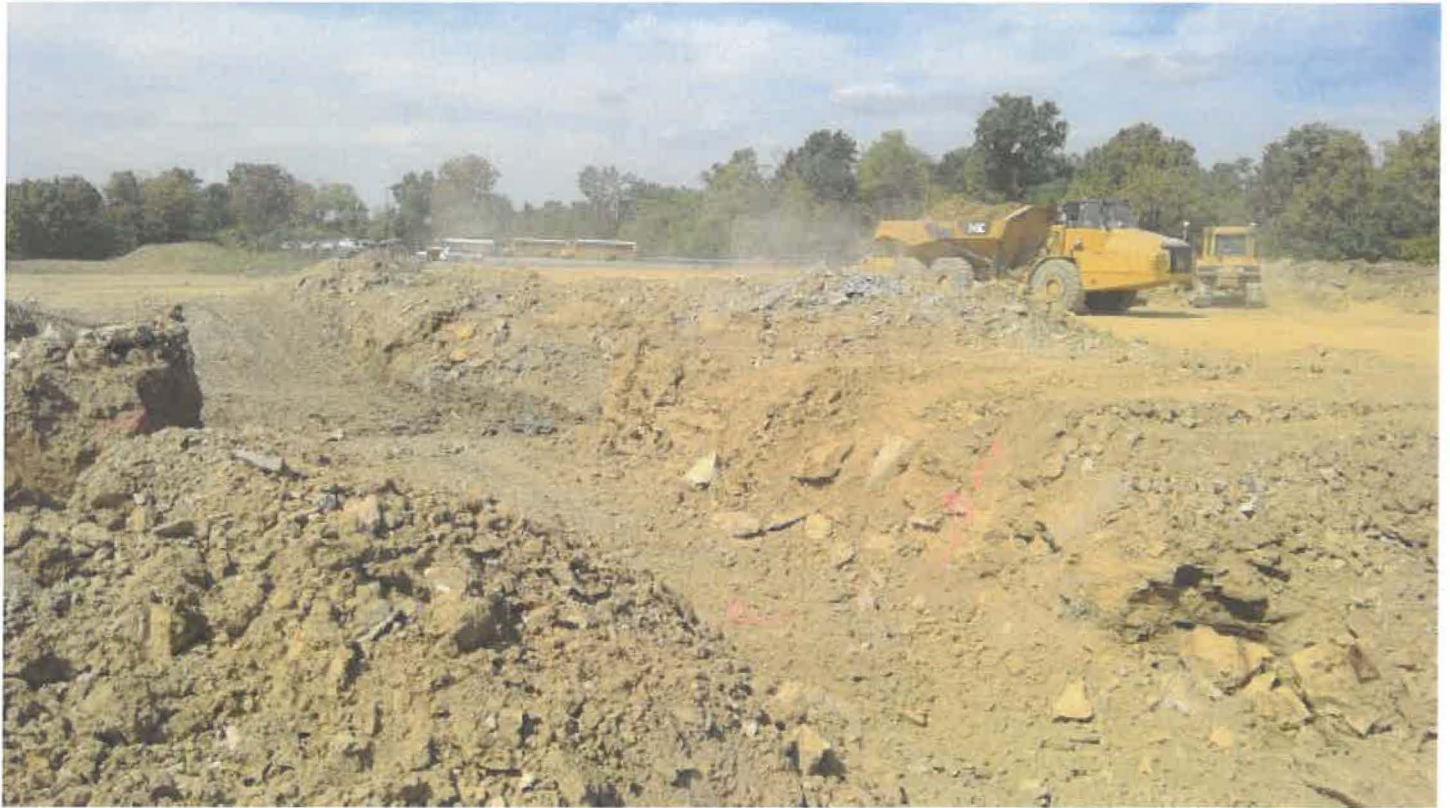
Undercut areas observed included foundation removal areas. Observed undercuts for the purpose of removing old foundations. Approximately 6.6-7.11 feet of material was removed from below existing subgrade. Approximate dimensions of material removed today was 82'x15'x7'; 28'x20'x7'; 35'x20.5'x6.5'; 59'x40'x7.11'; 42'x33'x6.6' for an approximate total of 1597 cubic yards. Observations were reviewed with the contractor.

**Remarks:** The writer had monitored the removal of dry loose material as part of the building fill area in two sections. The initial location of the undercuts was given by the contractor.

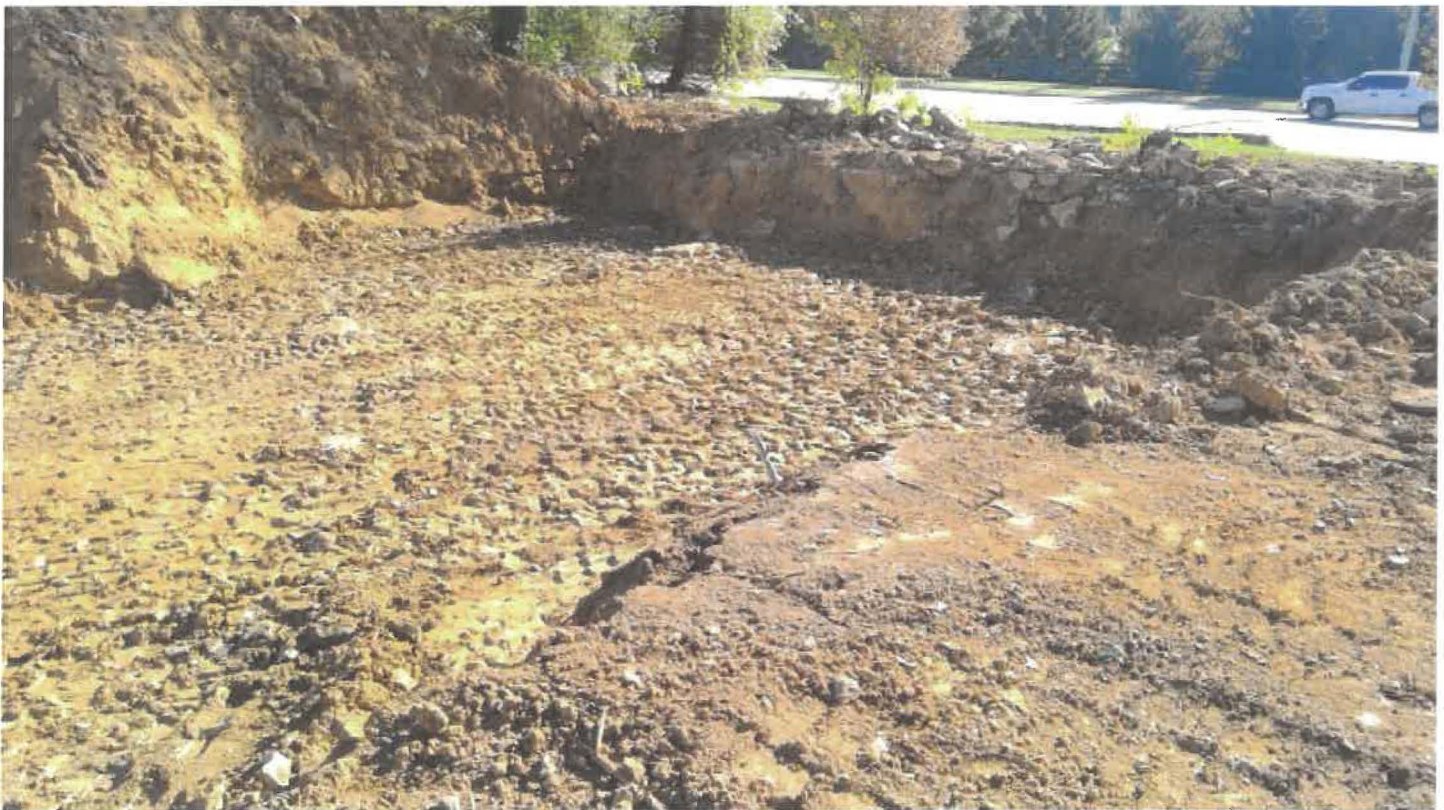
House on Turkeyfoot

Performed field density tests on fill material placed on the demolished house on Turkeyfoot and the central Building pad. The compaction and moisture content results comply with project specifications at the locations and elevations tested. The contractor was notified of test results.

The writer also shared the importance of rolling/sealing the fill adjacent to the sheer walls of the demolished area undercut.
