August 7, 2023

Re: Structural Observation at Estill County Middle School

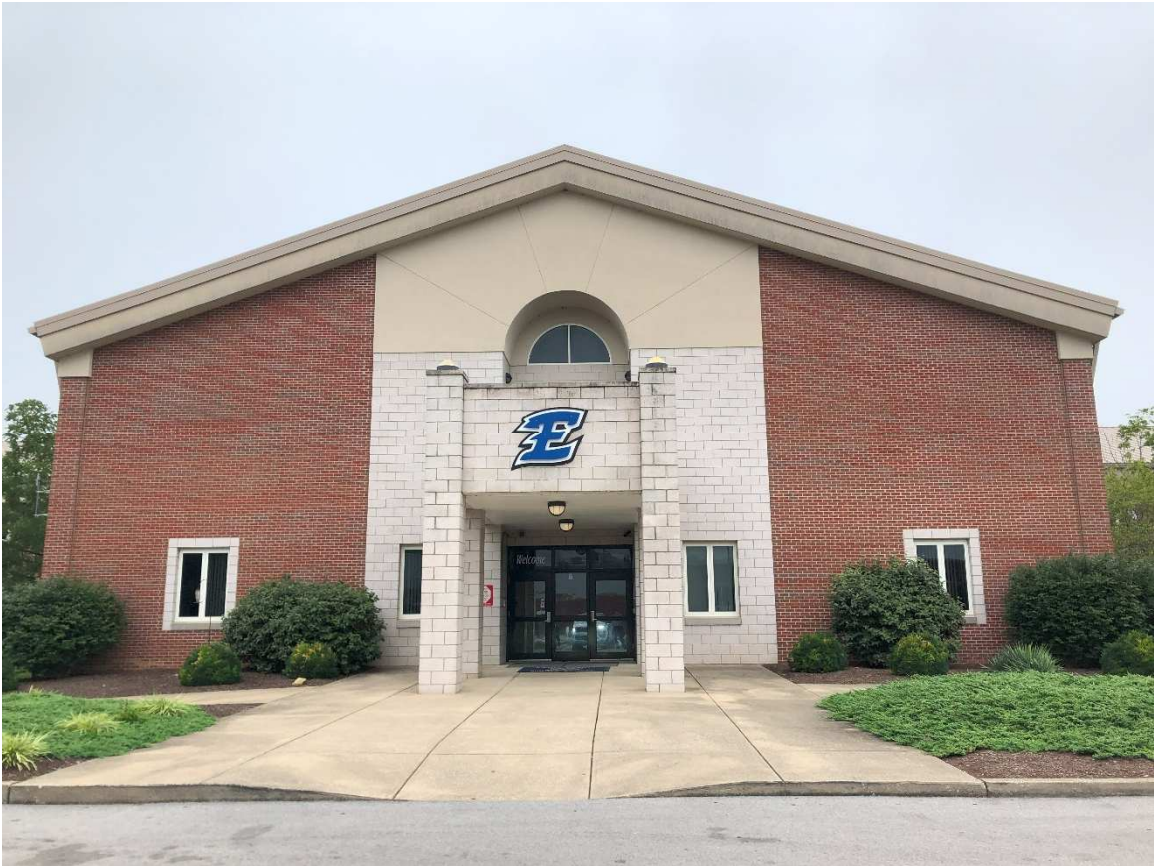
Front entrance of school

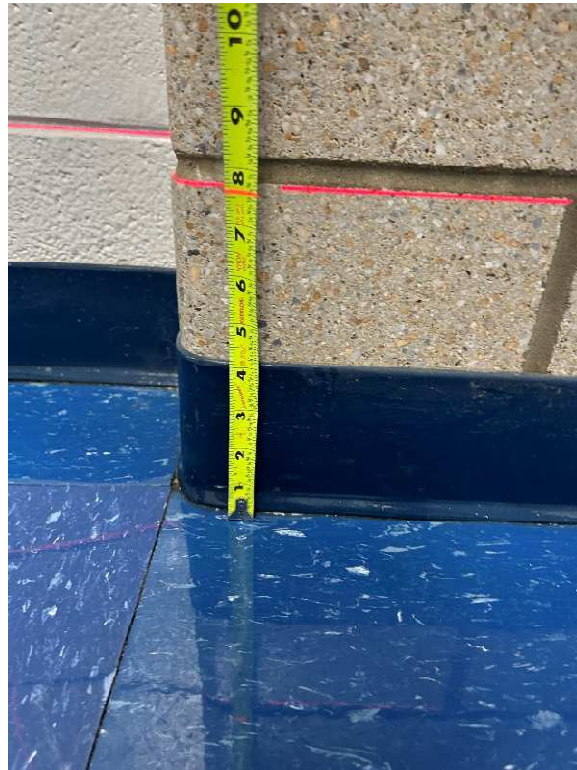
Laser level establishing reference point at front pilaster mortar joint

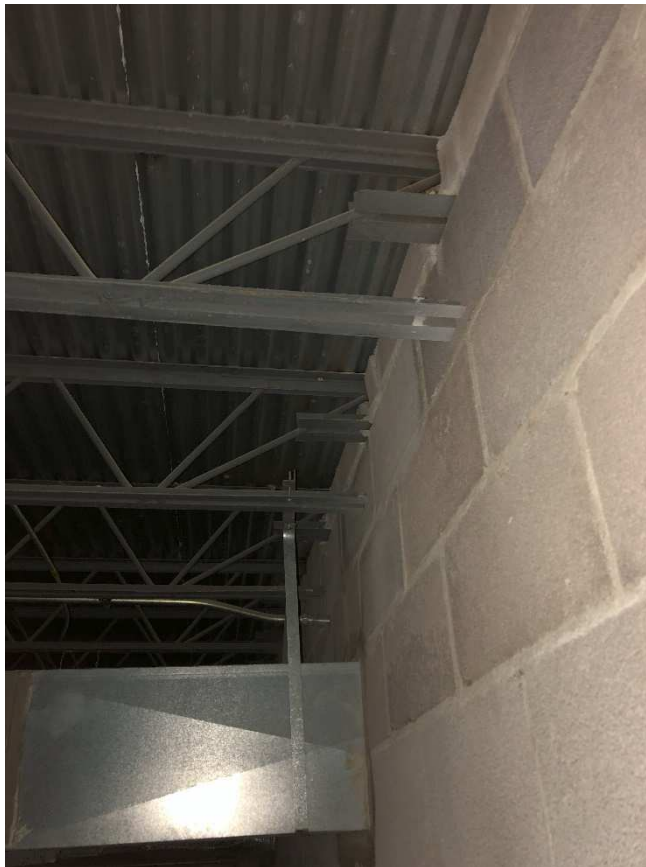
Joist bearing. No apparent issues at bearing locations observed.
