Inspection Report

Powell County Schools
Powell County High School
700 W College Ave
Stanton, KY 40380

Site Overview

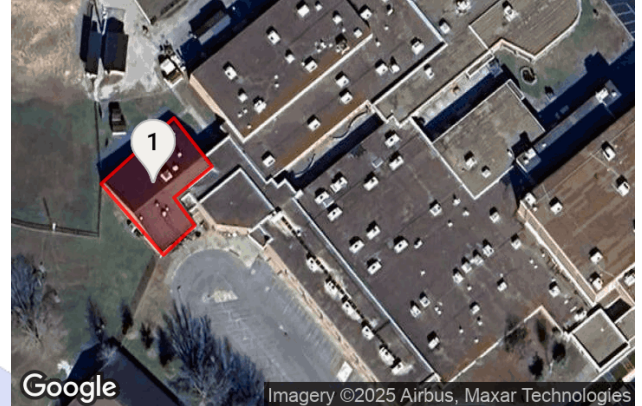
The current roof system has two layers of shingle on it. We recommend a full tear off of the existing roof and a replacement with either standing seam or shingles.

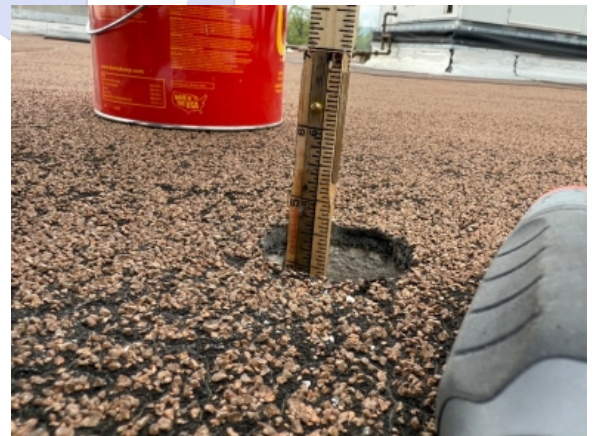
Core Sample Thickness

Core Sample was 4.5" to Tectum Deck

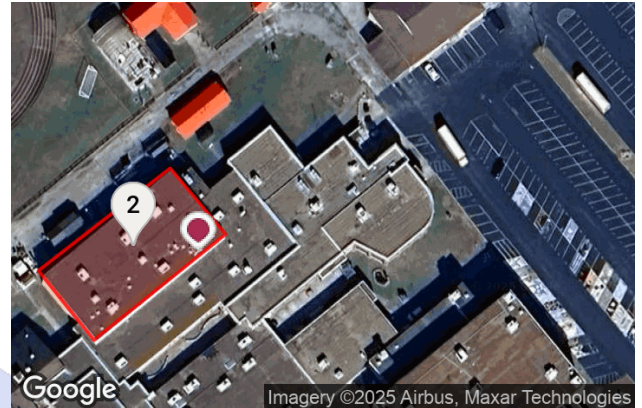
1

Improper Flashing (Emergency)

During roof project remove this penetration flashing and patch deck.

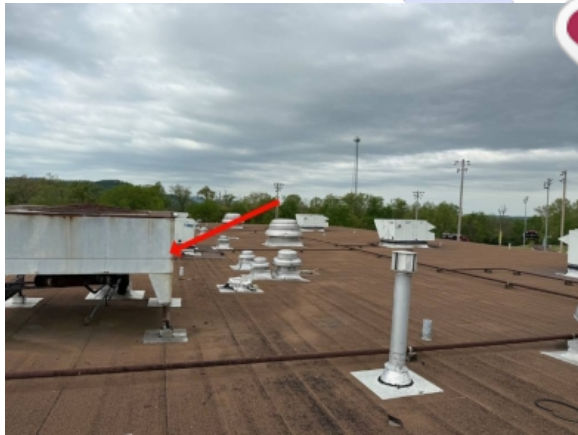
2

Wildlife Living Inside Unit

Properly remove wildlife from unit as to prevent damage to internal components.

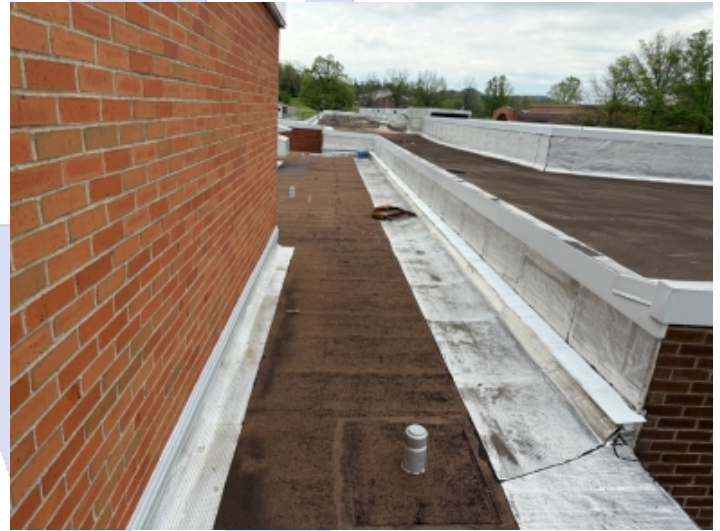
Debris & Granules in Drain Area

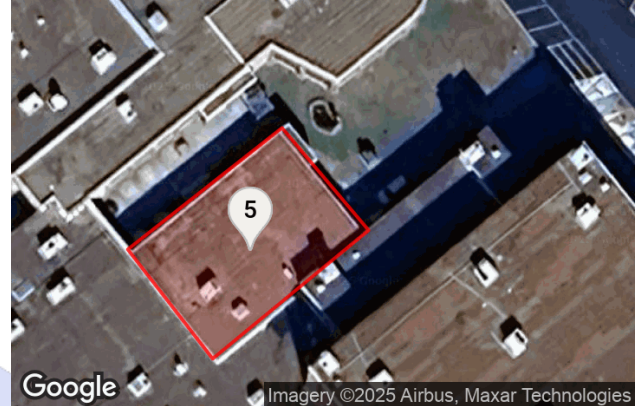
This roofing section is consistent with other evaluated systems. There does seem to be a thermal anomaly near one of the units. Further investigation is needed to determine the extent if any of moisture intrusion inside the roofing system.

We recommend a membrane overlay for this section with possibly some light roof removal for moisture damage.

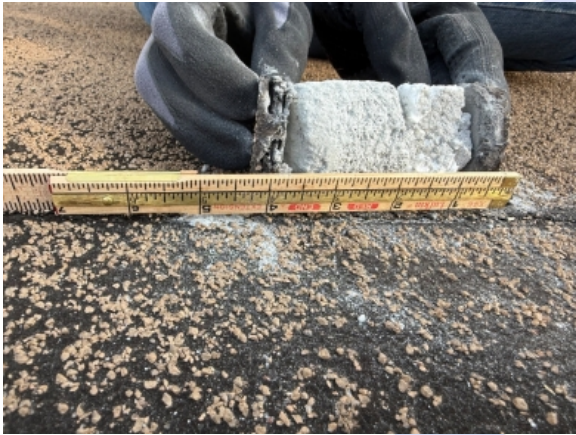
Core Sample

Roof Composition:

- Modified Bitumen
- LWIC
- EPS
- Tectum Deck

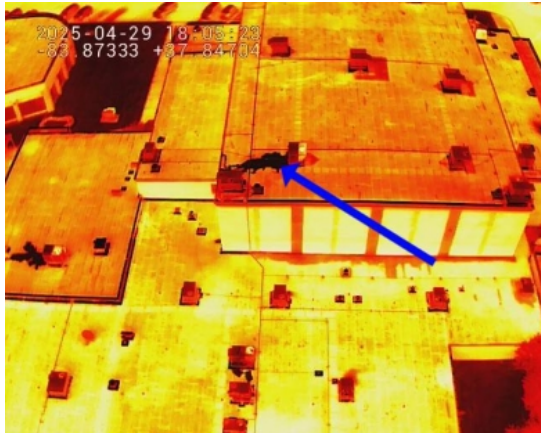
1

Possible Thermal Anomaly

The thermal anomaly at the referenced location could indicate moisture saturation in the existing system.

Perform additional investigation to determine moisture content.

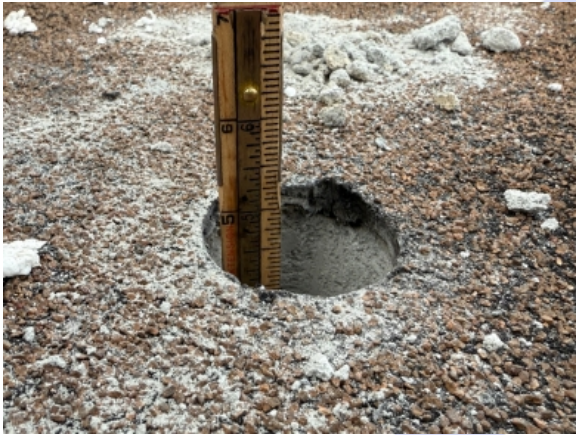
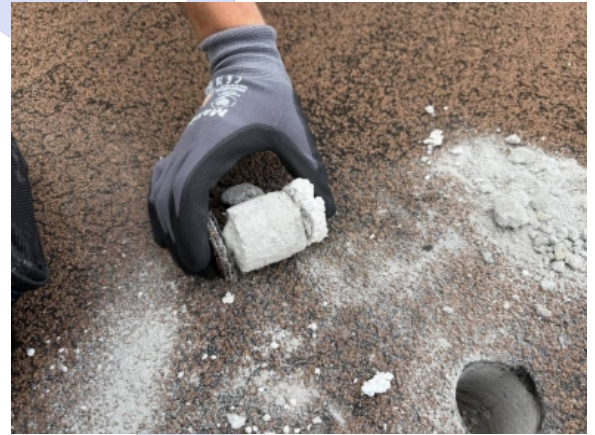
Core Sample Thickness

We took 3 core samples from this roof system to determine whether the slope was in the deck or in the roofing system. We determined that the roof slope was in the deck through these tests.

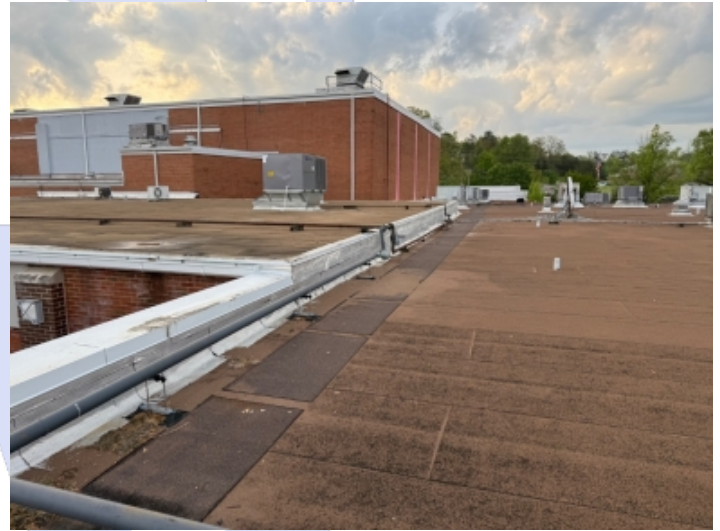
Wall Flashing Degradation
