**CONSENT ITEM B-4**

**OLDHAM COUNTY BOARD OF EDUCATION**

Consider Approval of Change Order #5 to the Site Access Improvements at Various Elementary Schools Ph. 2 project.

DATE: 12/2/25 CO #: Five (05)  
TO: Redlee Construction & PROJECT: Oldham Co. Elementaries Site  
Development, Inc. & Access Imp. – Phase 2  
800 Stonecreek Parkway, Suite 5A Oldham County, Kentucky  
Louisville, Kentucky 40223 BG 24-109  
RTA 23050  
CONTRACT DATE: September 20, 2024 CONTRACT FOR: General Construction

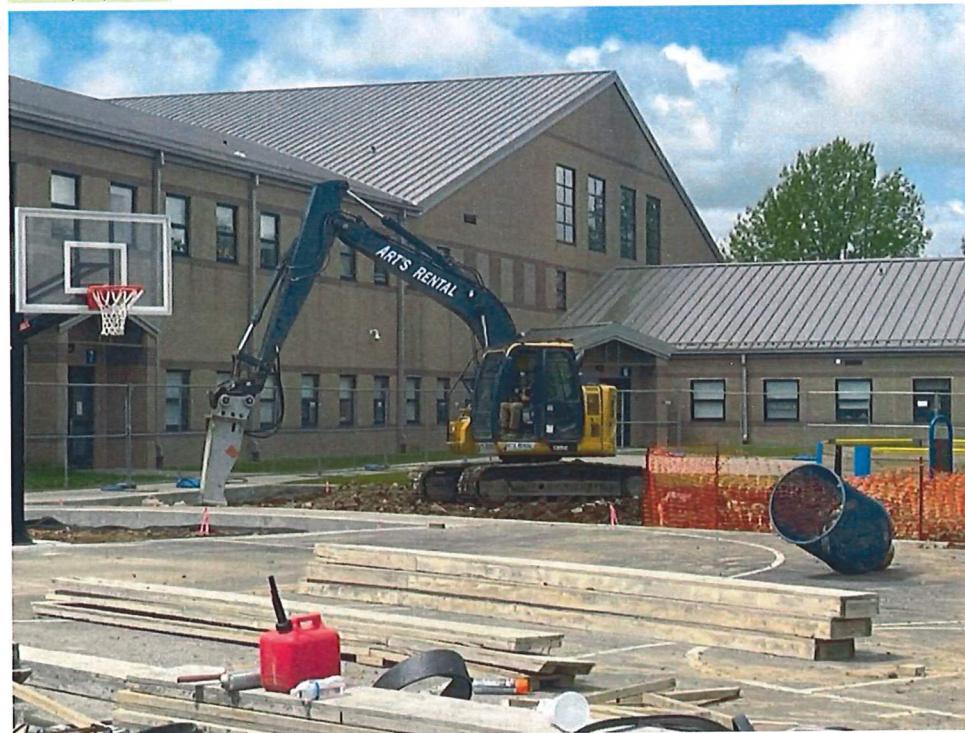
(4)

2 areas of bed rock encountered.  
Area 1 (right) 16' x 9'  
Area 2 (left) 16' x 7'

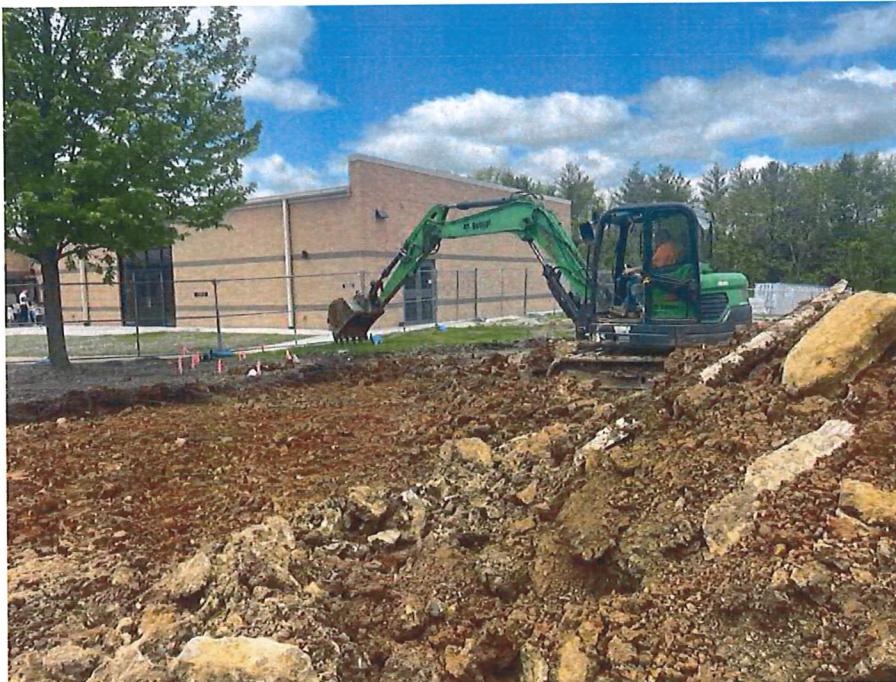
(5)

Rock excavated with excavator hammer.

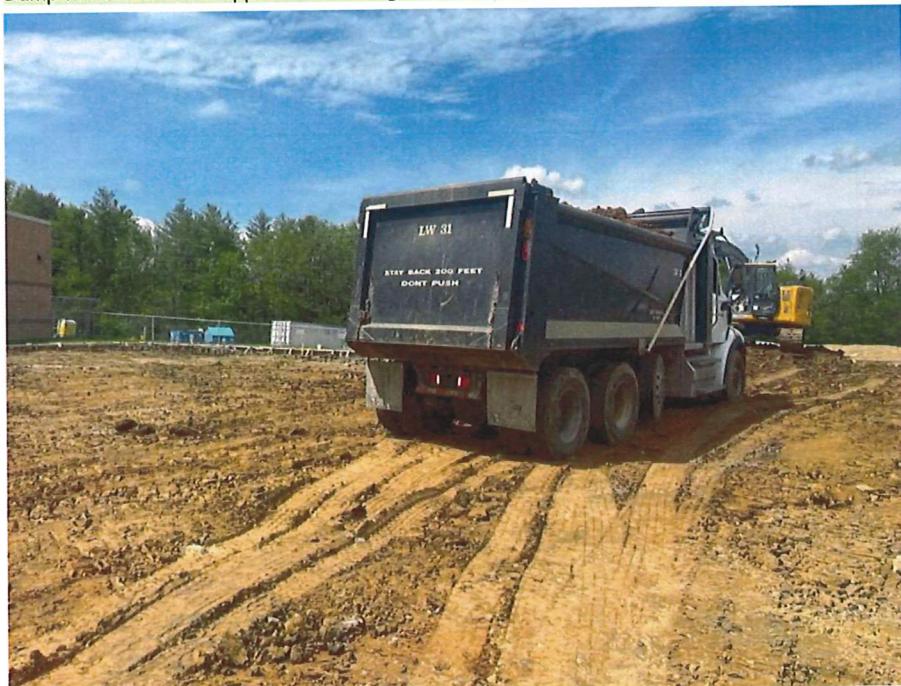
(8)

Dump Truck loaded with approximate average of 15 C.Y per truck. Truck loads removed today totaled 18 trucks.

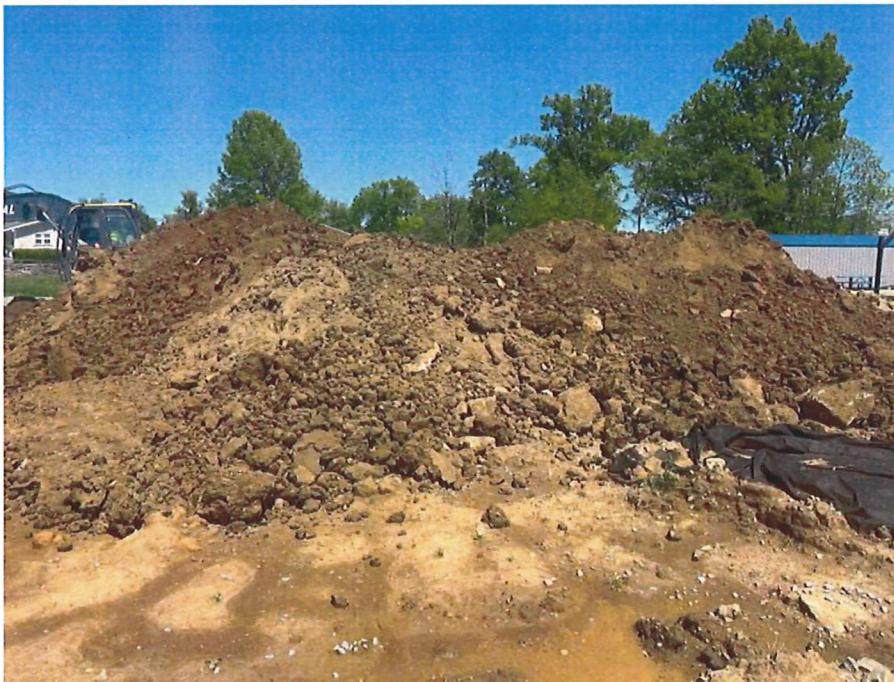
(6)

Rock and cobbles removed and stock piled.

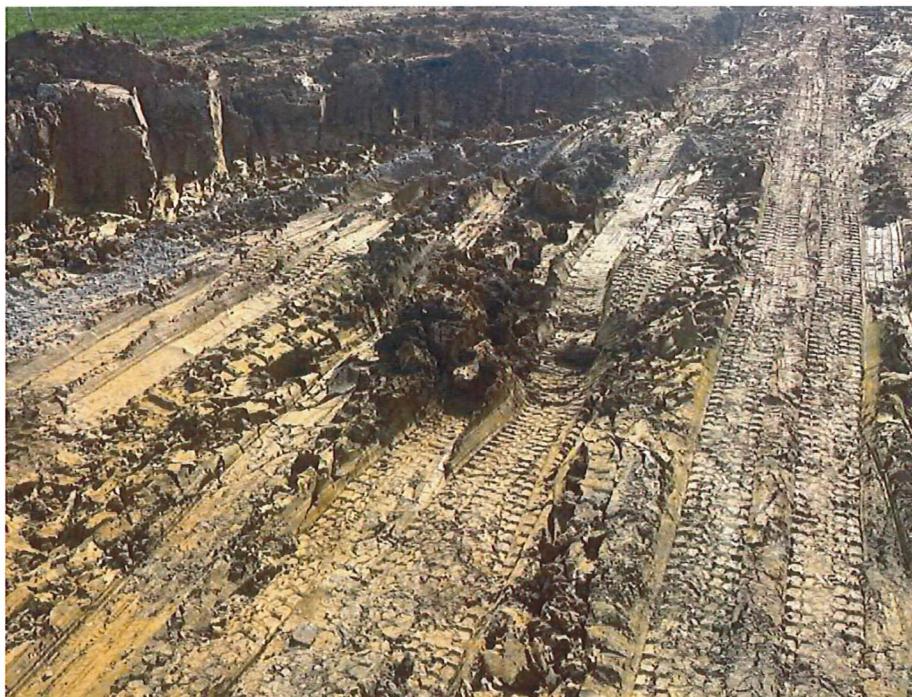
(4)

12" of organic material removed per engineered recommendation.

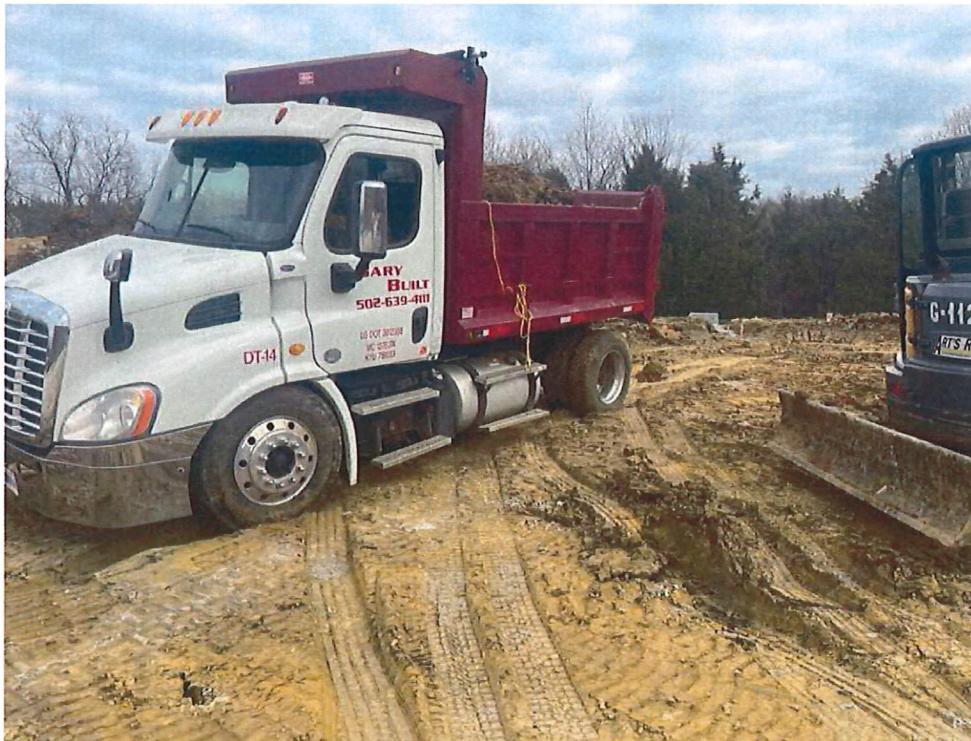
(6)

13' by 16' area of soft soil due to organics encountered. Contractor to remove soft soils down to competent material.  
(Southwest corner)

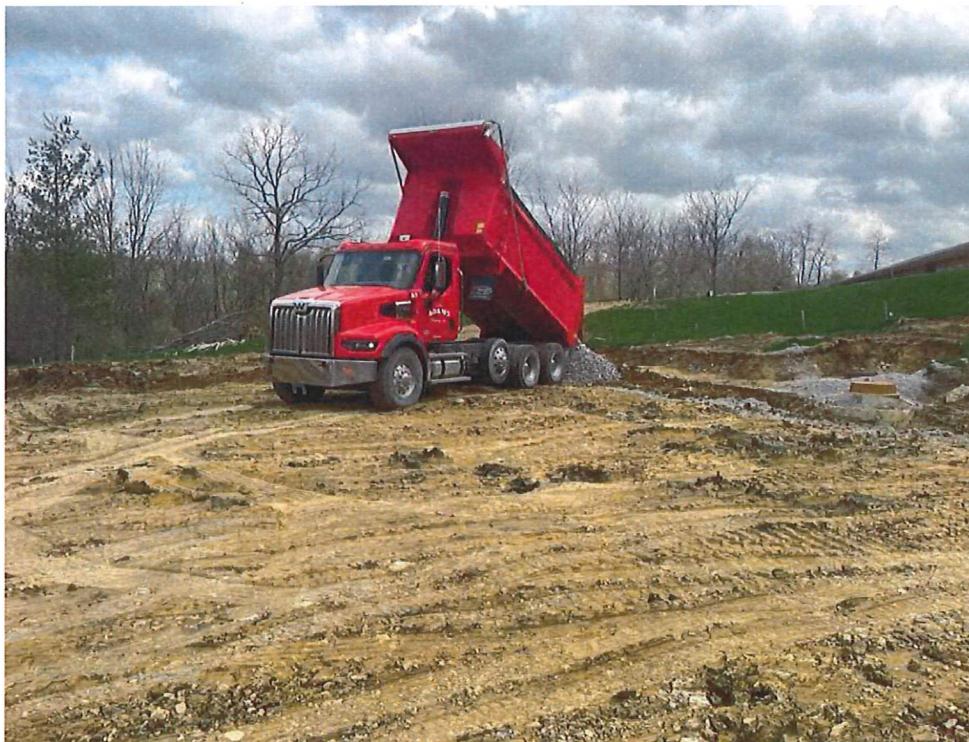
(10)

Contractor observed removing soft soils.

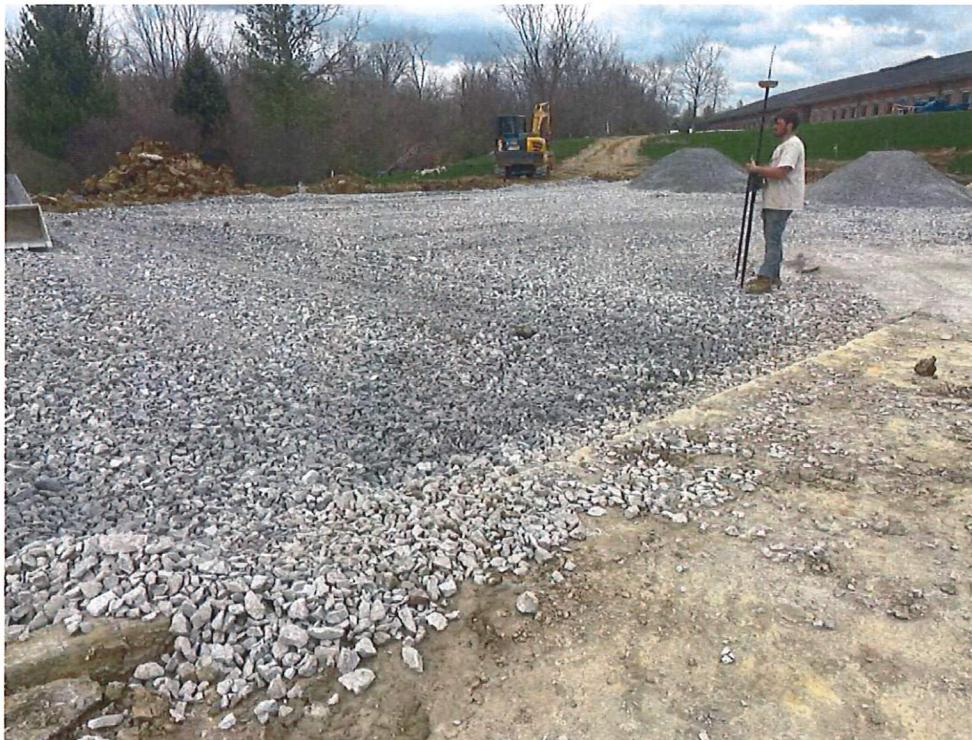
(12)

Contractor observed placing #3 stone.

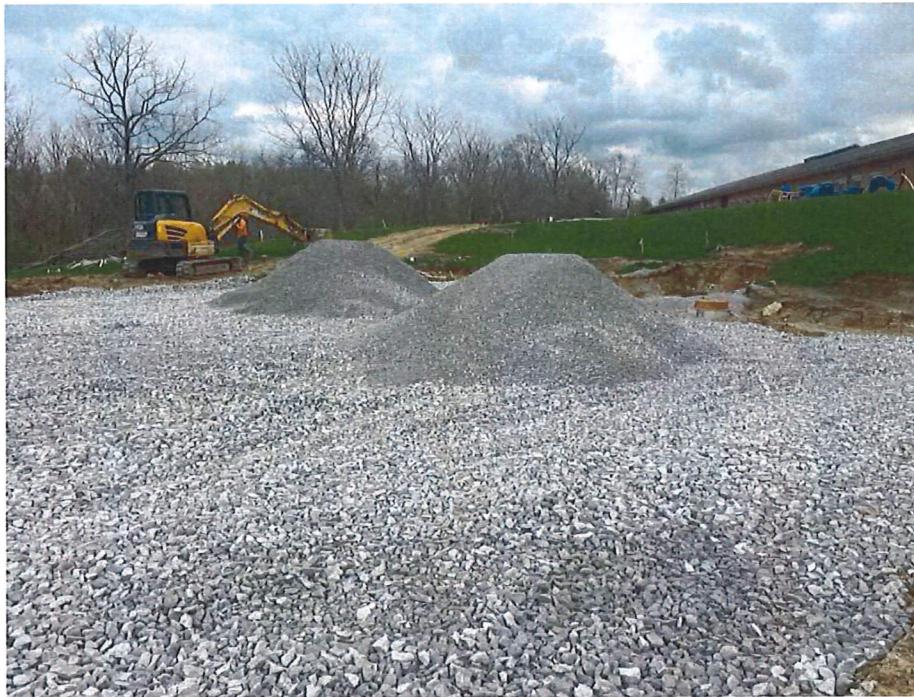
(13)

#3 stone place in and walked in by contractor.

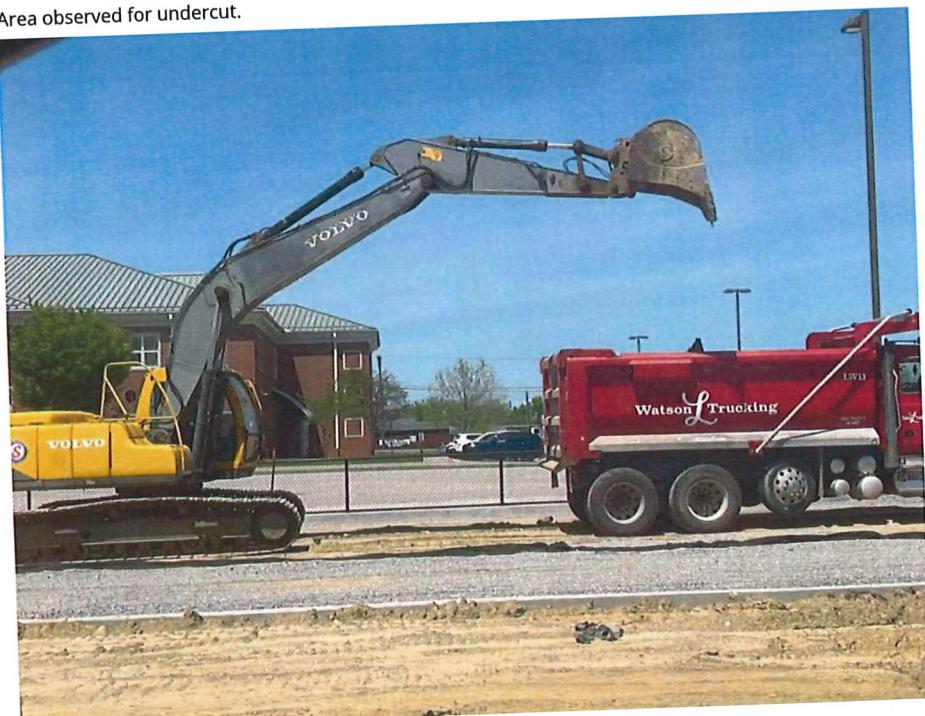
(8)

Area observed for undercut.
